MD Helicopters, LLC

***MD500C (369H) Series
Service Letters Package***

MODEL 369H (500C) HELICOPTER SERVICE LETTER INDEX

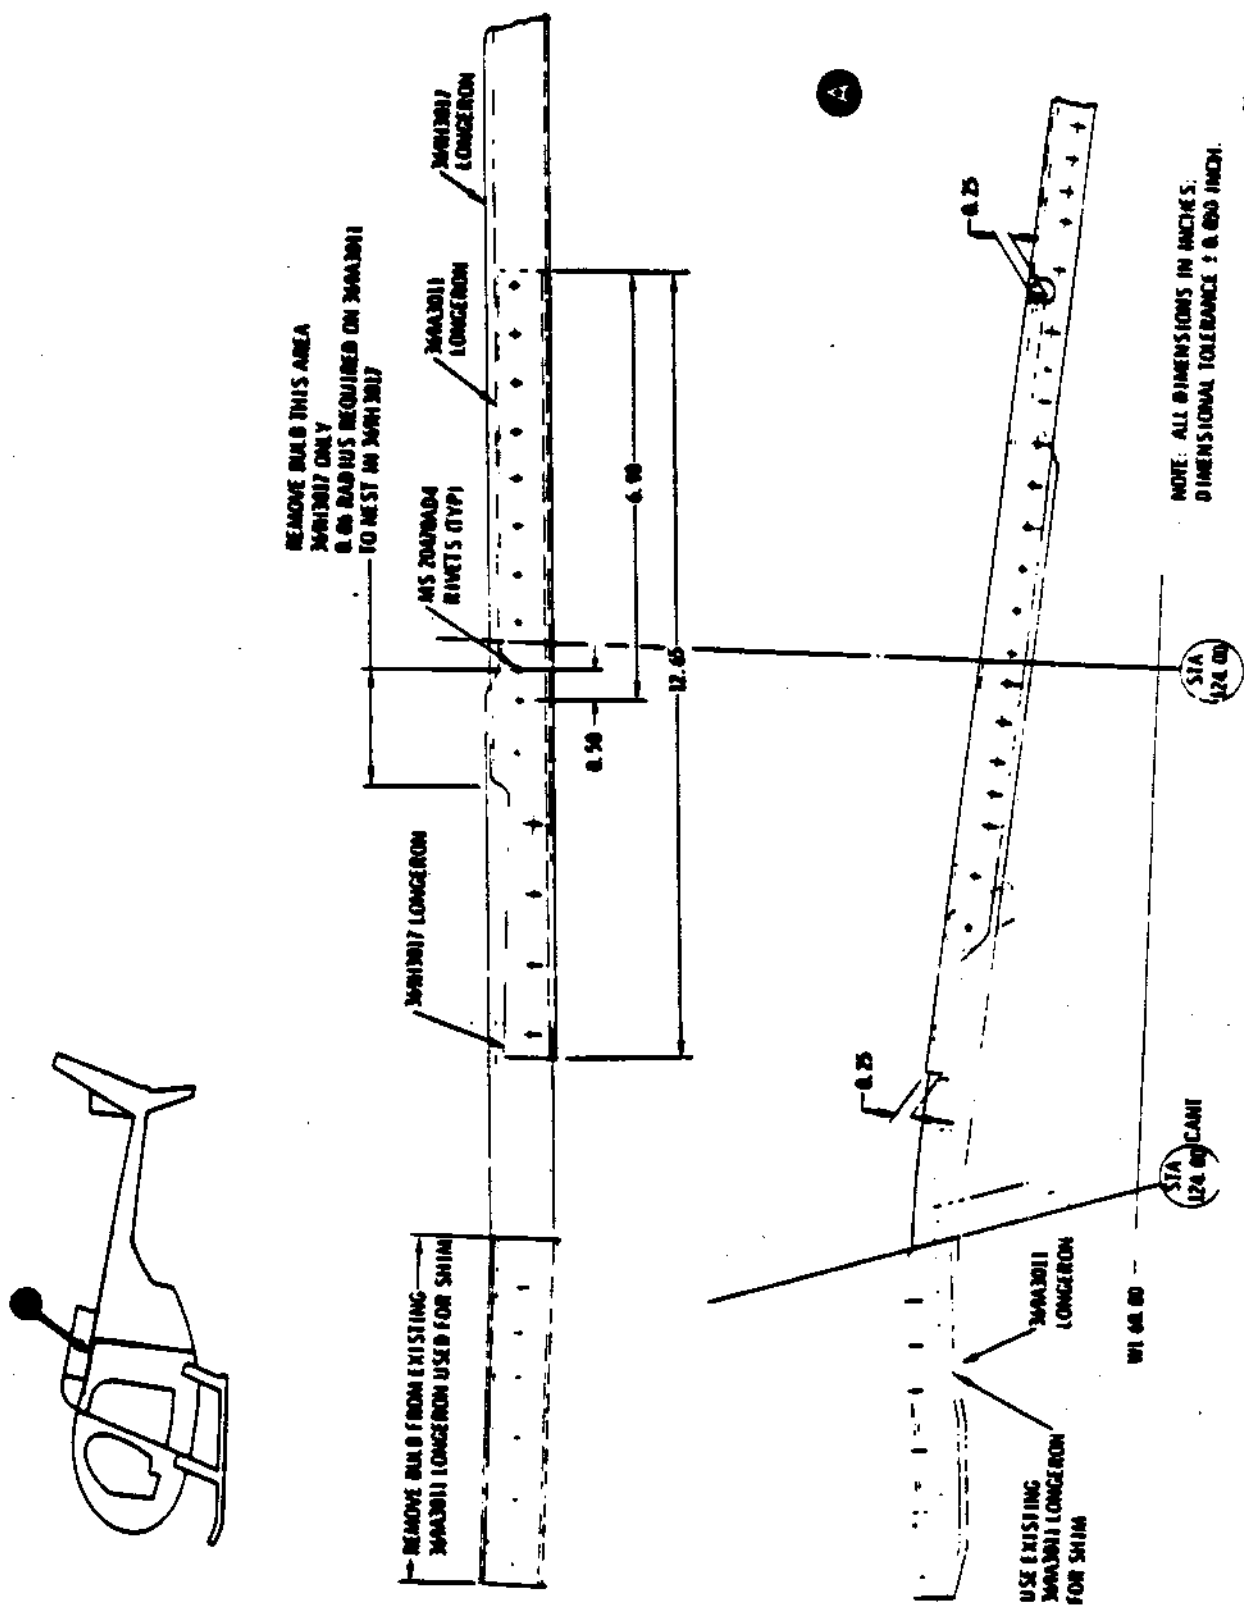
Figure 1. Modification and Replacement of Boom Fairing Assembly

Due to the difference in design of the mast support structure used on the above affected first production helicopters, it is necessary, when installing a replacement boom fairing assembly, to modify and lengthen the 369H3017 upper longerons to permit attachment at the mast support structure.

It is noted that modification of the 369H3017 upper longerons is not required when installing a replacement boom fairing assembly on later model helicopters, SN 0101 and subsequent. If further information is required, contact your Hughes Service Center or Field Service Representative.

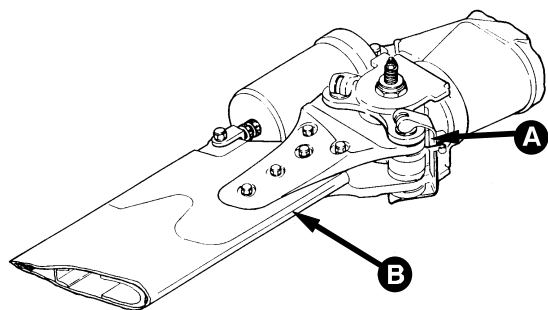
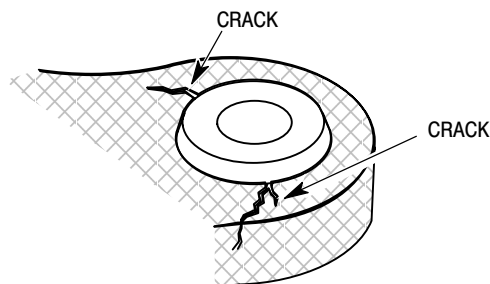
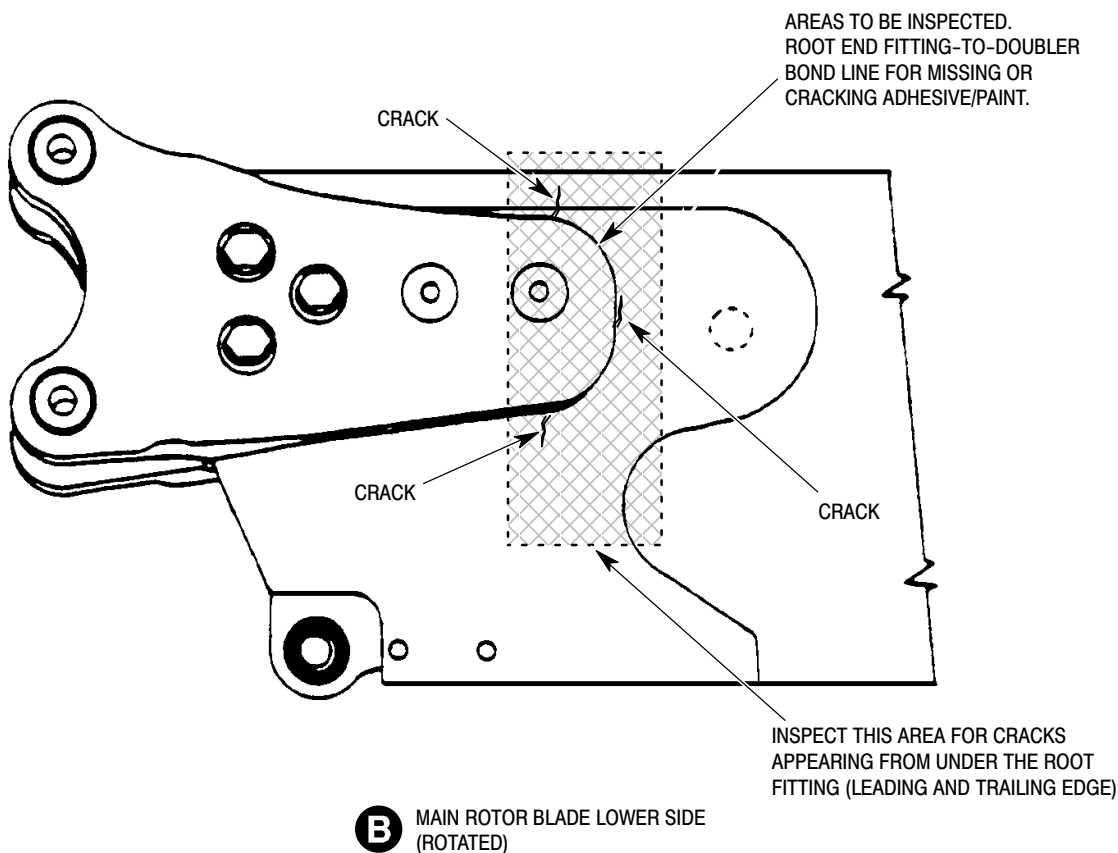
Figure 1. Main Rotor Blade and Lead-Lag Link Critical Areas

A MAIN ROTOR BLADE UPPER AND LOWER
ROOT FITTING AND LEAD-LAG LINK LUG
CRITICAL INSPECTION AREA
