***MD Helicopters, LLC***

***MD500/600 Series***  
***Service Bulletins Package***

## MODEL 369D, 369E, 369F/FF, 500N, 600N HELICOPTERS (500D, 500E, 530F, 520N, 600N) SERVICE BULLETIN PACKAGE TABLE OF CONTENTS

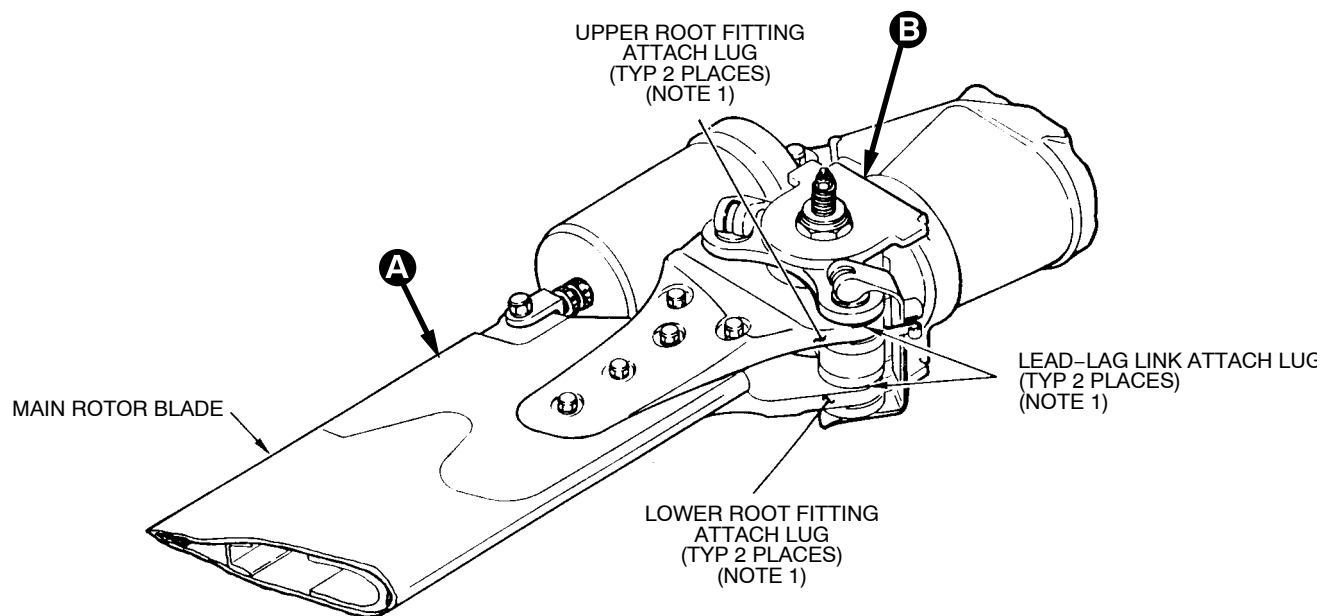
1. VISUALLY INSPECT AREAS OF ALL ROOT FITTINGS AND LEAD-LAG ATTACH LUGS FOR CRACKS OR BREAKS. INSPECT BLADE ATTACH BUSHINGS FOR LOOSENESS. IF LOOSE, REPLACE LEAD-LAG LINKS (REFER TO TEXT).
2. PAY PARTICULAR ATTENTION TO AREA AROUND ATTACH PIN HOLES IN LUGS.
3. SEAL ALL JUNCTIONS BETWEEN BUSHINGS AND ATTACH LUGS WITH SEALER OR PRIMER (REFER TO MATERIALS TABLE).
4. LEAD-LAG LINK ASSEMBLIES ARE SUBASSEMBLIES OF THE MAIN ROTOR HUB ASSEMBLY.

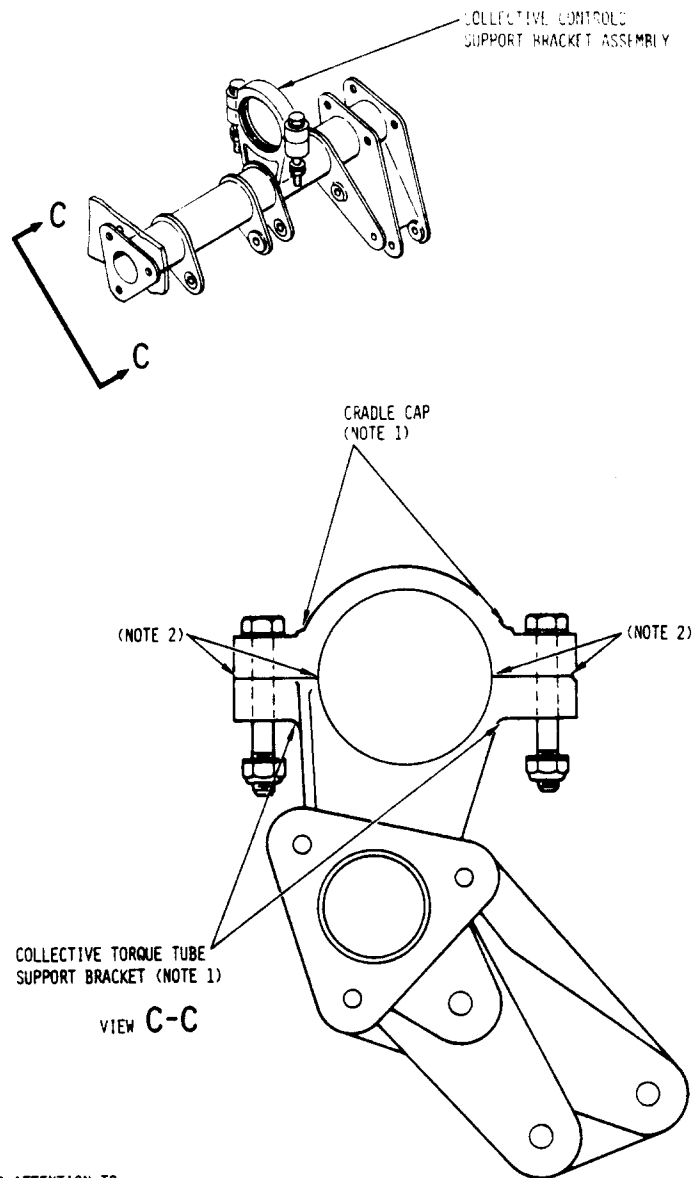
1. PAY PARTICULAR ATTENTION TO ATTACH LUG AREAS FOR CRACKS.
2. CHECK FOR GAPS BETWEEN CRADLE CAP AND BRACKET; PAY PARTICULAR ATTENTION TO MATING AREA NEXT TO TORQUE TUBE O.D. FOR GAPS.

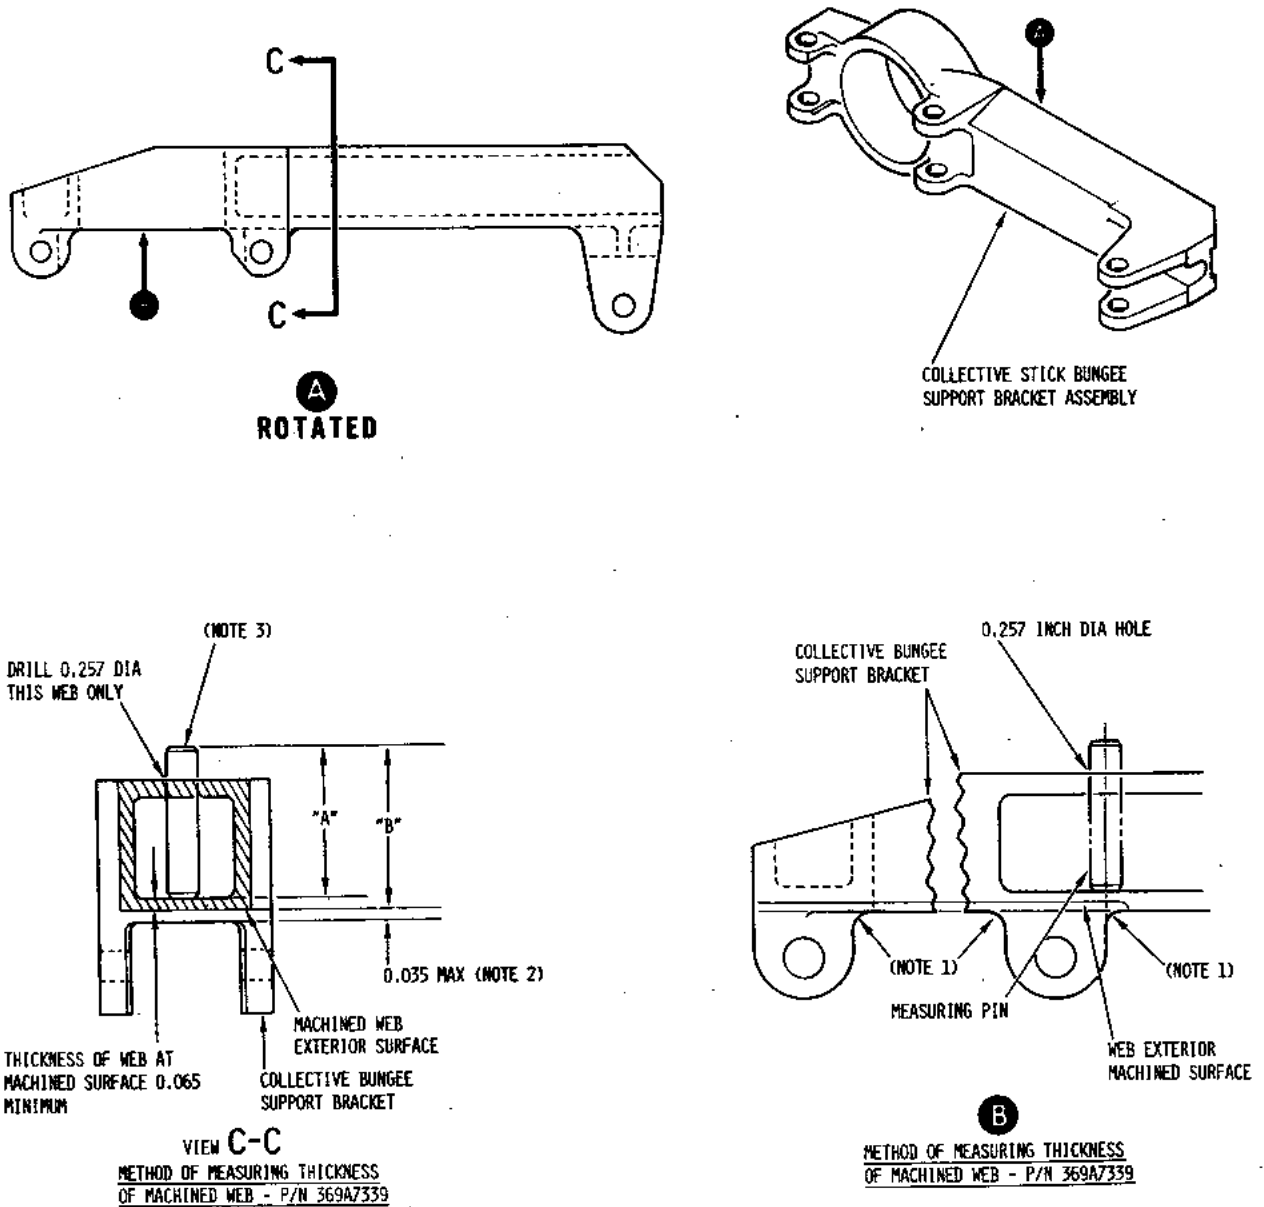
1. CHECK LUG AREAS FOR CRACKS, NICKS, GOUGES, SURFACE DAMAGE.
2. IF DEPTH IS GREATER THAN 0.035, CHECK THICKNESS REMAINING AS SHOWN.
3. MAKE PIN FROM 0.250 BOLT, SQUARE ENDS, MINIMUM LENGTH 1.25.
4. ALL DIMENSIONS IN INCHES.

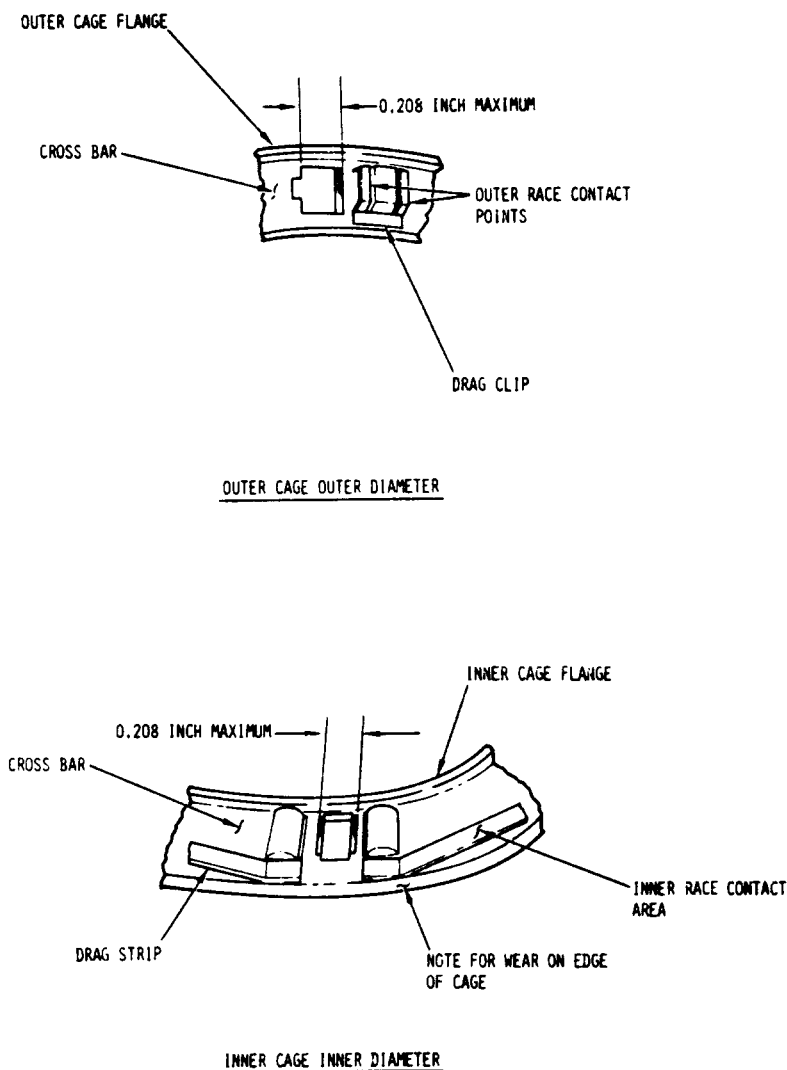
88-467

**Figure 1. Cage Wear Limits**

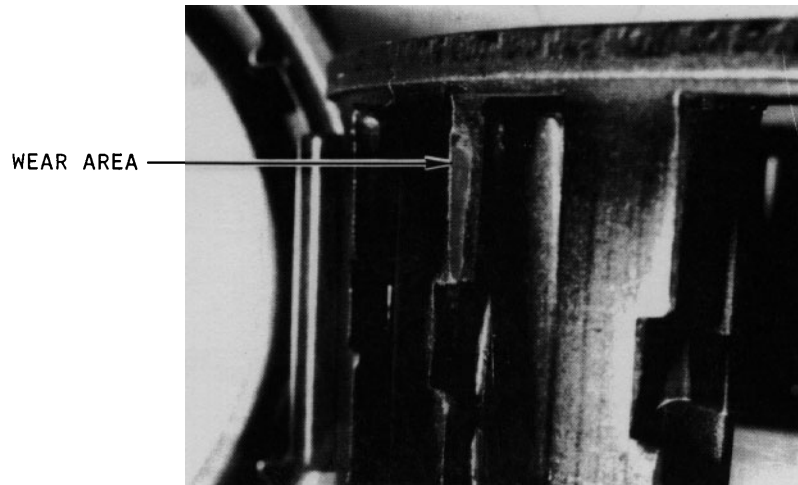
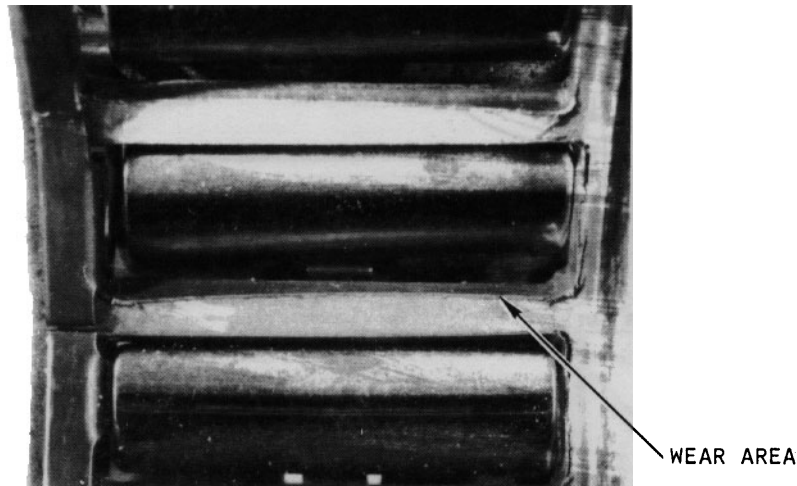
OUTER CAGE WEAR AREA

INNER CAGE WEAR AREA

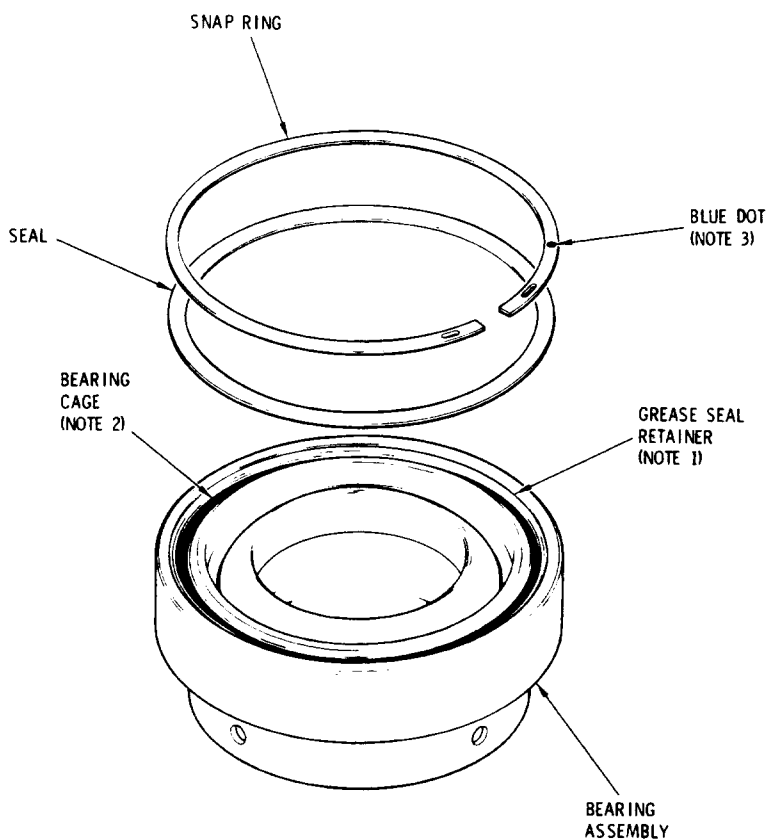
1. PART NO. AND SERIAL NO. ARE INK STAMPED ON GREASE SEAL RETAINER.
2. IF BEARING CAGE IS MISSING BALLS WILL BE VISIBLE.
3. AFTER INSPECTION, PLACE BLUE ACRYLIC LACQUER DOT, 1/8 INCH DIAMETER, ON SNAP RING AS SHOWN.

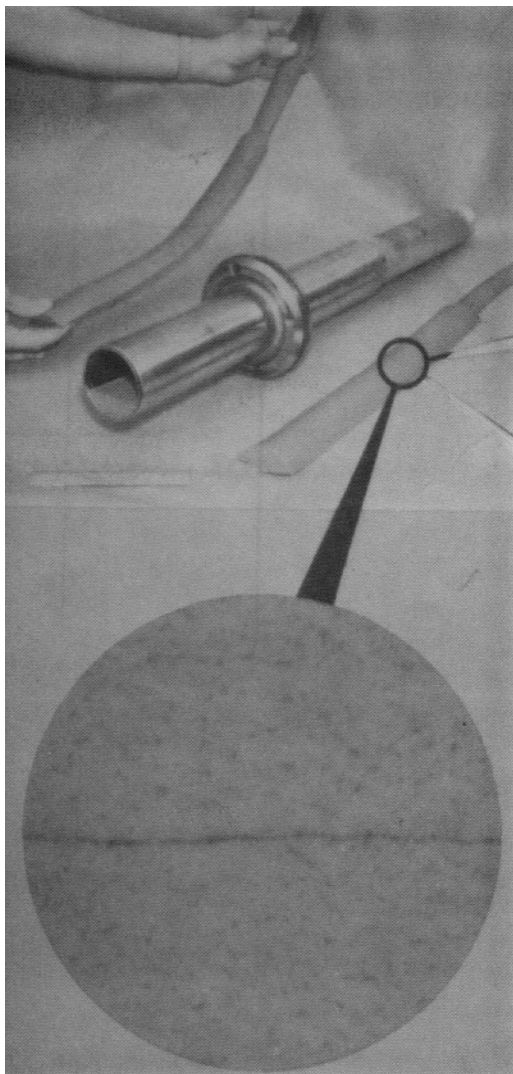
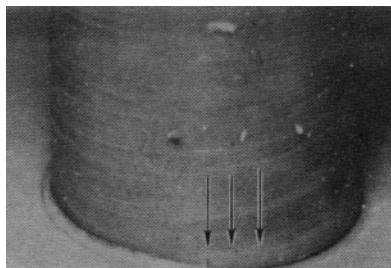
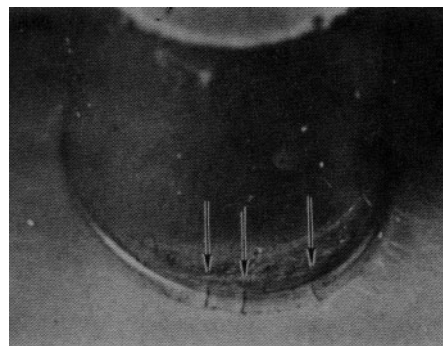
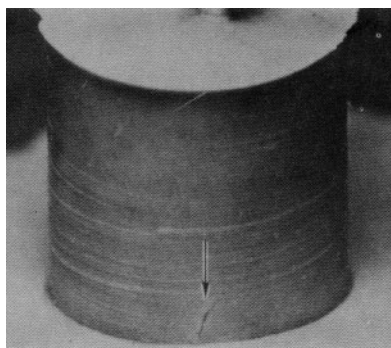
INDICATIONS OF CRACKING  
WHEN VIEWED WITH A  
10X MAGNIFYING GLASS  
(UNACCEPTABLE DRIVE SHAFT)

A. EDGE CRACKS IN THE .002"  
TO .015" SIZE RANGE

B. .020" TO .030" EDGE CRACKS

C. INTERNAL CRACK IN HOLE IS .050'  
IN LENGTH

SMALL CRACKS EASILY SEEN UNDER 10X MAGNIFICATION

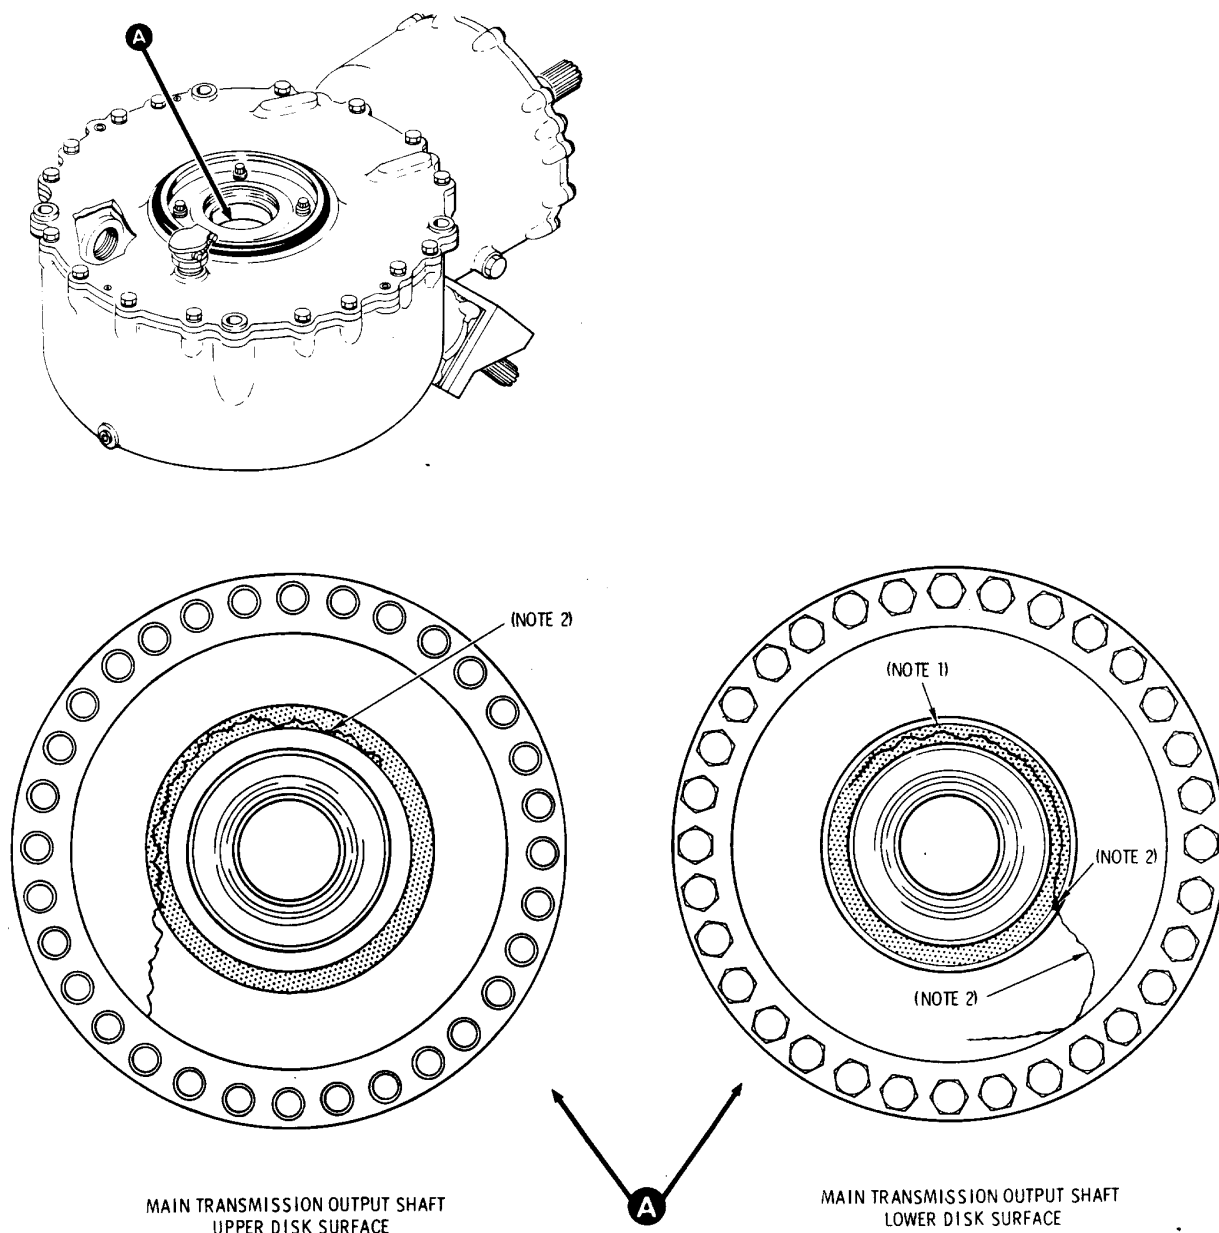
1. PAY PARTICULAR ATTENTION FOR CRACKS IN AREA OF ELECTRON BEAM WELD WHICH ATTACHES LOWER DISK TO OUTPUT SHAFT (SHADED AREA 360°).
2. PAY PARTICULAR ATTENTION FOR CRACKING OR CHIPPING IN FLAT SURFACE OF DISKS. SIMULATED CRACK PROPAGATION AND CHIPPING IS SHOWN.

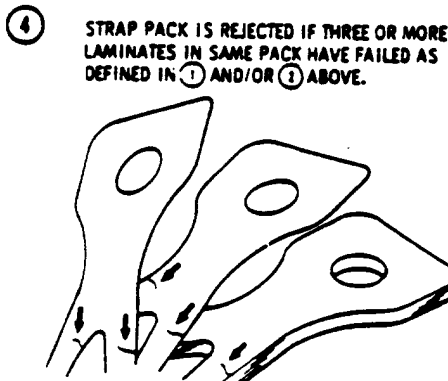
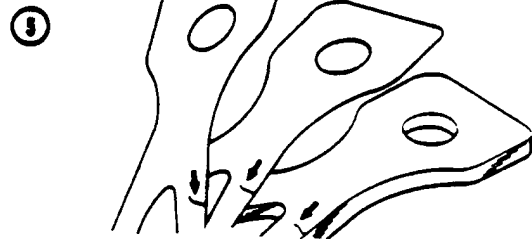
TWO LAMINATE FAILURES AS DEFINED IN ① AND/OR ② ARE ALLOWED IN EACH STRAP PACK ASSEMBLY. (TOTAL OF TEN LAMINATE FAILURES PER HUB ASSEMBLY.)

STRAP PACK IS REJECTED IF THREE OR MORE LAMINATES IN SAME PACK HAVE FAILED AS DEFINED IN ① AND/OR ② ABOVE.

STRAP PACK IS REJECTED IF THREE OR MORE LAMINATES IN SAME PACK ARE CRACKED IN THE LEG (LEAD OR LAG).

FAILED LAMINATE IF CRACK IS FOUND ON EITHER EDGE OF LAMINATE. IF ONE LAMINATE IS FAILED, REMOVE HUB.

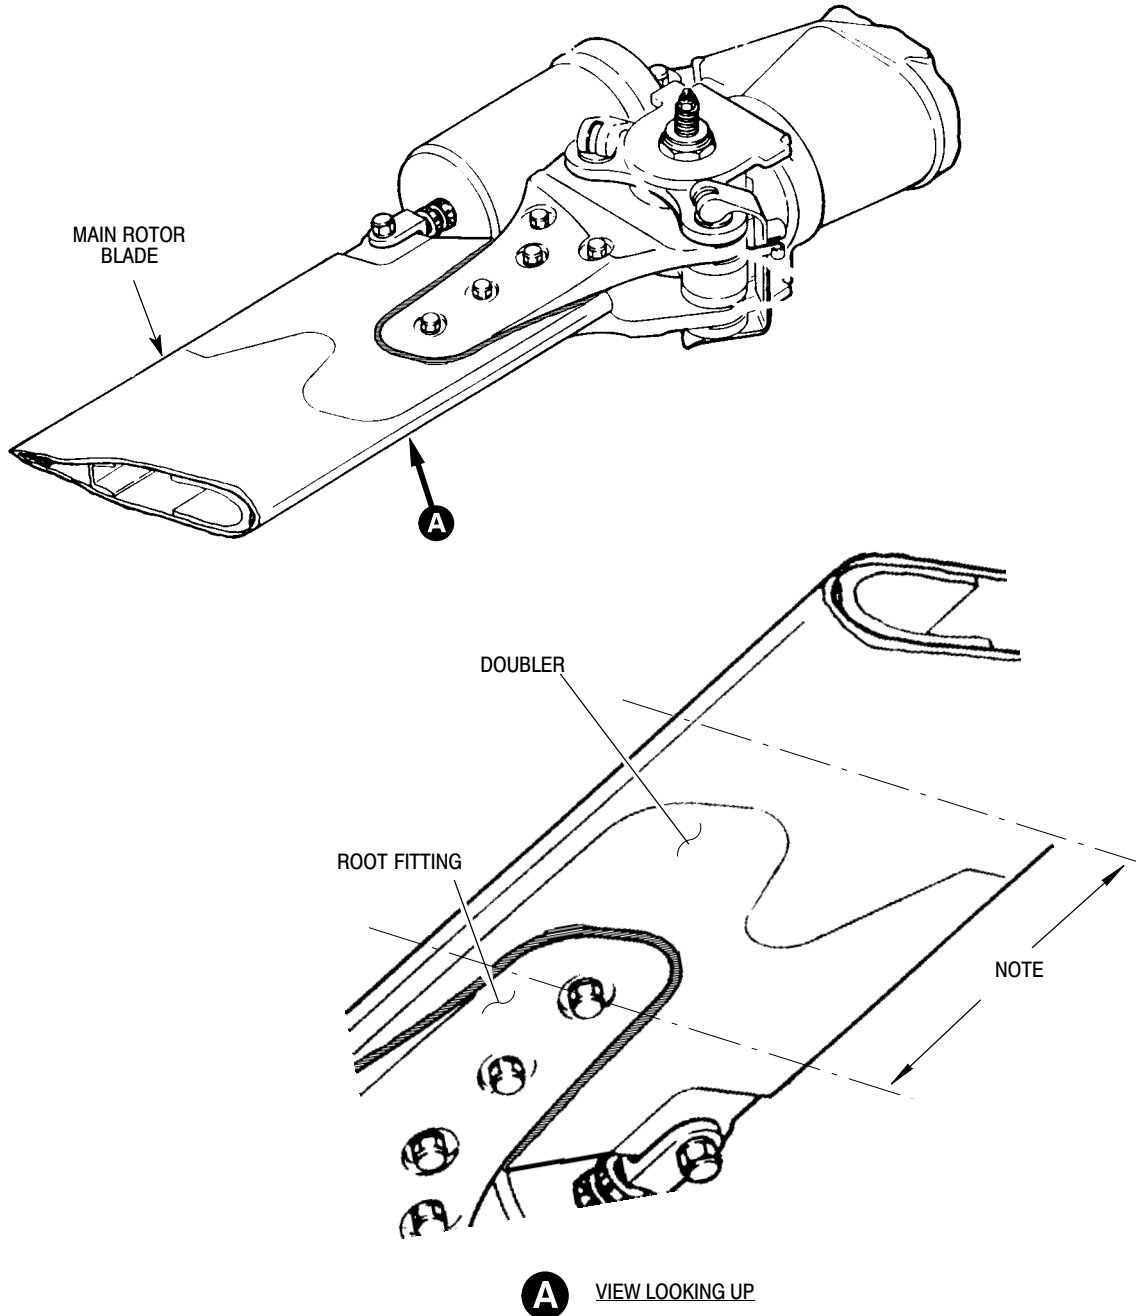
**NOTE:**  
USING BRIGHT LIGHT AND 10X MAGNIFYING GLASS, INSPECT FOR CHORDWISE CRACKS PROTRUDING FROM UNDER ROOT FITTING AND DOUBLER.

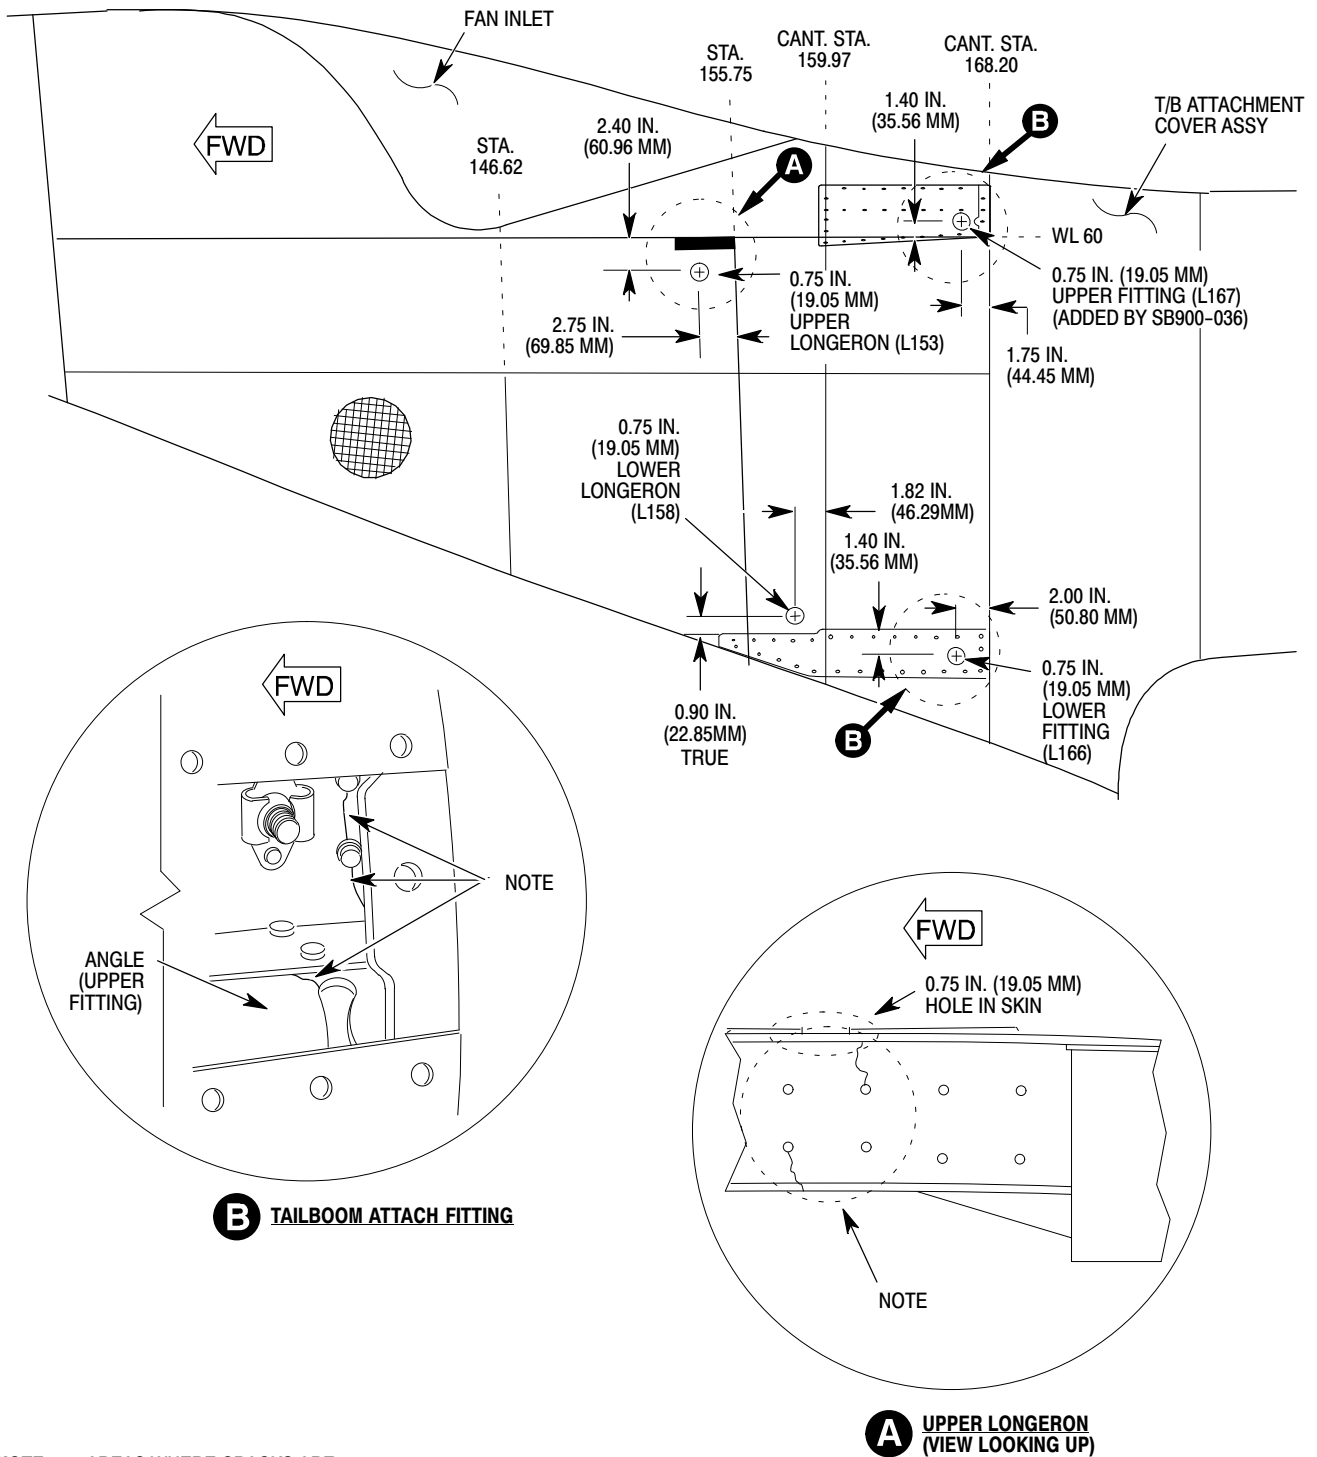
**NOTE:** AREAS WHERE CRACKS ARE MOST LIKELY TO APPEAR.

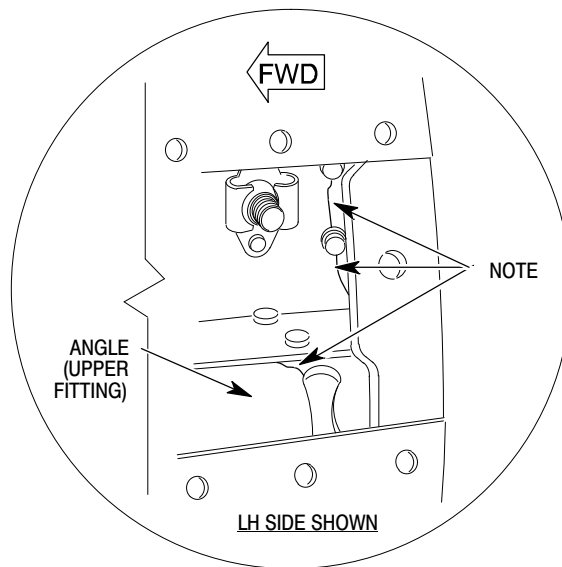
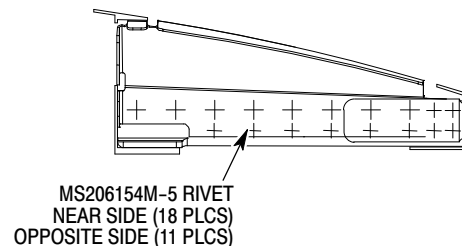
**NOTE:**  
AREAS WHERE CRACKS ARE MOST LIKELY TO APPEAR.

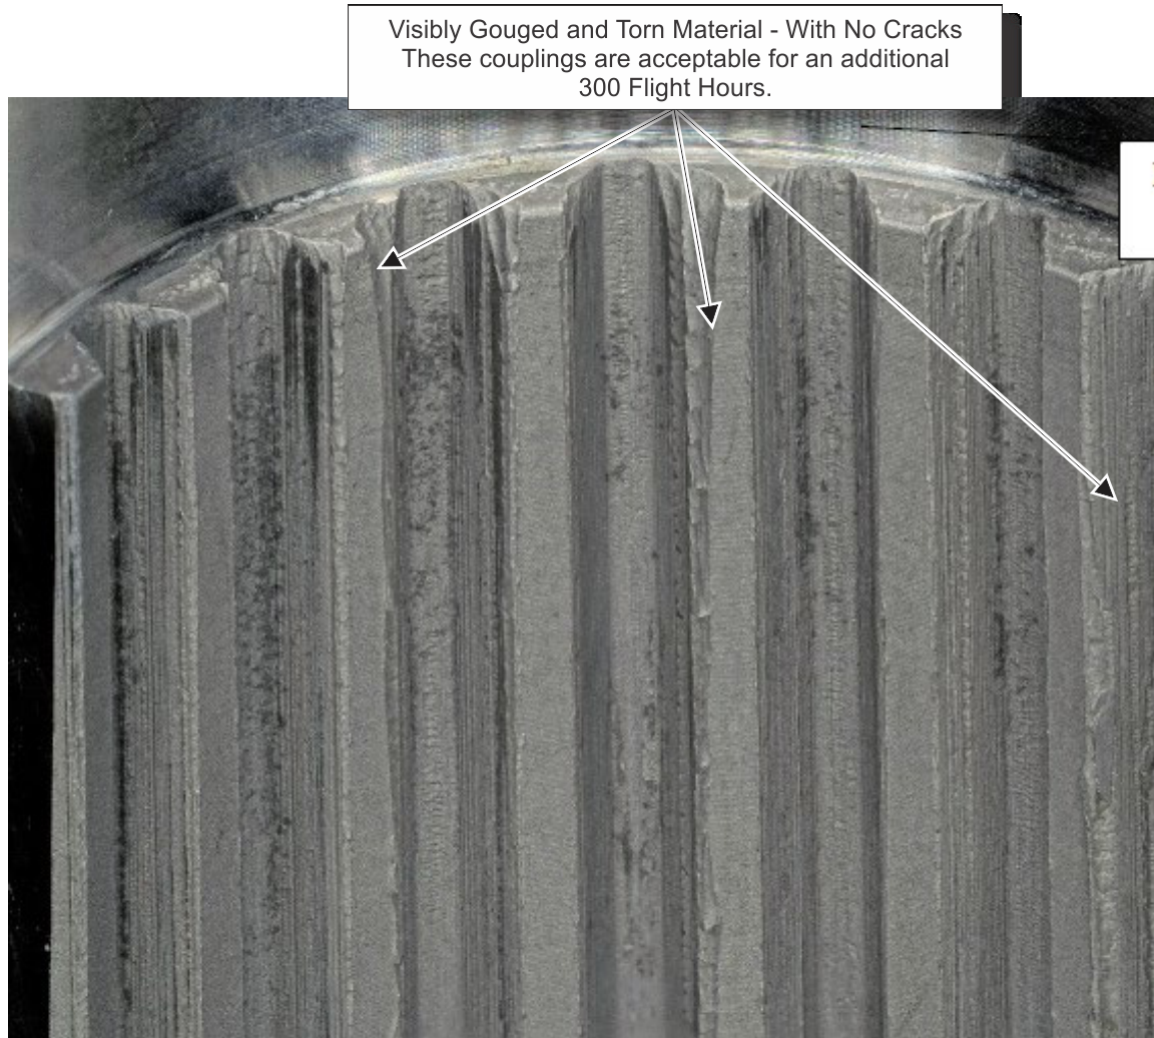
**NOTE:** COUPLINGS THAT HAVE NO CRACKS, BUT HAVE GOUGING OR TORN MATERIAL, ARE ACCEPTABLE FOR AN ADDITIONAL 300 FLIGHT HOURS. THEY MUST BE REPLACED AFTER 300 FLIGHT HOURS.
