MD Helicopters, LLC

***MD500/600 Series
Service Letters Package***

22 August 2023

MODEL 369D, 369E, 369F/FF, 500N, 600N HELICOPTERS (500D, 500E, 530F, 520N, 600N) SERVICE LETTER PACKAGE TABLE OF CONTENTS

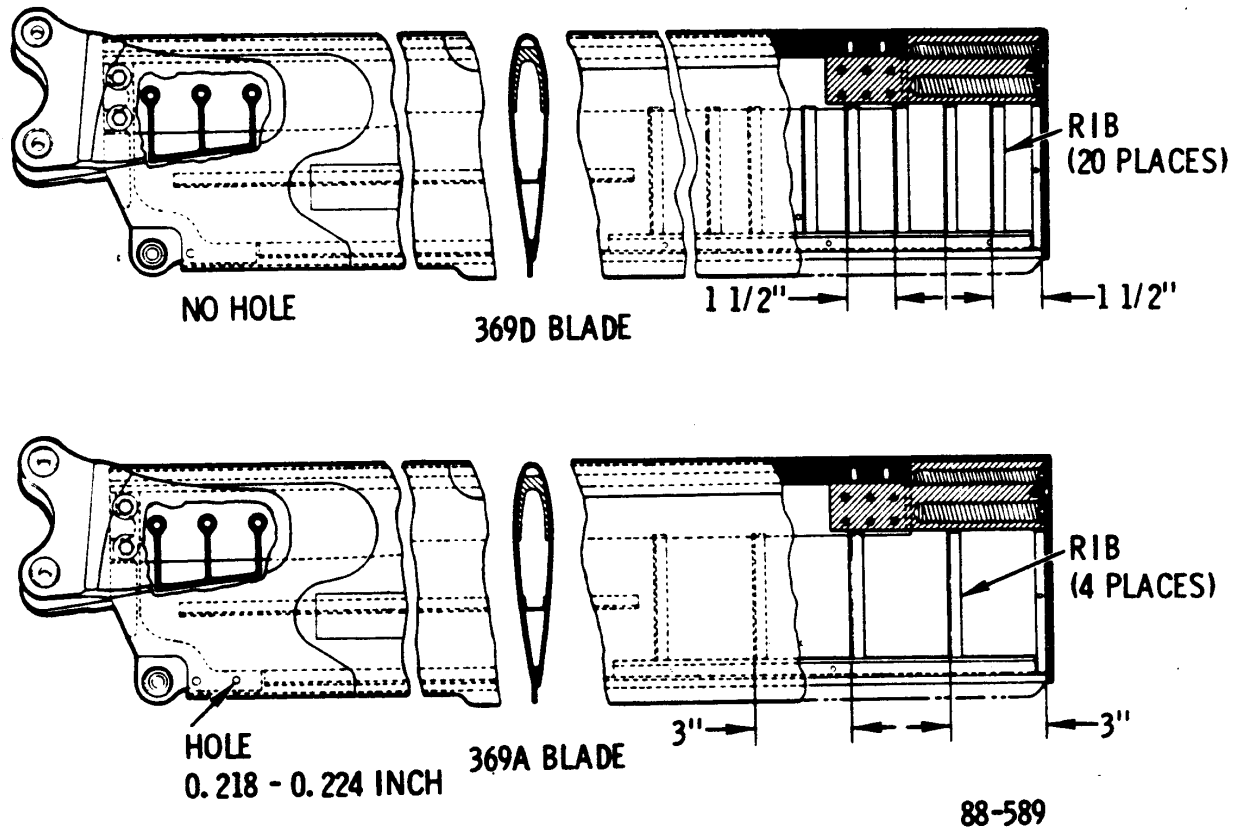
It is possible that more of these bogus main rotor blades have been sold. These blades have probably exceeded their FAA assigned service life. If used, they could fail, causing an accident in which personal injury could occur. In addition, use of these blades could void insurance claims.

Figure 1. Bogus 369D Main Rotor Blade Identification

Any main rotor blade found that has been altered or suspected of having been altered, should be removed from service or spares inventory immediately. Contact Hughes Customer Service Department, or your Hughes Service Center if any such blades are found, or if you have any questions concerning this matter.

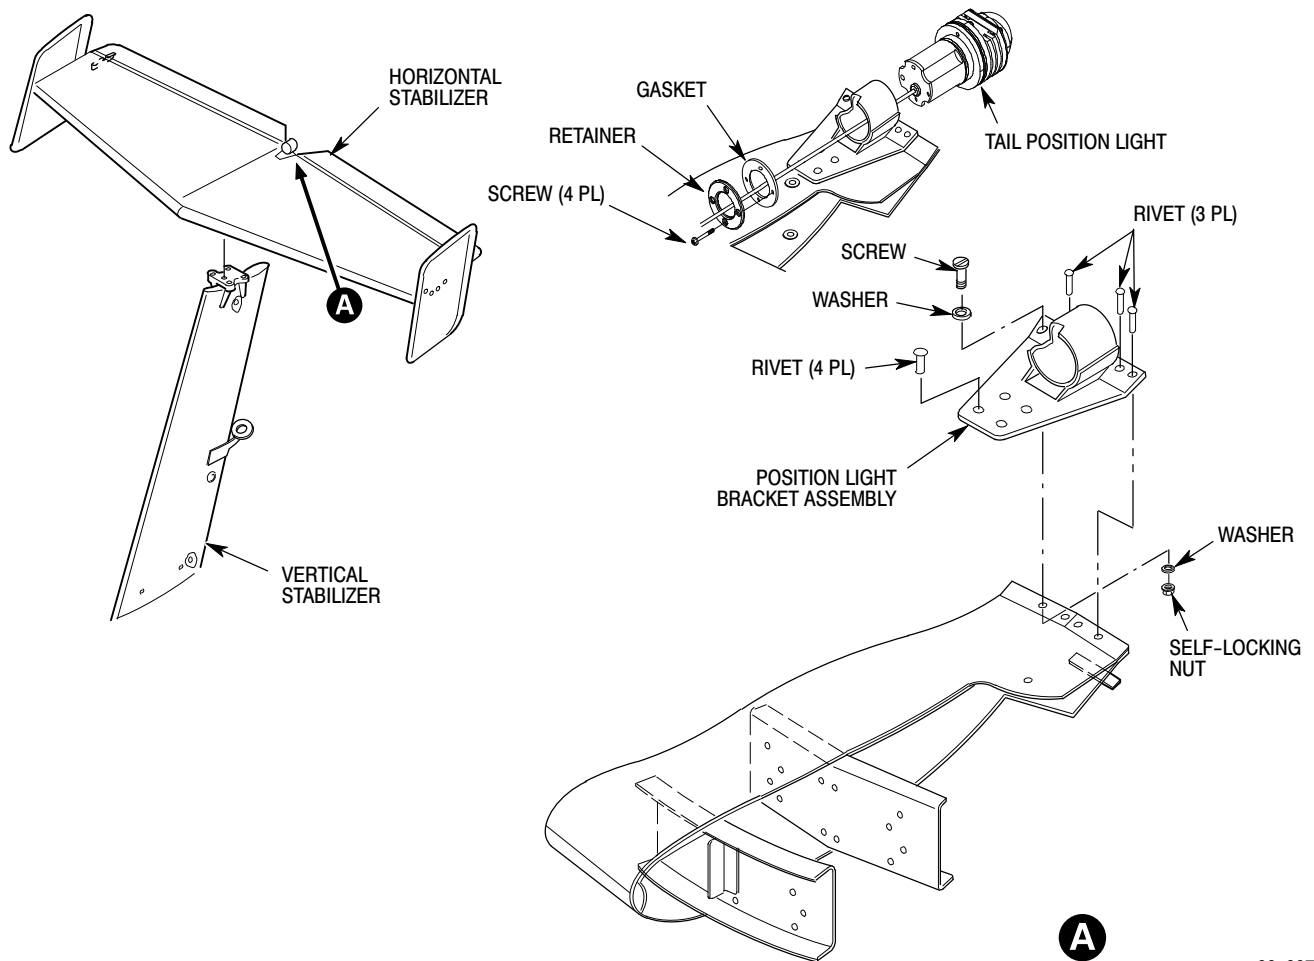
Figure 1. Position Light Mounting Bracket and Tail Position Light Installation

If there is looseness or damage to the bracket, fill out a Service and Operations Report (SOR) at <https://www.mymd.aero/dashboard> (select the **SUPPORT** dropdown menu, and then select **New SOR**, to start).

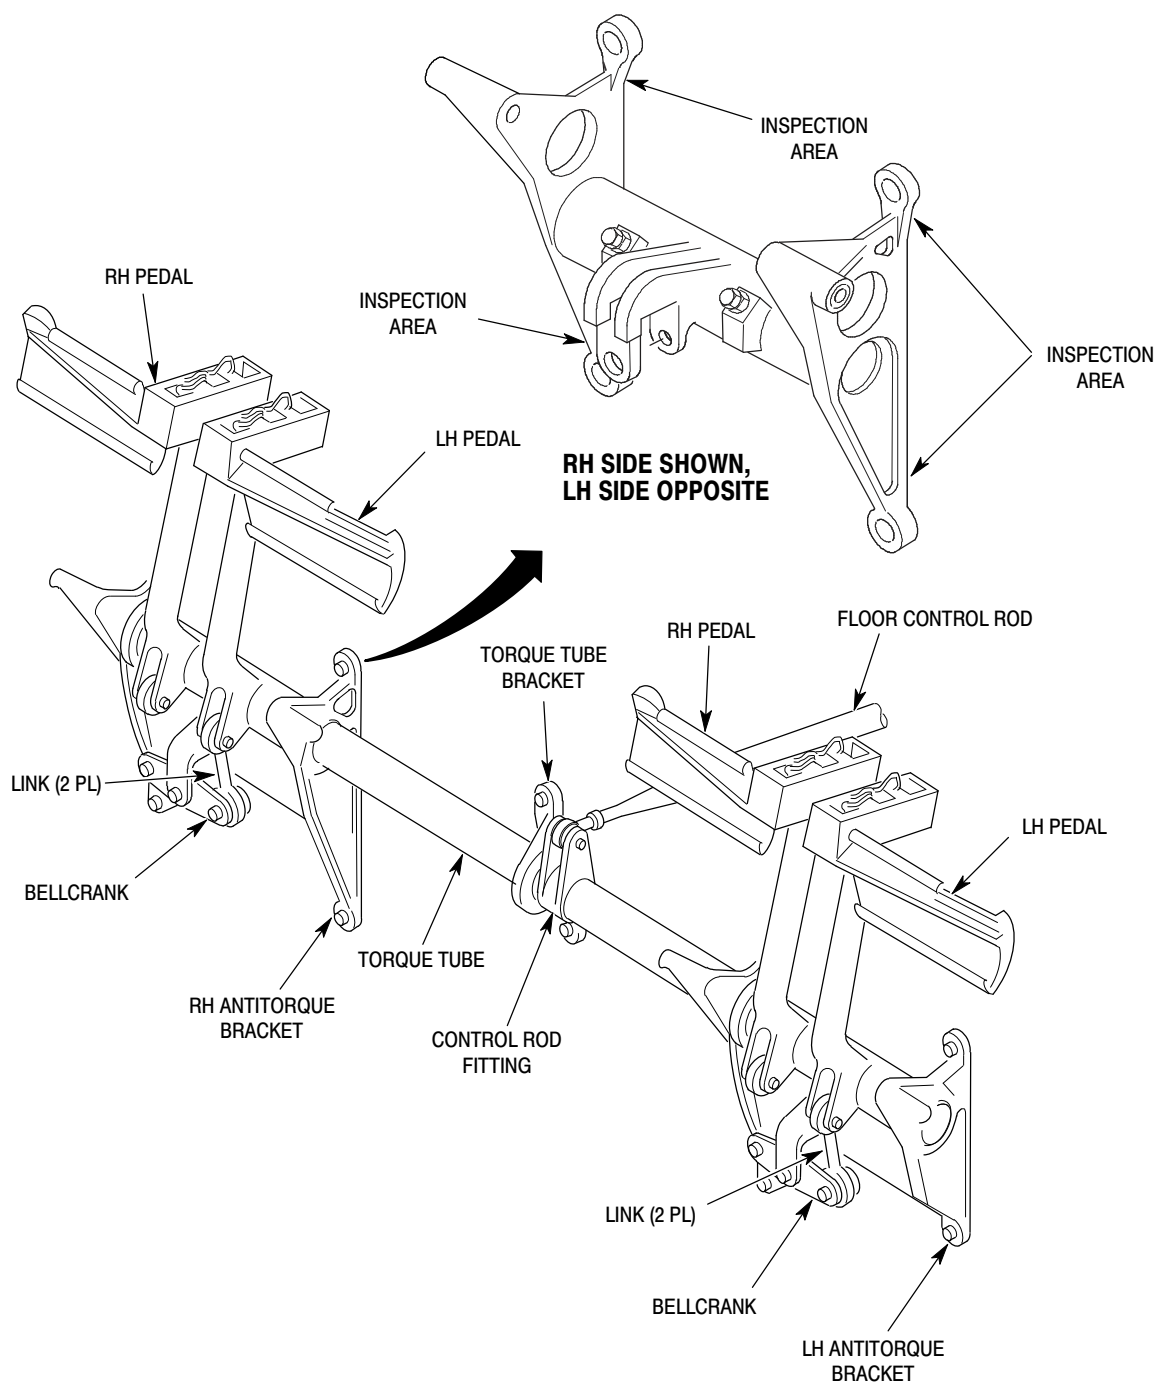
Figure 1. Inspection of the Pedal Brackets for Cracks

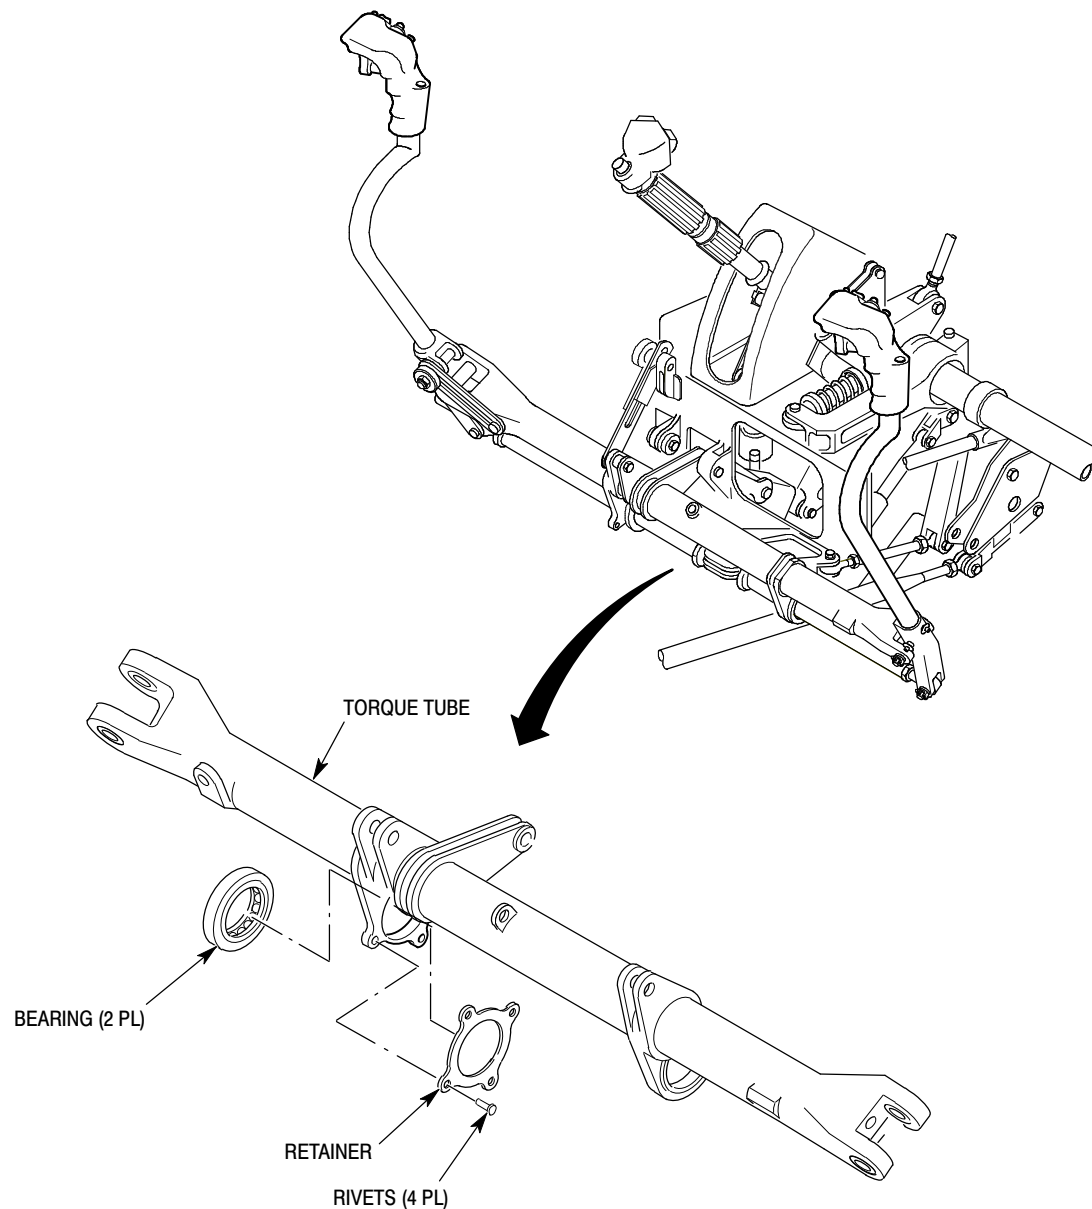
Figure 1. Inspection of the Pilot's Interconnecting Cyclic Pitch Torque Tube Assembly
