MODEL MD900 SERIES
SERVICE LETTER PACKAGE

THIS PACKAGE CONTAINS A COMPLETE SET OF ALL
MD900 SERIES SERVICE LETTERS ISSUED THROUGH:

16 DECEMBER 2022

MODEL MD900[®] ROTORCRAFT (MD EXPLORER[®]) SERVICE LETTERS

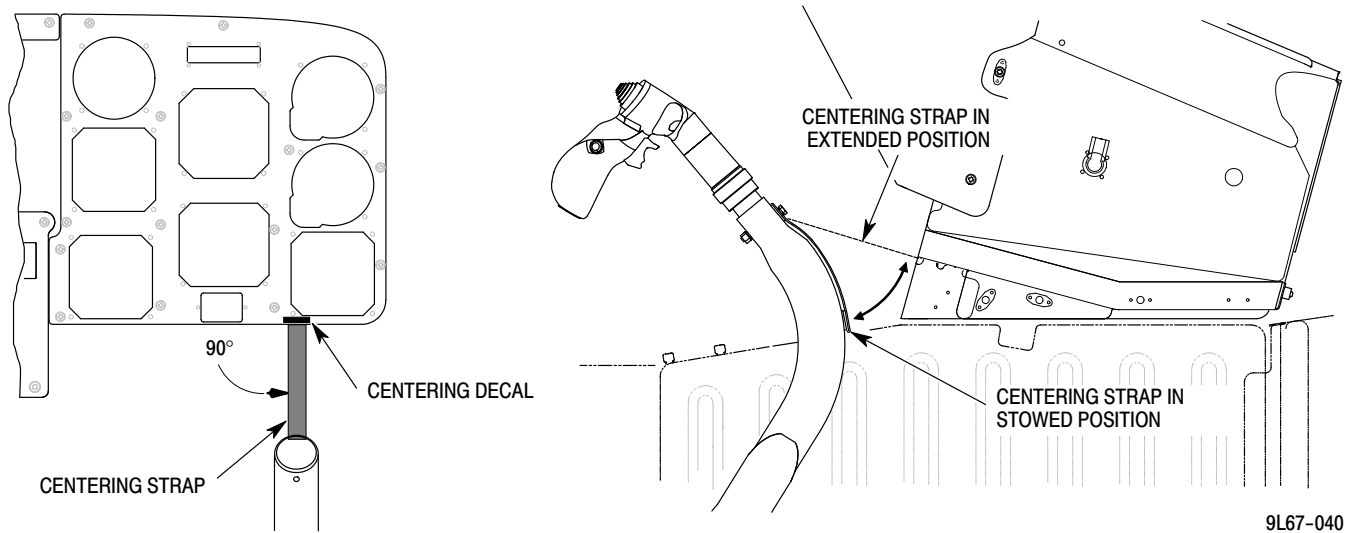
CAUTION: CYCLIC SHOULD BE TRIMMED TO THE NEUTRAL POSITION FOR START-UP AND SHUTDOWN.

NEUTRAL POSITION IS ACHIEVED WITH CENTERING STRAP EXTENDED. TOUCHING CENTERING DECAL WHEN PERPENDICULAR TO INSTRUMENT PANEL.

RECOMMENDED PROCEDURES: During startup and shutdown, ensure cyclic stick is centered using cyclic stick centering strap (ref. Figure 1). Do not exceed the maximum up limits for the main rotor hub flexbeam during ground handling, maintenance, and pre-flight operations. (See CAUTION below.)

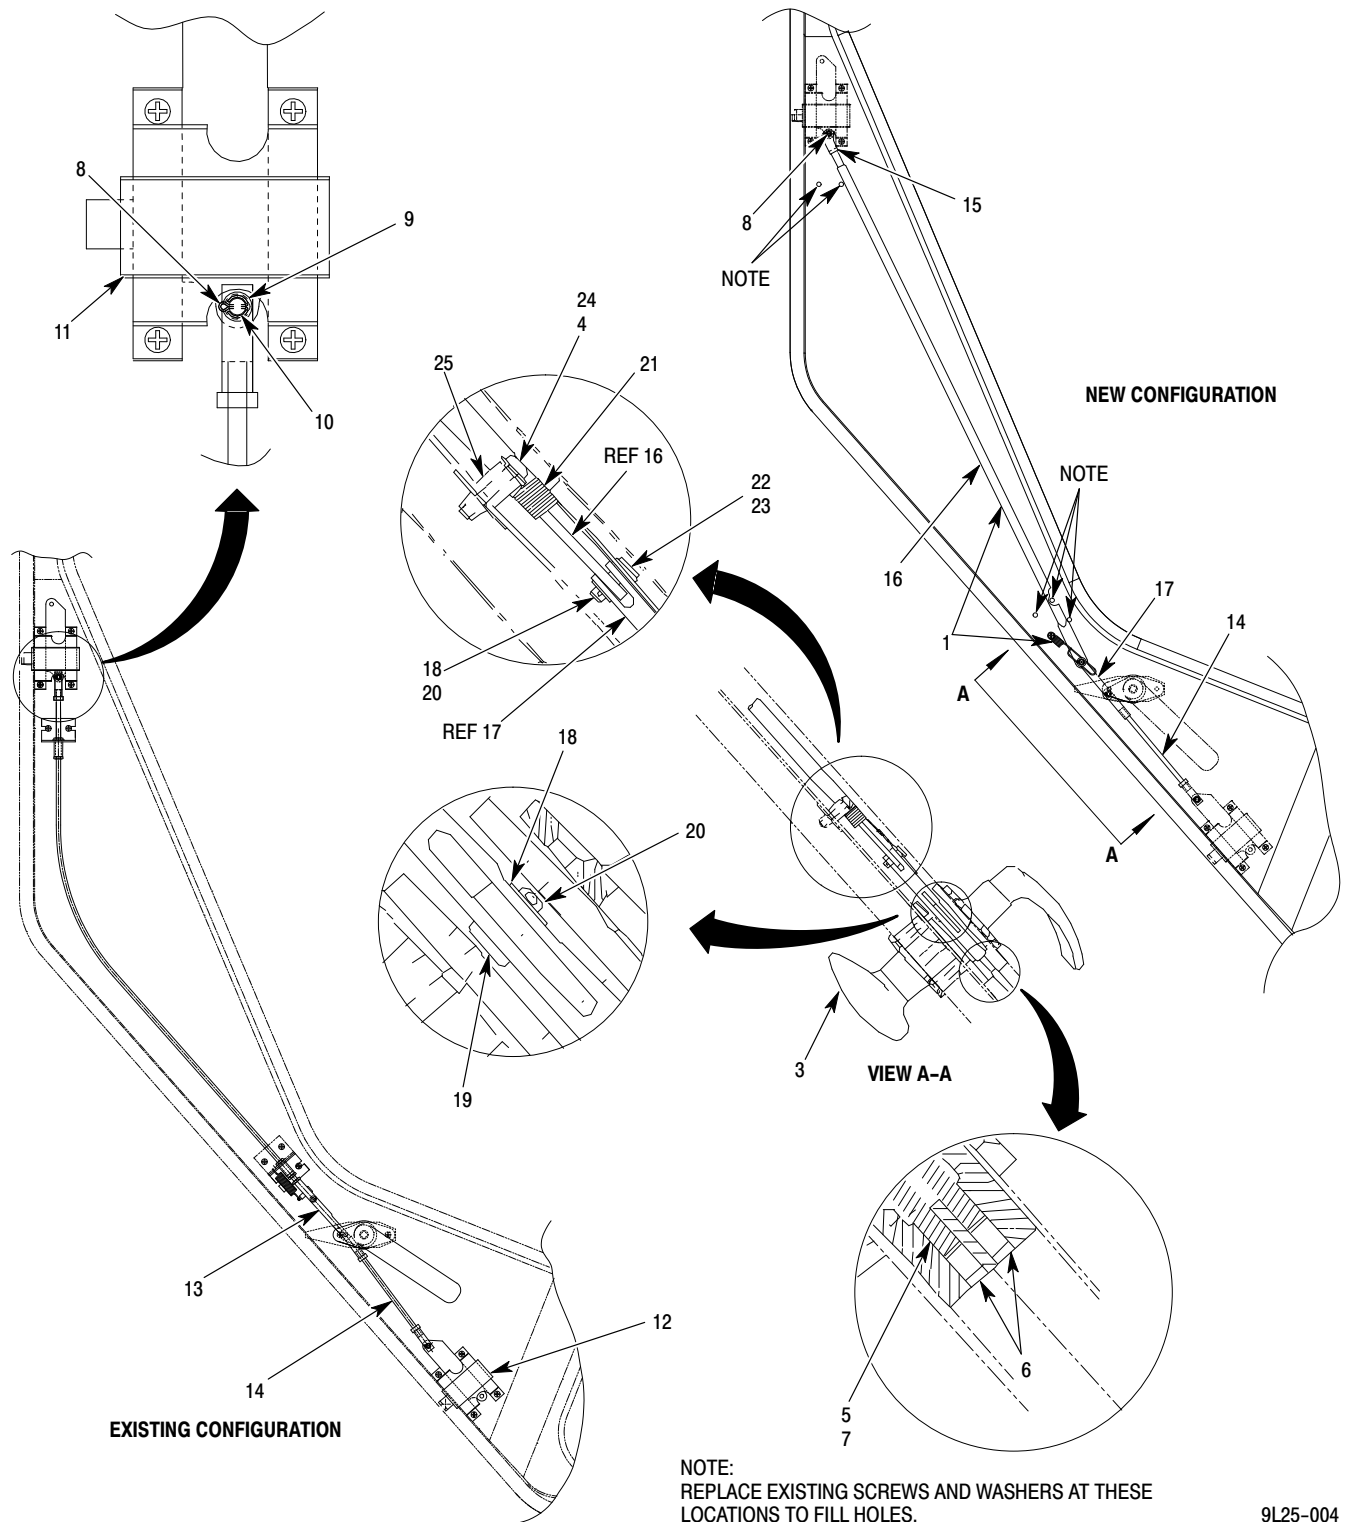
Figure 1. Door Latching Mechanism Removal

- A. Assembly/Components Affected by this Notice: Cockpit Door Latching Mechanism, P/N 900F3305181-101.
- B. Reason: The purpose of this letter is to inform all MD900 helicopter owners and operators of the optional modification that upgrades the cockpit door latching mechanism to the new and improved latch system configuration. This task can be accomplished by normal field maintenance. In the future, only the new configuration latching mechanism components will be provided as a spare. Customers will need to perform this modification if repairs are required to the old configuration components.

- B.** Remove compression springs (5) from door handle (3) by releasing screws (6).
- C.** Replace springs (5) with replacement compression springs (7) and secure with existing screws (6).
- D.** From upper latch block assembly (11), remove and discard cotter pin (8). Remove and retain washer (9) and clevis pin (10).
- E.** Except for that of the lower latch block assembly (12), remove and discard remainder of cotter pins (8).
- F.** Remove and retain remainder of washers (9) and clevis pins (10).
- G.** Remove link (13) from upper end of lower push/pull rod (14).
- H.** Install clevis (15) onto connecting tube (16).
- I.** Attach to upper latch block (11) using washer (9) and clevis pin (10). Install new cotter pin (8).
- J.** Install LH clevis (17) onto upper end of lower push/pull rod (14).

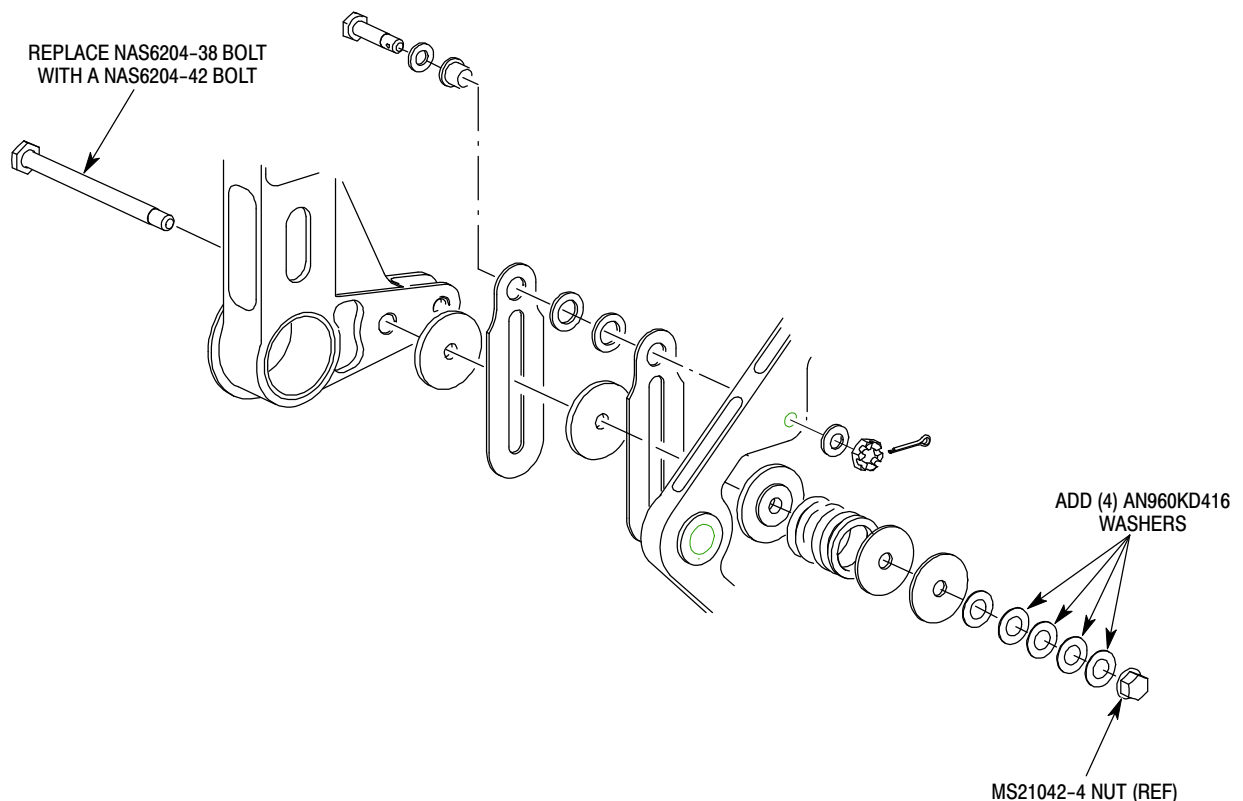
Figure 1. Pedal Friction Hardware Change.

Operators are now allowed to make a change to MD900 pedal assembly hardware that will allow pedal breakout forces to be maintained by providing additional adjustment capability. The NAS6204-38 bolt may be replaced with a NAS6204-42 bolt. Additionally, four AN960KD416 washers must be added under the MS21042-4 nut as shown in Figure 1. Removal of any number of AN960KD416 washers is acceptable to achieve required breakout forces.

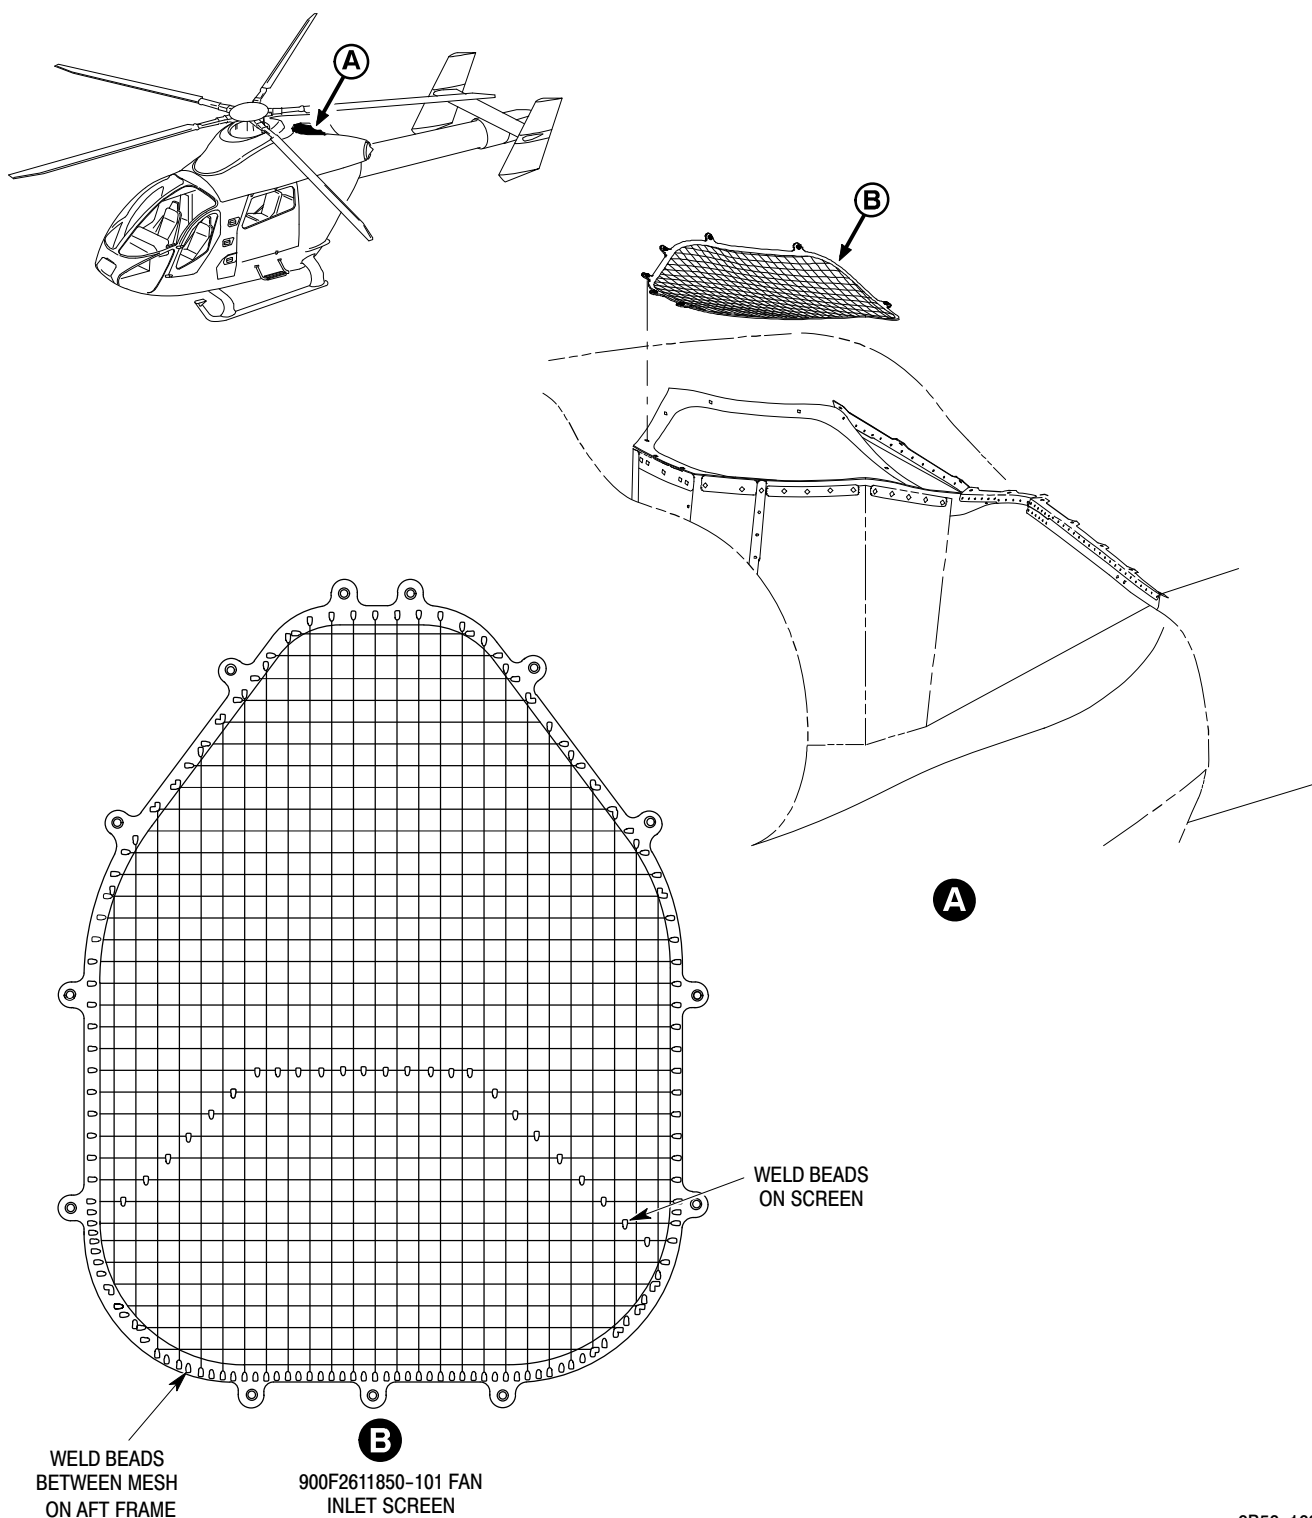
Figure 1. Anti-Torque Fan Inlet Screen

This Service Letter is issued to advise all owners and operators of possible cracks occurring in certain P/N 900F2611850-101 anti-torque fan inlet screens. These screens can be identified by weld beads between the mesh on the aft screen frame and weld beads on the screen itself (Ref. Figure 1).

If any of these screens are found or any broken strands are noted during the pilot's daily preflight check or any maintenance activity, contact the Field Service Department at MDHI, Mesa, Arizona by telephone at (800) 388-3378 or (480) 346-6387 for information on obtaining a replacement screen.

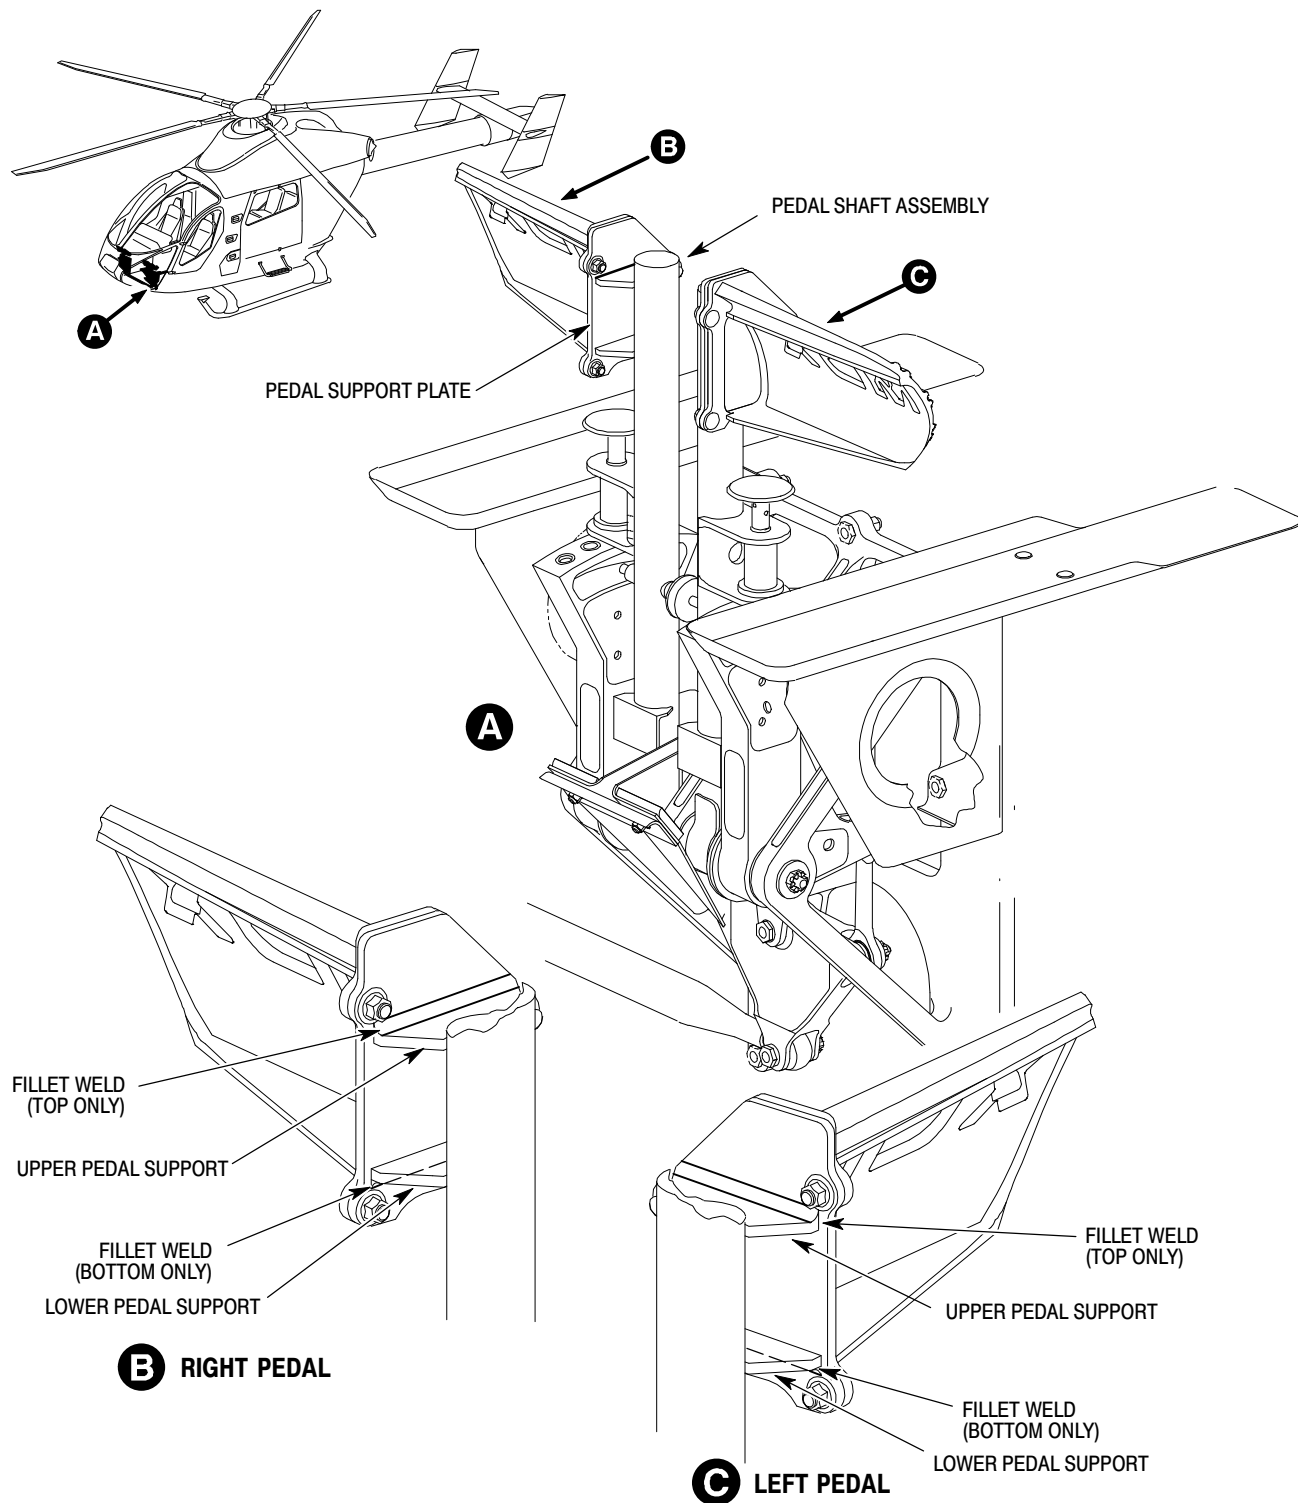
Figure 1. Anti-Torque Control Pedal Installation

This Service Information Letter is issued to inform owners and operators of MD900 helicopters of an accident where an anti-torque control pedal separated from the pedal shaft assembly. This incident is under investigation. A possible cause may be poor penetration on the fillet weld on the pedal support plate and fatigue (Ref. Figure 1).

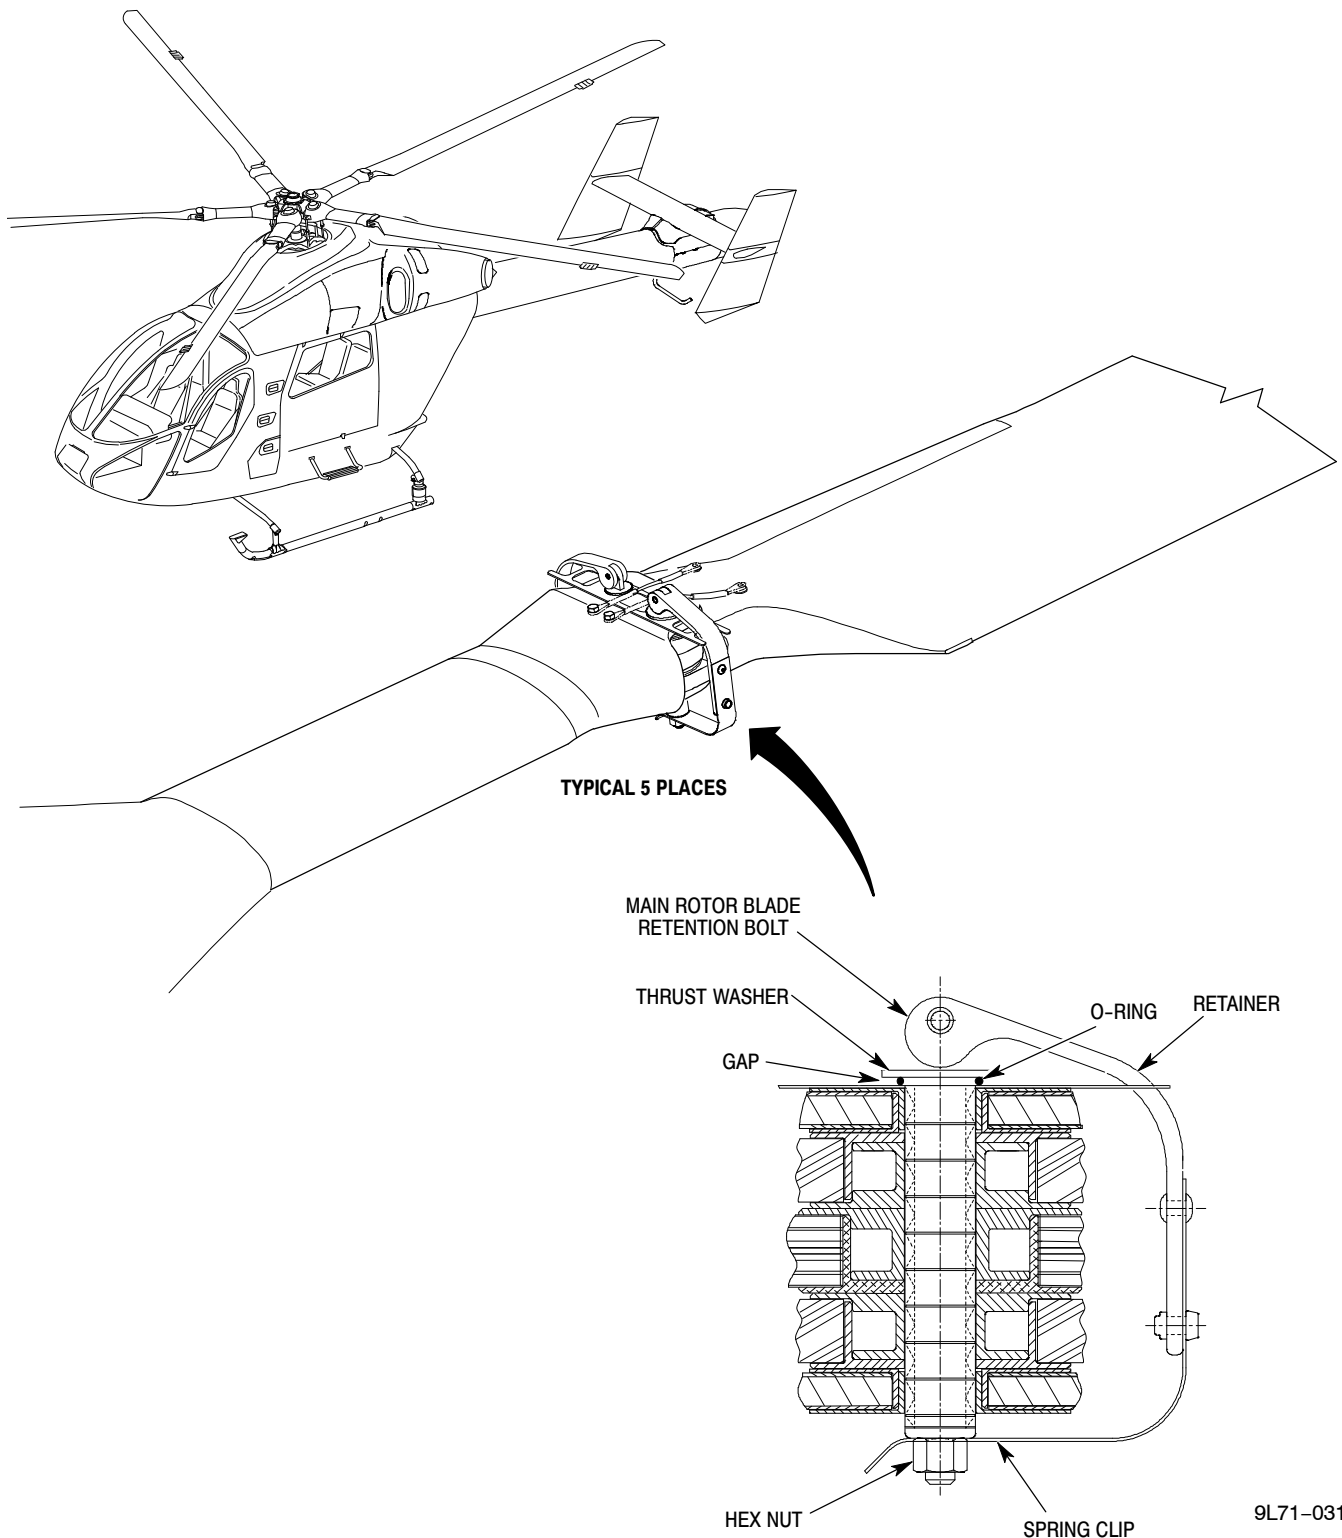
Figure 1. Main Rotor Blade Retention Bolt

Visually examine the area around the hex hole in the spring clip for cracks. Make sure spring clip hex hole is fully engaged on hex nut. Visually examine the position of each main rotor blade retention bolt to make sure it has not moved up in the pitchcase. Make sure there is a gap between the main rotor blade retention bolt thrust washer and the retainer. Compare the gap between the main rotor blade retention bolt thrust washer and retainer to the gap at the other nine bolts. Each of the ten gaps must be almost the same.

If you think a main rotor blade retention bolt has cracks around the spring clip hex hole, spring clip hex hole is not fully engaged on hex nut, has moved up, or there is no gap under the thrust washer, have a certificated maintenance technician remove bolt and do a detailed inspection of the bolt (Ref. CSP-900RMM-2, Section 62-10-00). If no defects are found, install bolt (Ref. CSP-900RMM-2, Section 62-10-00).

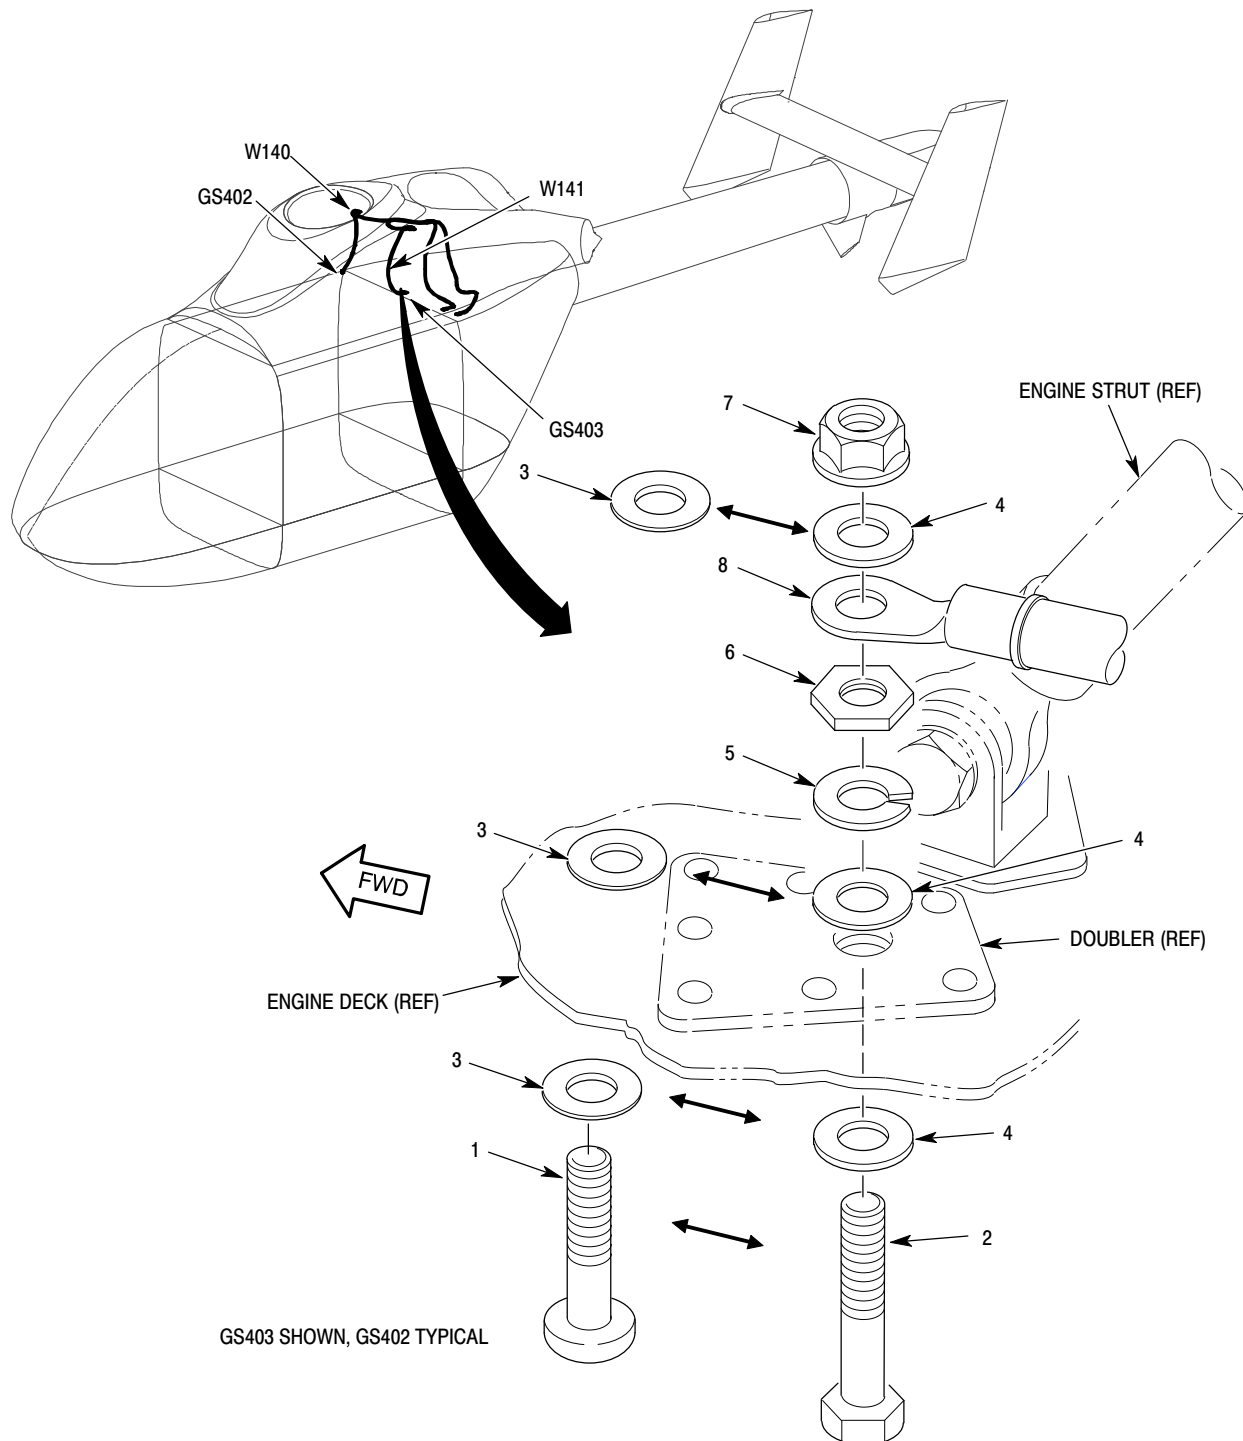
Figure 1. Stack-up of Ground Studs at GS402 and GS403

If arcing or corrosion is found, the wire lug and its interfaces must be cleaned.
