***MD Helicopters, LLC***

***MD500/600 Series***  
***Service Bulletins Package***

## MODEL 369D, 369E, 369F/FF, 500N, 600N HELICOPTERS (500D, 500E, 530F, 520N, 600N) SERVICE BULLETIN PACKAGE TABLE OF CONTENTS

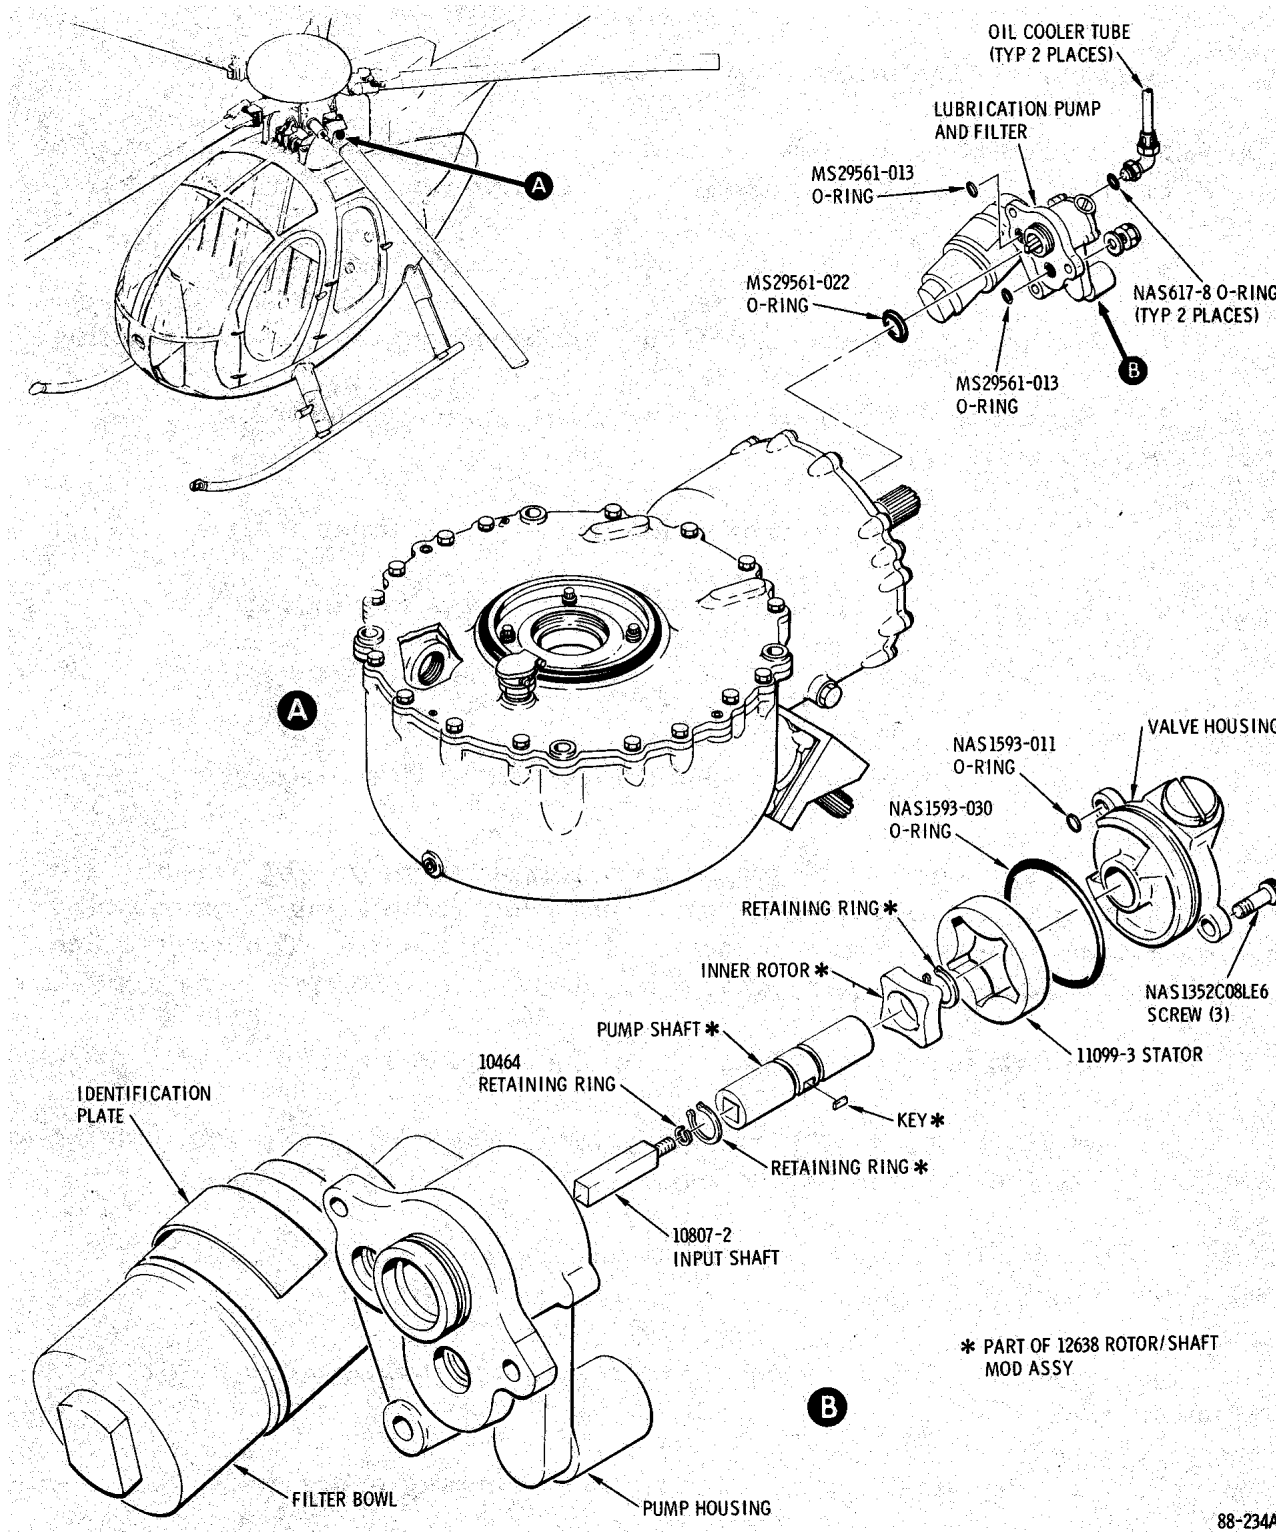
**Figure 1. Field Modification - Main Transmission Lubrication Pump PN 369D25167**

**NOTE:** Torque required should be less than 10-inch pounds over several revolutions of pump. If pump exhibits excessive torque or binding, loosen three screws and rotate valve housing until free running operation is obtained. Tighten three screws and repeat step 10.

- (10). Connect-transmission oil cooler hoses; use new O-rings.
  - (11). Check pump installation; perform the following:
    - (a). Ground run helicopter according to 369D Owners Flight Manual and check pump interface for leaks. (Refer to Fluid Leak Analysis, Section 2 of Basic HMI - Vol 1. ) Verify that pump pressure warning light is not ON at 55% N2.

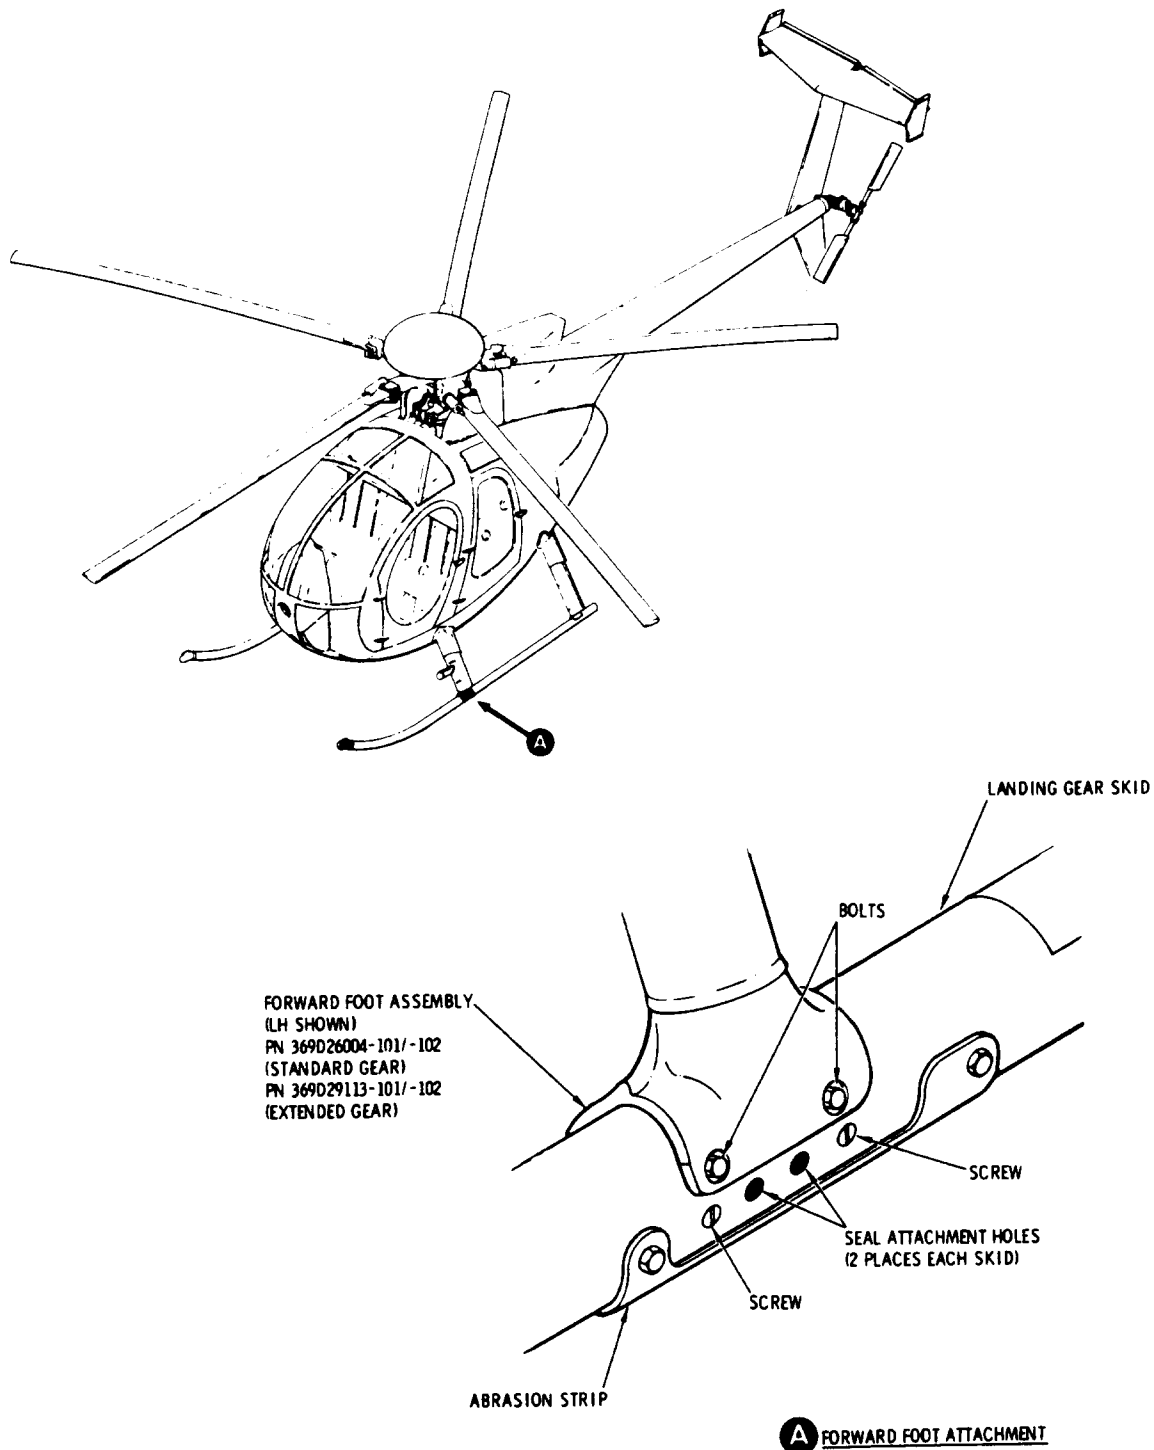
88-250

The subject landing gear skid assemblies are predrilled with additional attachment holes for the forward foot assemblies, to provide for LH and RH skid interchangeability. The information given in this Service Information Notice lists a procedure for sealing the open attachment holes at the forward foot location on each skid assembly, to prevent water seepage and entrapment and possible corrosion damage to the skid assembly.

**Figure 1. Rework of Landing Gear Skid Assemblies**

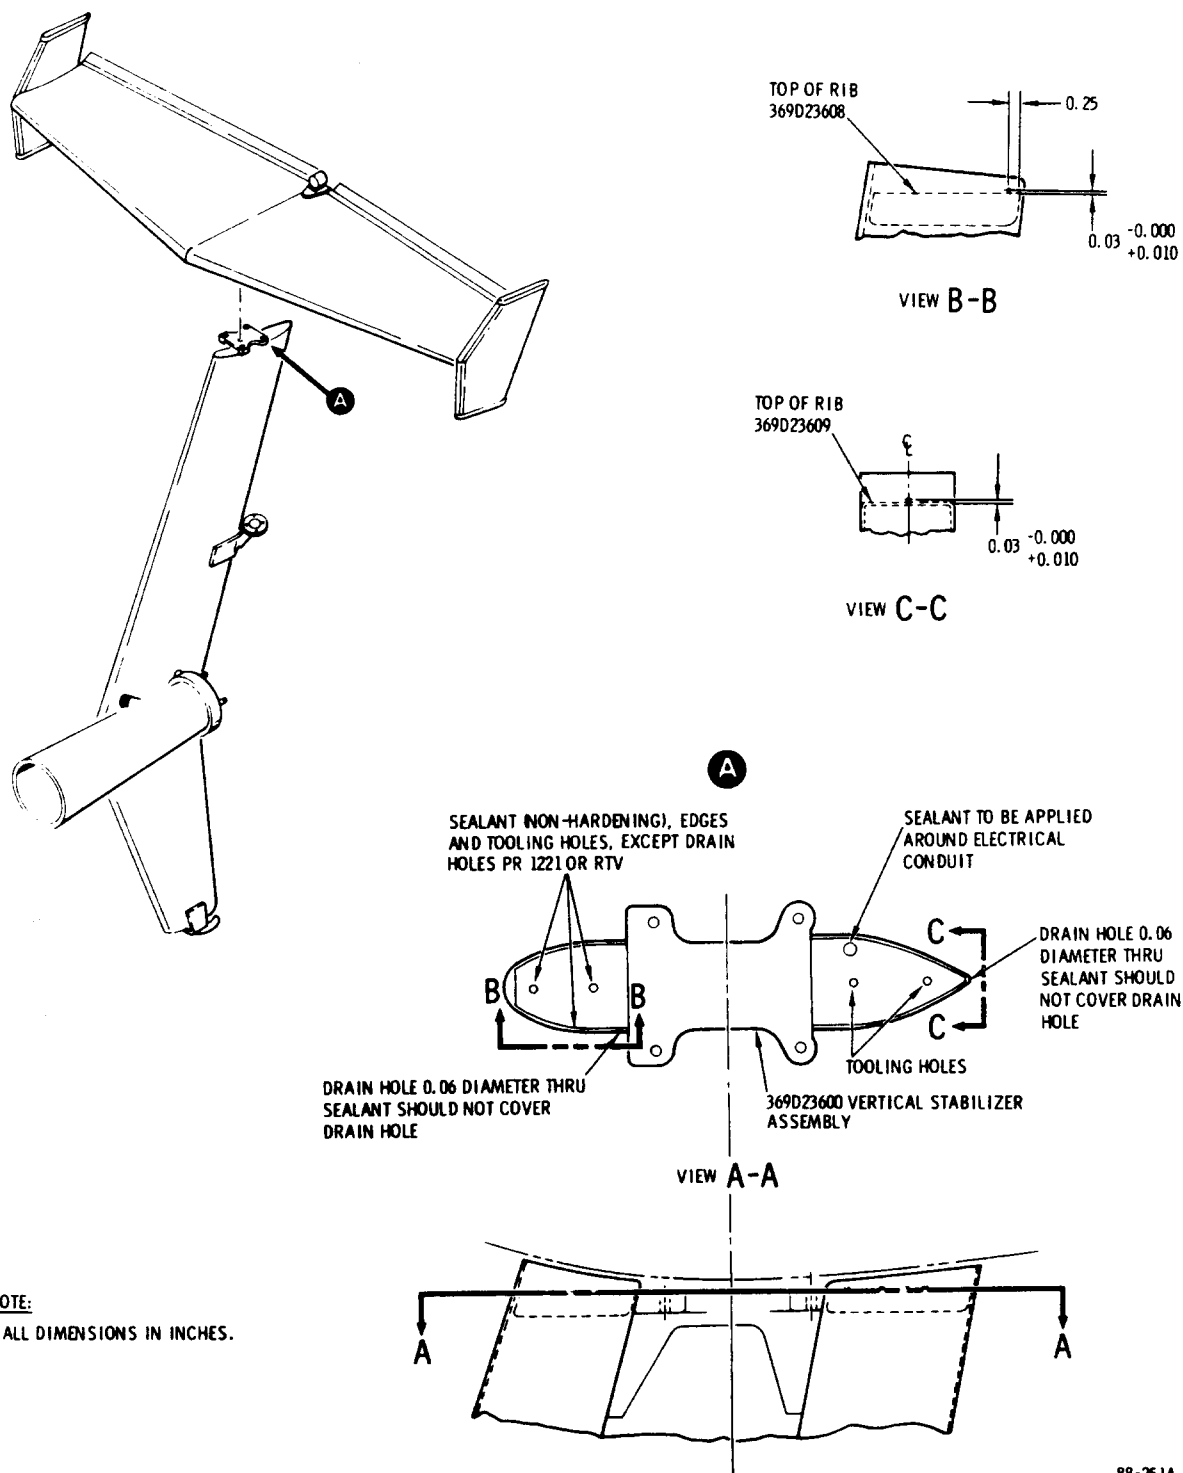
88-251A

**Figure 1. Sealing - Stabilizer Assembly**

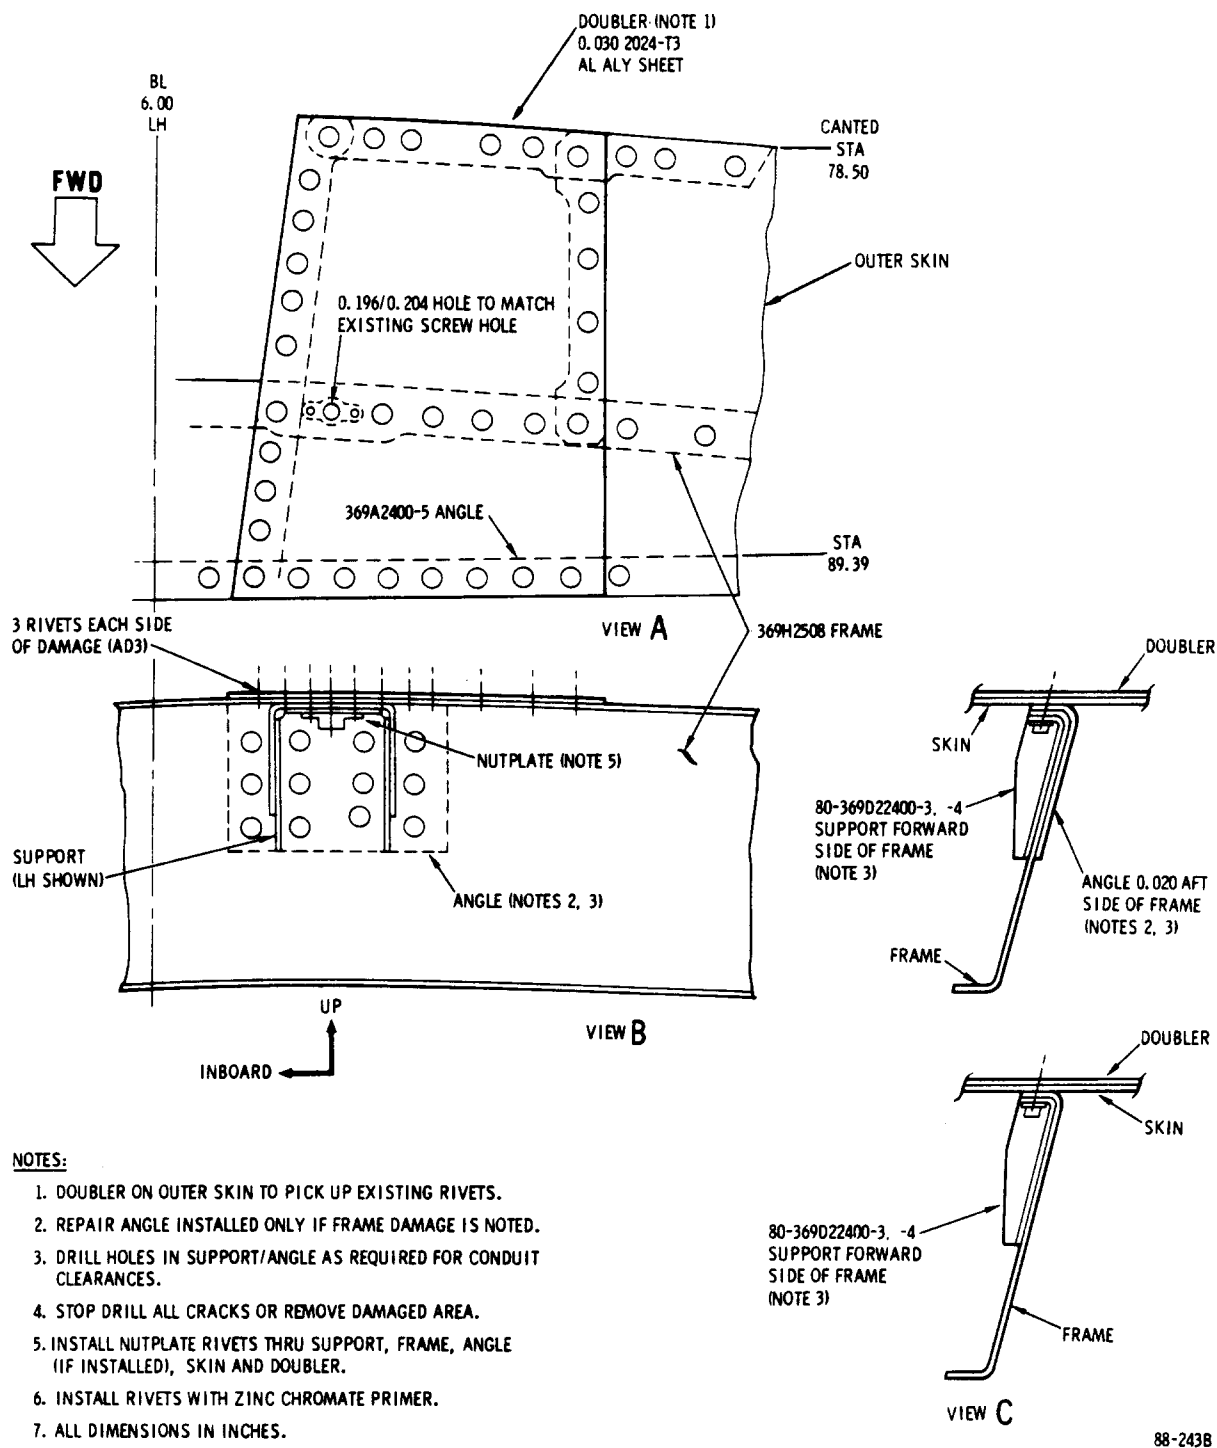
- (5). Inspect fuselage frame structure (channel) for cracks or damage at forward nutplate attach areas.

If cracking or damage to fuselage frame is noted, perform the following:

**Figure 1. Rework of Fuselage Structure - Forward Section**

**NOTE:** If no cracking or damage to fuselage frame is noted, install 80-369D22400-3 and -4 support assemblies at FORWARD side of frame structure, using rivets as shown in Figure 1, View C. Drill holes in support assemblies for nutplates and for conduit clearances as required. Install nutplate rivets through support, frame, upper skin and doubler, if installed.

1. Stop drill all cracks or remove damaged area prior to installation of repair angles and support assemblies. Perform all work in accordance with FAA AC 43.13-1A Aircraft Inspection and Repair,

2. Field fabricate and install repair angles at AFT side of fuselage frame structure (channel); and install 80-369D22400-3 and -4 support assemblies at FORWARD side of frame structure, using rivets as shown in Figure. 1, View B, Drill 0.096 inch diameter rivet holes in angles to match support assemblies.

3. Drill holes in support assemblies and repair angles for nut plates and for conduit clearances as required. Install nutplate rivets through support, frame, angle, upper skin and doubler if installed.

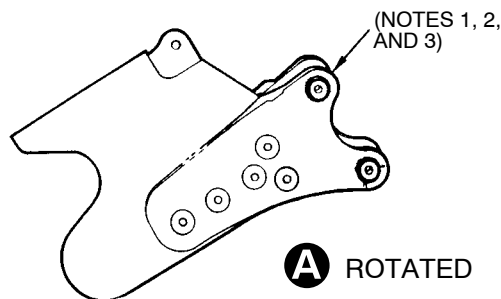
1. VISUALLY INSPECT AREAS OF ALL ROOT FITTINGS AND LEAD-LAG ATTACH LUGS FOR CRACKS OR BREAKS. INSPECT BLADE ATTACH BUSHINGS FOR LOOSENESS. IF LOOSE, REPLACE LEAD-LAG LINKS (REFER TO TEXT).
2. PAY PARTICULAR ATTENTION TO AREA AROUND ATTACH PIN HOLES IN LUGS.
3. SEAL ALL JUNCTIONS BETWEEN BUSHINGS AND ATTACH LUGS WITH SEALER OR PRIMER (REFER TO MATERIALS TABLE).
4. LEAD-LAG LINK ASSEMBLIES ARE SUBASSEMBLIES OF THE MAIN ROTOR HUB ASSEMBLY.

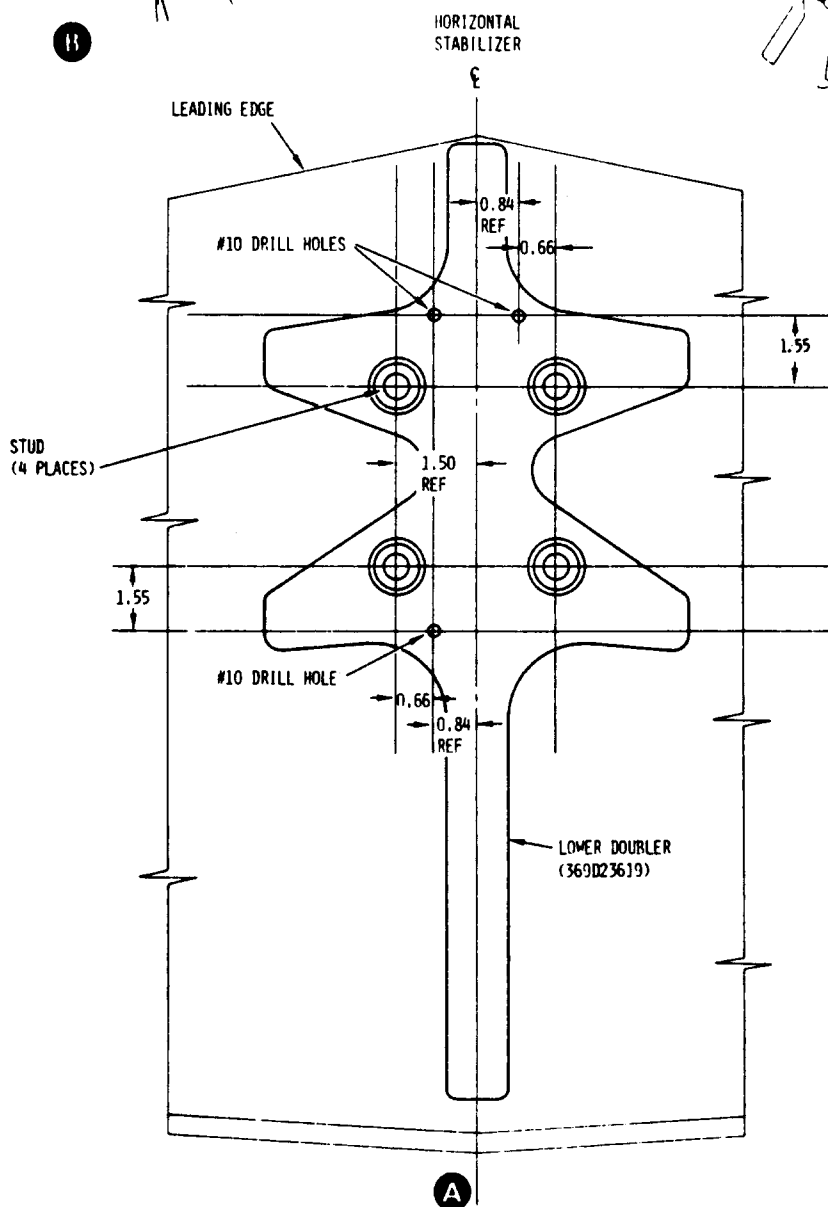
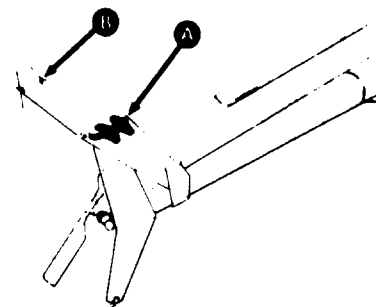
88-362

**Figure 1. Drilling of Drain Holes, Horizontal Stabilizer Lower Surface**

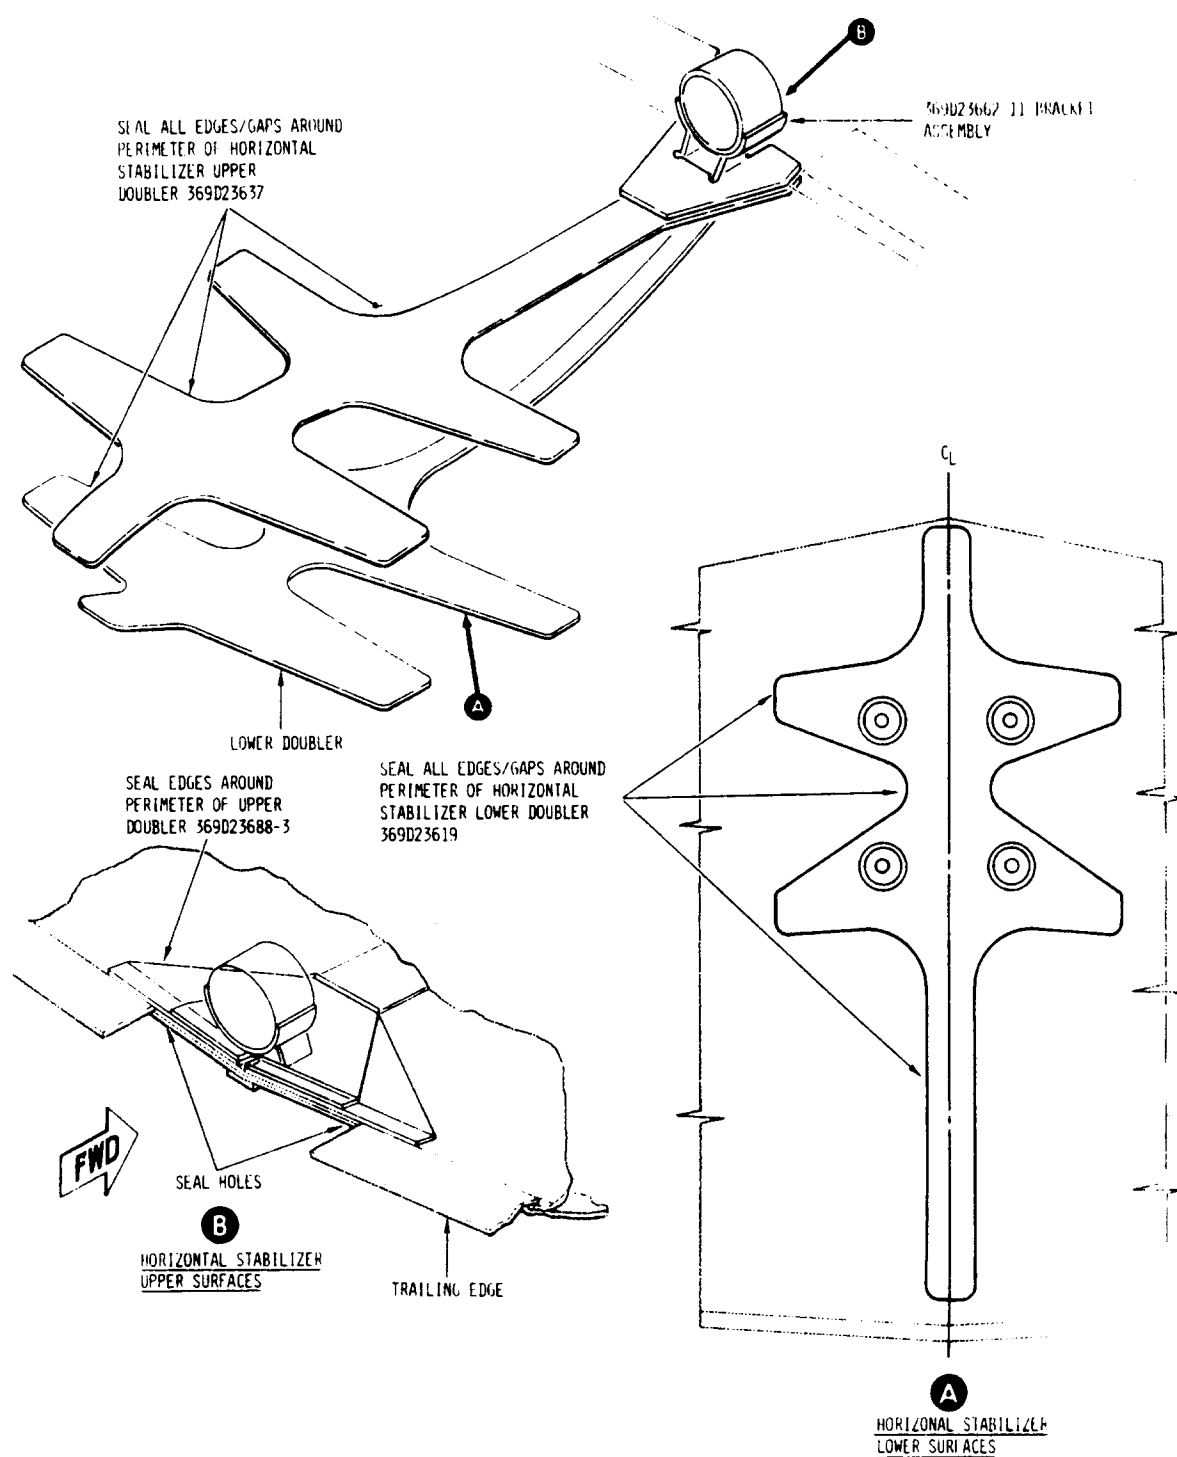
ADN63-1

**Figure 2. Horizontal Stabilizer - Sealing of Doubler Edges**

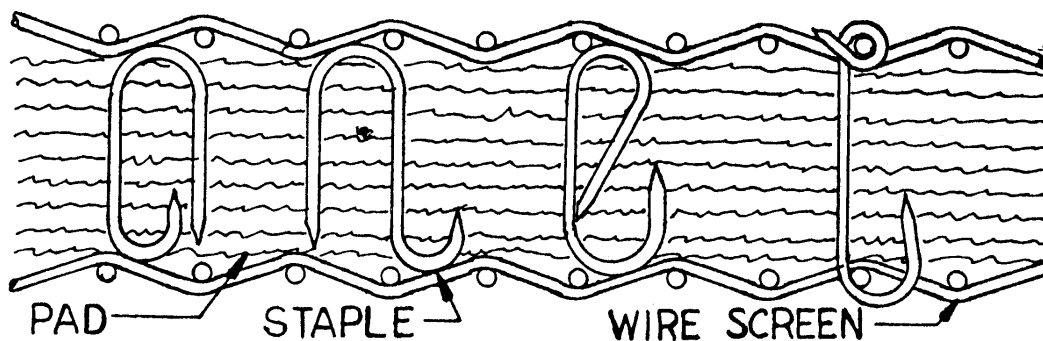
Figure 1. Sample Staple Installations

CAUTION: THE INSTALLED WIRE STAPLES DO NOT NECESSARILY CONFORM TO  
ONE SPECIFIC SHAPE. CARE MUST BE EXERCISED NOT TO DAMAGE  
THE MIST ELIMINATOR PAD DURING THE REMOVAL PROCESS. REFER  
TO FIGURE 1.

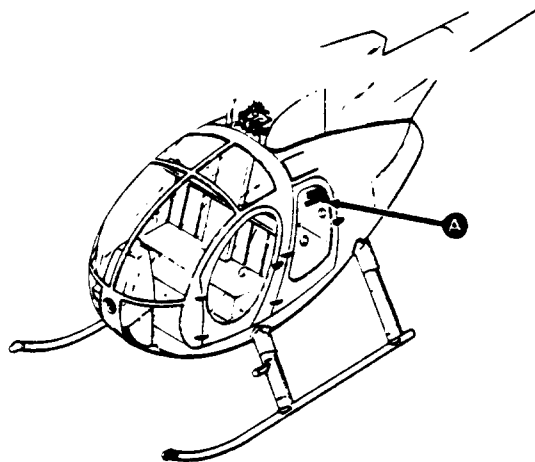
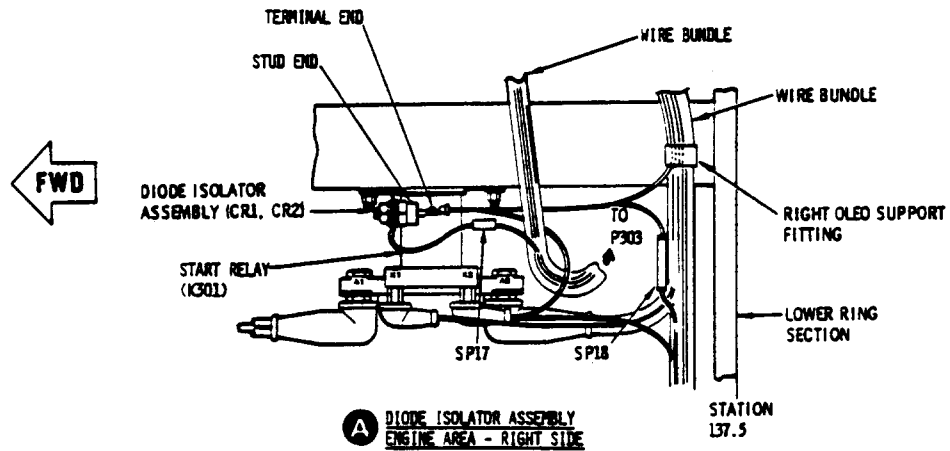
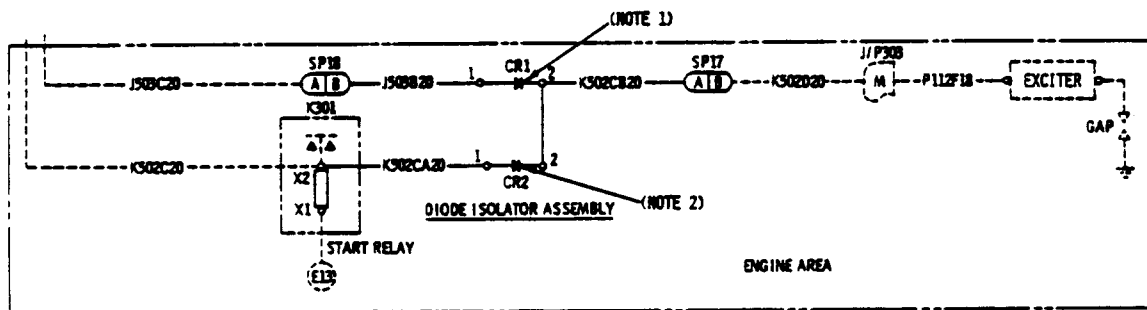
WIRING DIAGRAM

Field reports indicate that a small number of the above affected kits delivered during 1979 inadvertently incorporated diodes with reversed polarity (1N3210R). The two above kit installations are the only places the reverse polarity diodes would be installed on 500D helicopters. Installation of diodes with improper polarity can result in inability to start the engine or in malfunction of the automatic reignition system.

1. If PN of diodes is 1N3210, perform steps f and g only.
2. If PN of diodes is 1N3210R, replace diodes with new PN 1N3210 diodes; perform steps e, f and g below.
3. If PN of diodes cannot be determined, perform steps d, -e, -f and g below.
- d. Test diodes, using ohmmeter (with forward polarity) at electrical connector pins. Check for low forward resistance with positive lead applied to terminal end and negative lead applied to stud end. Reverse leads and check for very high back resistance.

**NOTE:** If polarity of diode is reversed, replace existing diodes with new 1N3210 diodes.

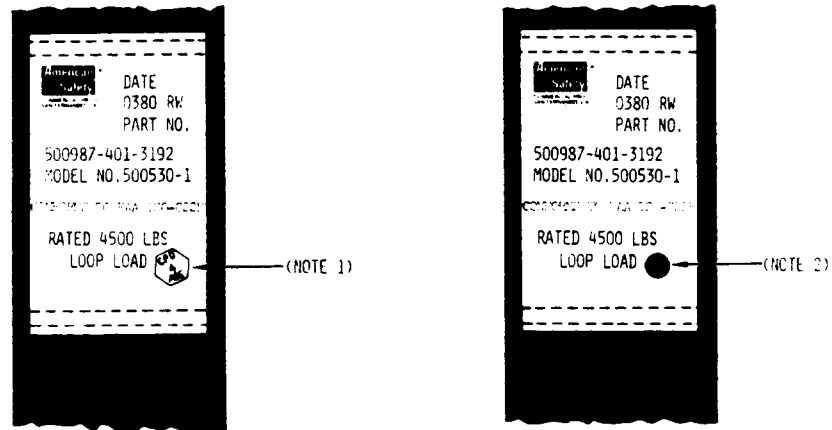
EXPLANATION: There is a possibility that some lap belt assemblies due to the thickness of the connector may have interference. See Section B-B of Figure 1. This condition makes it possible for the connector to be pushed in and retained in the buckle without being locked. See Section A-A of Figure 1.

1. GREEN HEX-SHAPED STAMP DENOTES LAP BELT ASSEMBLY REWORKED BY AMERICAN SAFETY EQUIPMENT CORPORATION (NO FIELD REWORK REQUIRED).
2. GREEN DOT DENOTES LAP BELT ASSEMBLY REWORK ACCOMPLISHED PER THIS NOTICE.

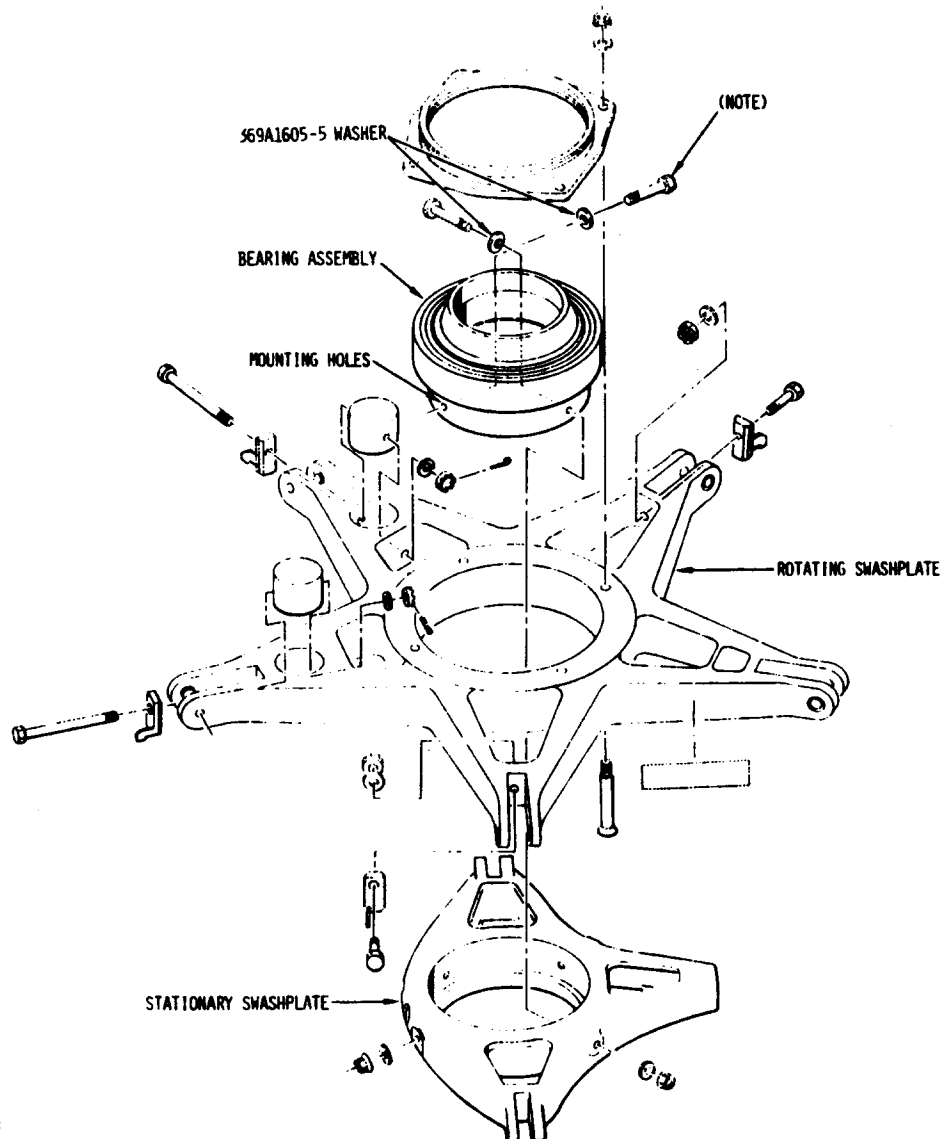
The information given in this Service Information Notice lists a procedure for inspection of PN 369A7003-3 bearing assembly for cracks around mounting holes in the bearing sleeve.

- a. Remove swashplate assembly from helicopter (refer to Basic HMI-Vol 1, Section 7 ).
- b. Remove PN 369A7003-3 bearing assembly from swashplate assembly and clean (refer to 369D-COM, Part V, Sections 2 and 3).
- c. Inspect subject bearing assembly for cracks using the dye penetrate method, with special attention to area of bearing sleeve around four mounting holes where bearing assembly bolts to stationary swashplate.

- d. If cracks are found in bearing assembly, it must be replaced with a new bearing assembly and installed per steps f. and g. below.
- e. If no cracks are found in bearing assembly, it may be reinstalled per steps f. and g. below.

BOLTS MAY BE INSTALLED WITH HEADS FACING INWARD AS AN ALTERNATE METHOD. REFER TO TEXT FOR INSTRUCTIONS.

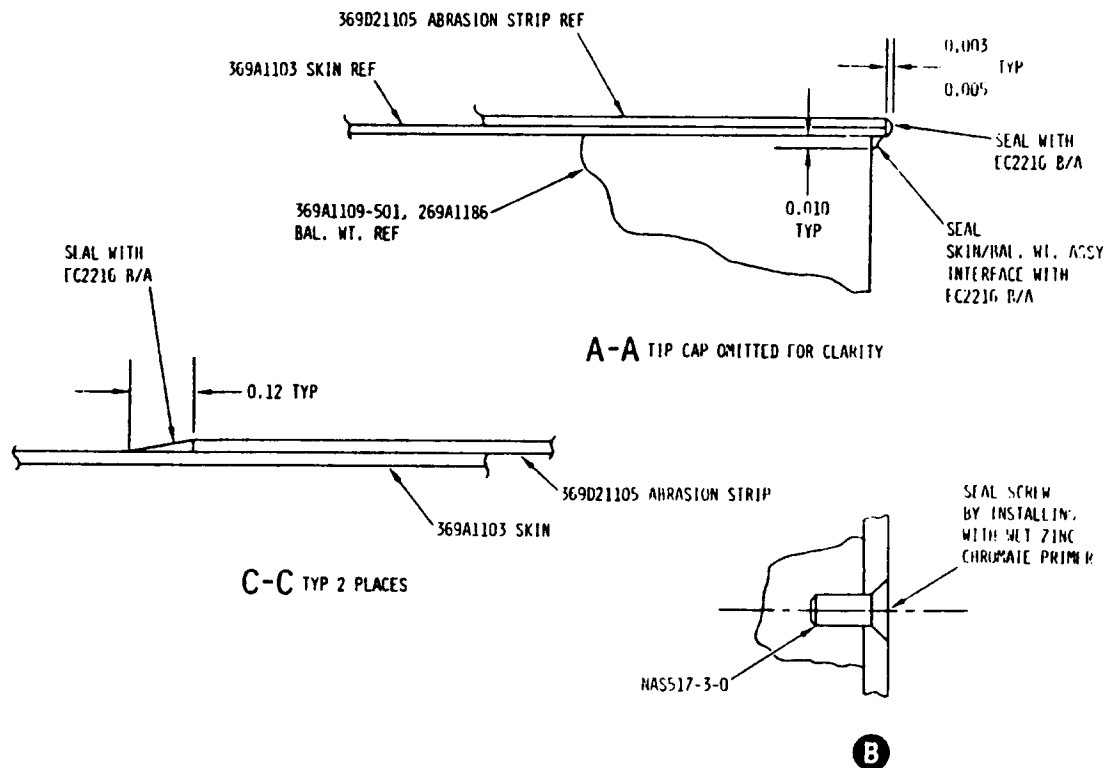
**Figure 1. Sealing of Abrasion Strip and Tip Cap**

The information given in this Service Information Notice lists a procedure for sealing of interfaces of abrasion strip and main rotor blade skin to inhibit corrosion and/or adhesive erosion.

- a. Remove screw and tip cap from main rotor blade.
- b. Remove any loose or cracked sealant or adhesive from areas of main rotor blade shown in Figure 1.

- c. Clean areas to be sealed with clean cloth moistened with M-114M solvent. For hard to clean problem areas MEK solvent may be used. Wipe surface dry before solvent evaporates.
- d. Prepare EC2216 B/A adhesive per manufacturer's instructions.
- e. Apply bead of adhesive to interface of abrasion strip and blade skin as shown in Figure 1. Ensure that there are no gaps or bridges in bead. Cure adhesive Net manufacturer's instructions.
- f. Seal tip cap as follows: (See Figure 1)
  1. Apply release agent to inside of tip cap per manufacturer's instructions.
  2. Prepare and apply a 0.010 to 0.020 inch coating of PR1436G Class B-2 or PR1422G Class B sealant to laying surfaces per manufacturer's instructions.
  3. Attach tip cap to blade and install screw with zinc chromate primer.
  4. Wipe off squeezed out sealant flush with surface.

**NOTE:** To inhibit moisture entering bond joint of abrasion strip · after initial application, reapply sealant, when sealant is worn away or becomes cracked.

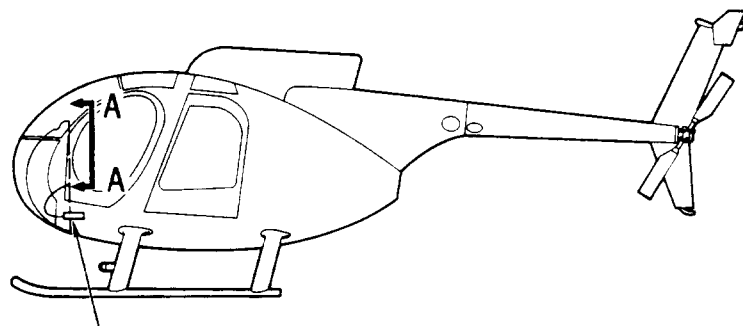
EXISTING (R500) CP-5-0.25 RESISTOR  
 ATTACHED TO 369H4140 HARNESS

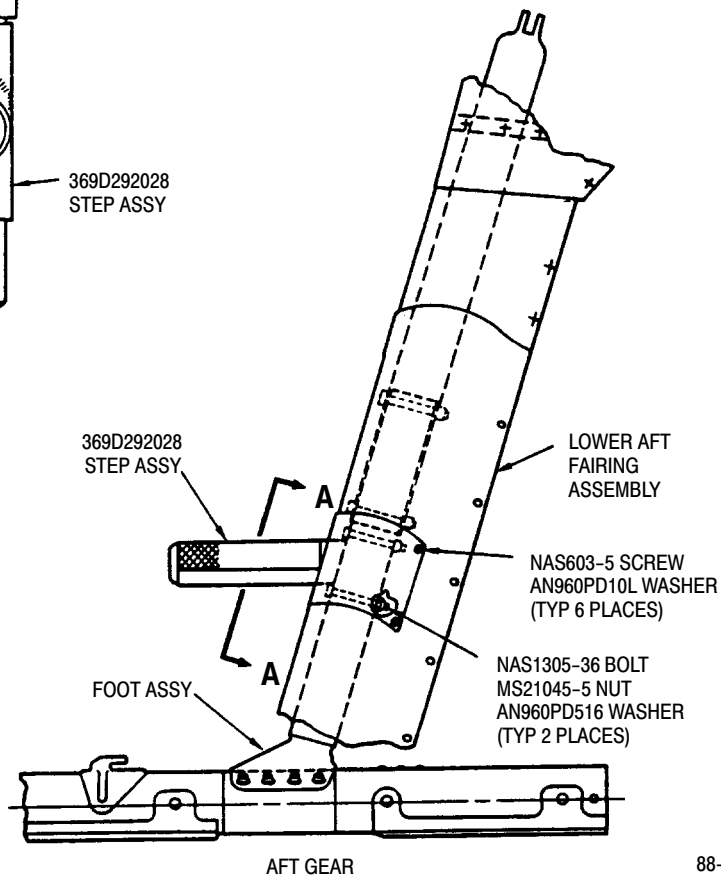
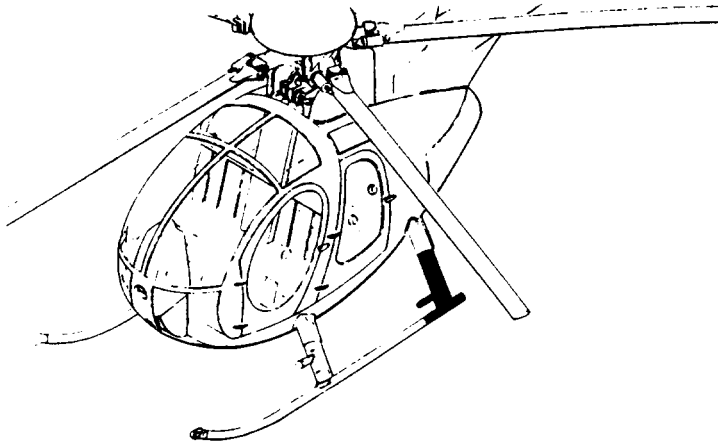
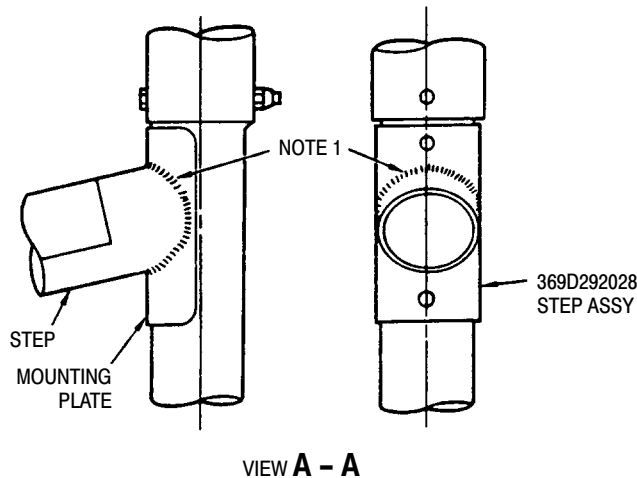
**Figure 1. Inspection of Aft Extended Landing Gear Step and Strut Assemblies**

**NOTE:** If cracking is noted, modify step, inspect foot and install per Part III of this Notice or procure a new (369D292028-5) passenger step assembly, inspect foot and install per Part III of this Notice.

1. CHECK TOP AREA OF WELD WHERE STEP ATTACHES TO MOUNTING PLATE. USE 10X MAGNIFYING GLASS.
2. TO OBTAIN ACCESS TO INSPECT WELD AREA, REMOVE (6) SCREWS AND WASHERS SECURING COVER TO LOWER FAIRING.

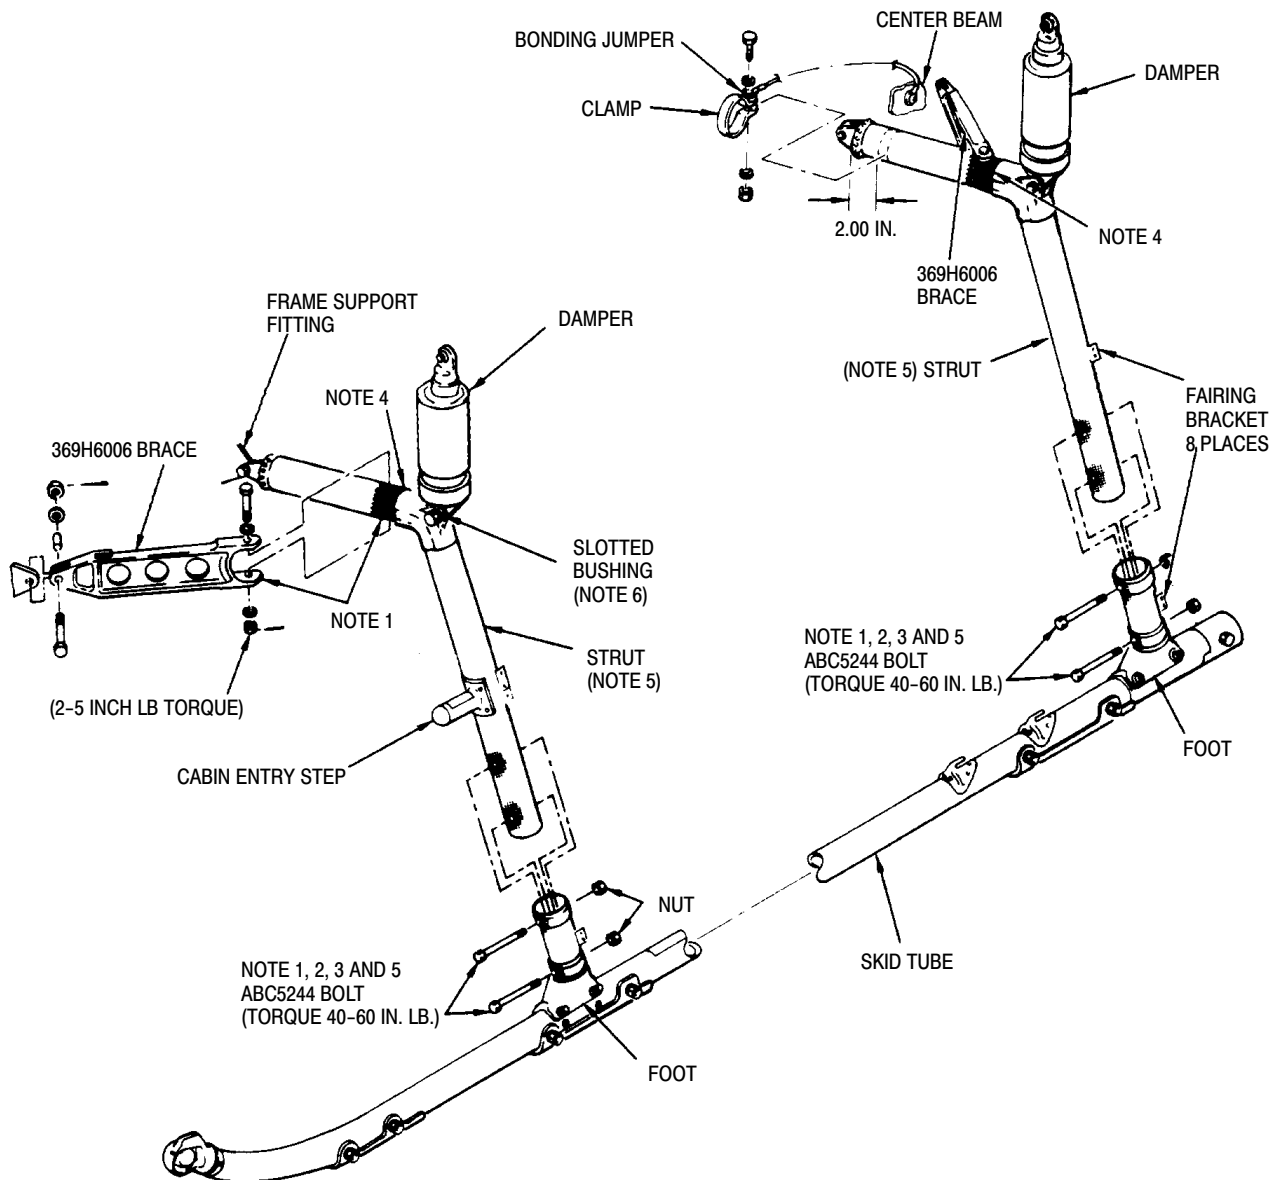
- (2). Using 10X glass and bright light, visually check bolt holes in feet and struts for cracks or corrosion.
  - (a). Remove light surface corrosion and treat affected area according to Section 2, HMI - Volume 1. If more severe corrosion (ref. Corrosion Control Manual) is present, replace affected part.
  - (b). Cracks are not permitted in landing gear struts or feet. If any cracks are noted, replace affected part (Section 6, HMI - Volume 1).
- (3). Using 10X glass and bright light, visually check struts and feet for cracks around and between the foot to strut bolt holes. Replace cracked parts per Section 6, HMI - Volume 1.
- (4). Remove each 369H6006 brace and check bolt holes in strut where brace attaches for cracks or corrosion. See Figure 1.
  - (a). Pull strut fairing fillet downward against spring tension. Secure in place with duct tape.

- (a). If cracks are noted, replace strut (Section 6, HMI - Volume 1).
  - (b). Remove light surface corrosion and treat affected area according to Section 2, HMI - Volume 1. If more severe corrosion (ref. Corrosion Control Manual) is present, replace strut (Section 6, HMI - Volume 1).

1. APPLY ZINC CHROMATE PRIMER, COLOR Y TO MATING HOLES ALL ATTACHING HARDWARE. REASSEMBLY WHILE WET.
2. SEAL AROUND BOLT HEAD AND NUT WITH PR1436-G SEALANT.
3. NUT IS PROVIDED WITH ABC5244 BOLT.
4. INSPECT ALL BOLT HOLES IN SHADED AREAS FOR CRACKS.
5. INSPECT FOR CRACKS, CHIPPED PAINT OR LOSS OF CORROSION PROTECTION.
6. EDGE OF BUSHING MUST PROTRUDE 0.010-0.060 INCH BEYOND OUTSIDE SURFACE OF PART AFTER NUT IS TIGHTENED.

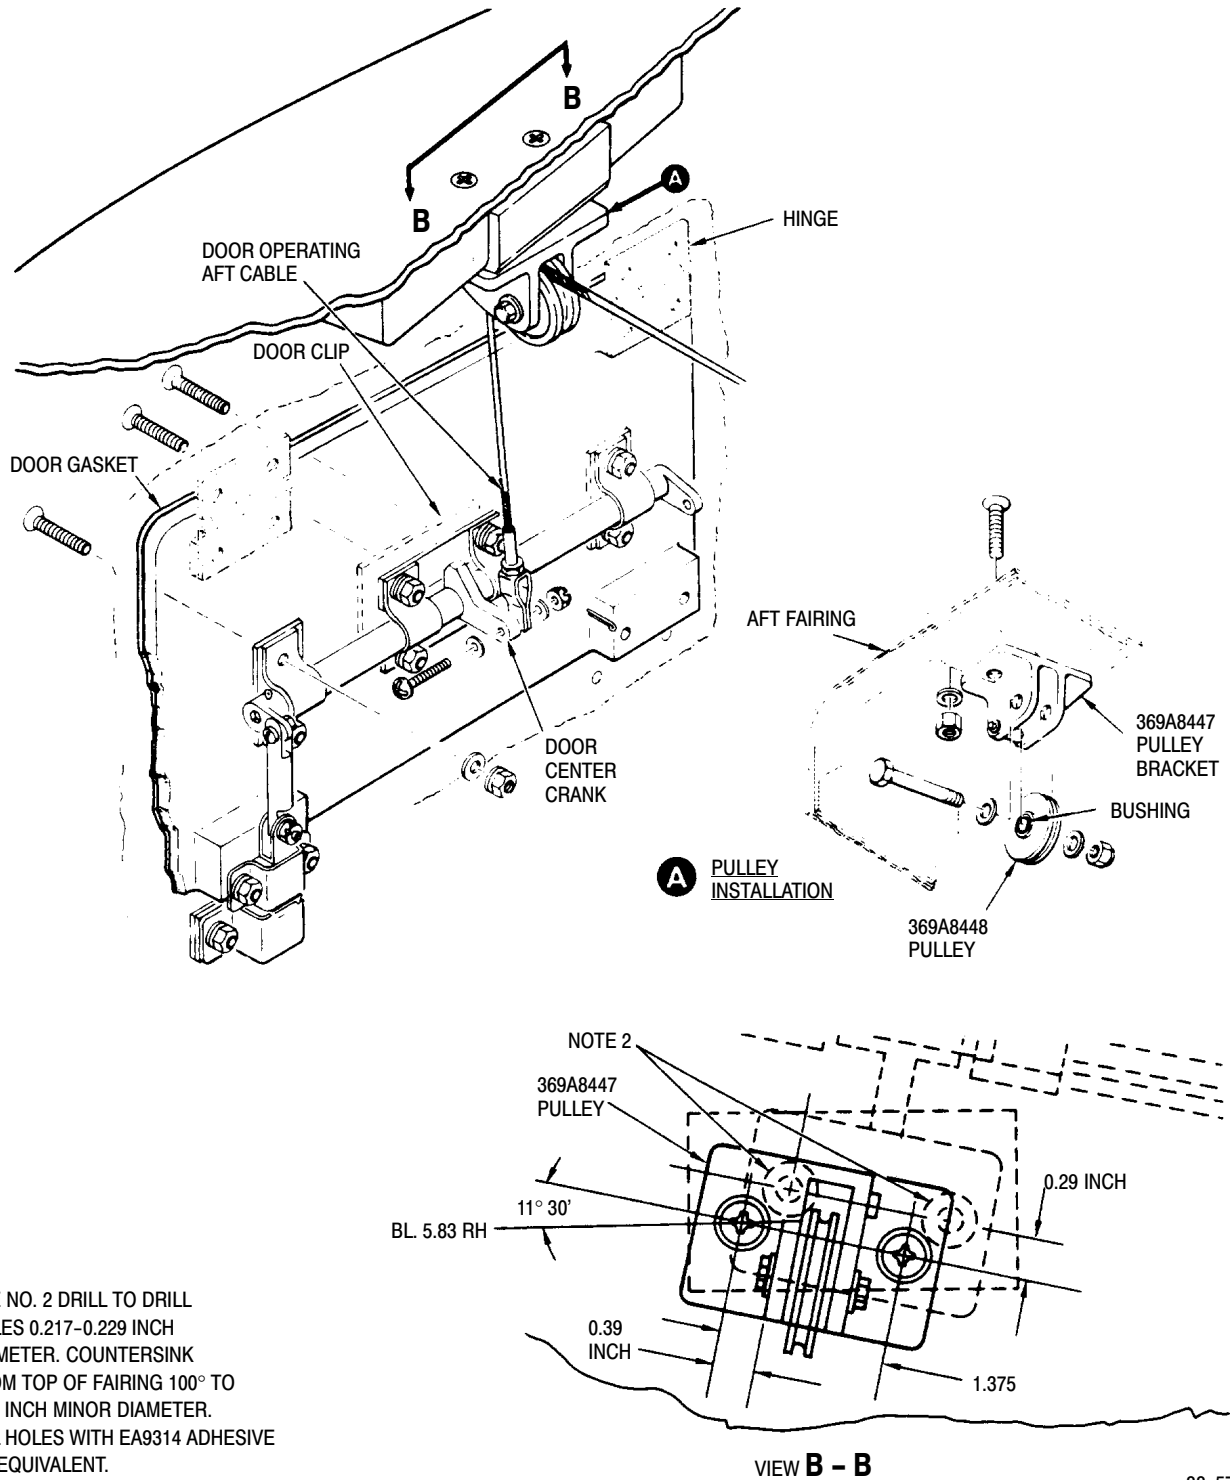
**Figure 1. Bracket (PN 369A8447) and Pulley (PN 369A8448) Relocation**

Information given in this Service Information Notice lists procedures for relocating the Engine Air Inlet Particle Separator Filter bypass door aft pulley (PN 369A8448) and bracket (PN 369A8447), to improve pulley alignment. Investigation has shown that realignment of the 369A8448 pulley will reduce the possibility of cable assembly (PN 369H90150-41) fraying, caused by the swaged end of the cable being pulled at an angle during opening of the filter bypass door.

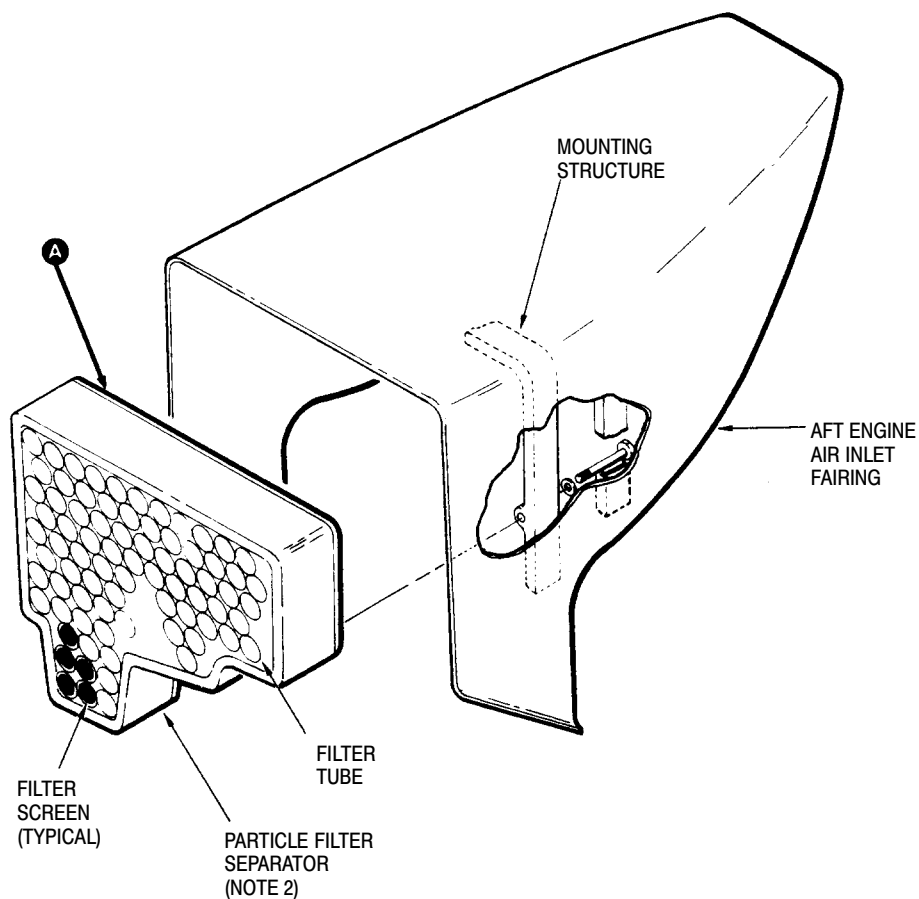
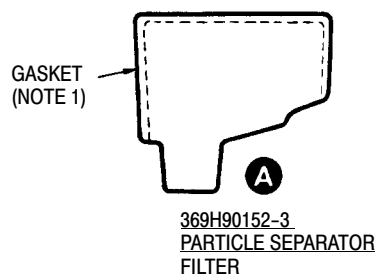
**Figure 2. Particle Separator Filter (PN 369H90152-3) Gasket. Used with 369H90148-503 and -505 Installations**

- (4). For 369H90148-503 and -505 installations, visually check the exposed aft side of 369H90152-3 particle separator filter, using flashlight, to ensure the 0.50-inch wide, soft rubber gasket is in place, undamaged and that deterioration or flaking of the rubber is not evident. (See Figure 2.) If gasket is not in place, is damaged or deterioration is evident, replace gasket as follows:

1. INSTALL GASKET AS SHOWN ON AFT FACE OF 369H90152-3 PARTICLE SEPARATOR FILTER.
2. CLEAN WHEN REMOVED (SECTION 2, CSP-004).
