***MD Helicopters, LLC***

***MD500/600 Series***  
***Service Bulletins Package***

## MODEL 369D, 369E, 369F/FF, 500N, 600N HELICOPTERS (500D, 500E, 530F, 520N, 600N) SERVICE BULLETIN PACKAGE TABLE OF CONTENTS

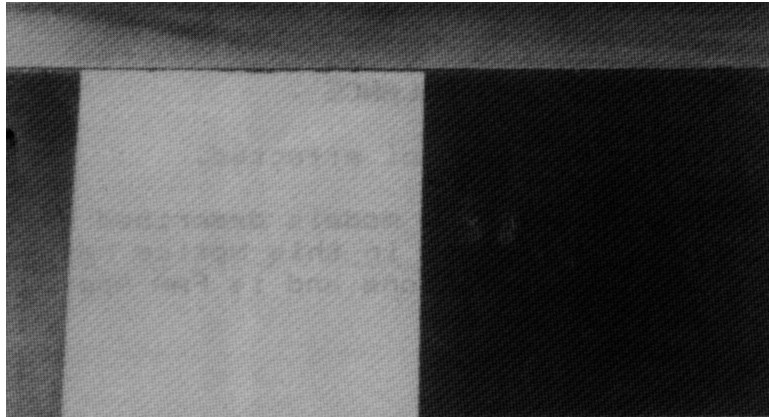
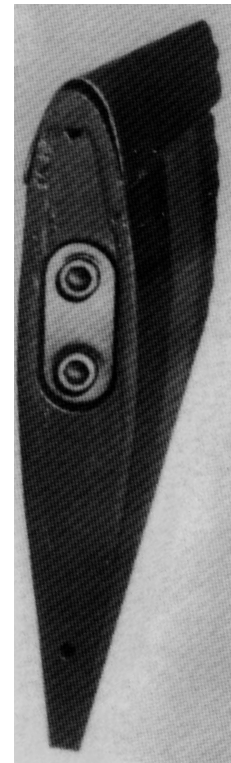
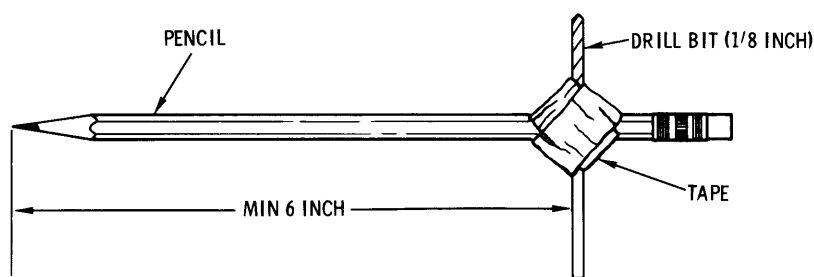
SHOWN ABOVE: UNBONDING OF EPOXY ADHESIVE AND ABRASION STRIP WITH SEPARATION BETWEEN ABRASION STRIP AND AIRFOIL SURFACE, BLADE UNACCEPTABLE FOR SERVICE.

SHOWN RIGHT: UNBONDED AND DISPLACED ABRASION STRIP AT BLADE TIP; SEPARATION BETWEEN ABRASION STRIP/AIRFOIL SURFACE ALONG BOND LINE, BLADE UNACCEPTABLE FOR SERVICE.

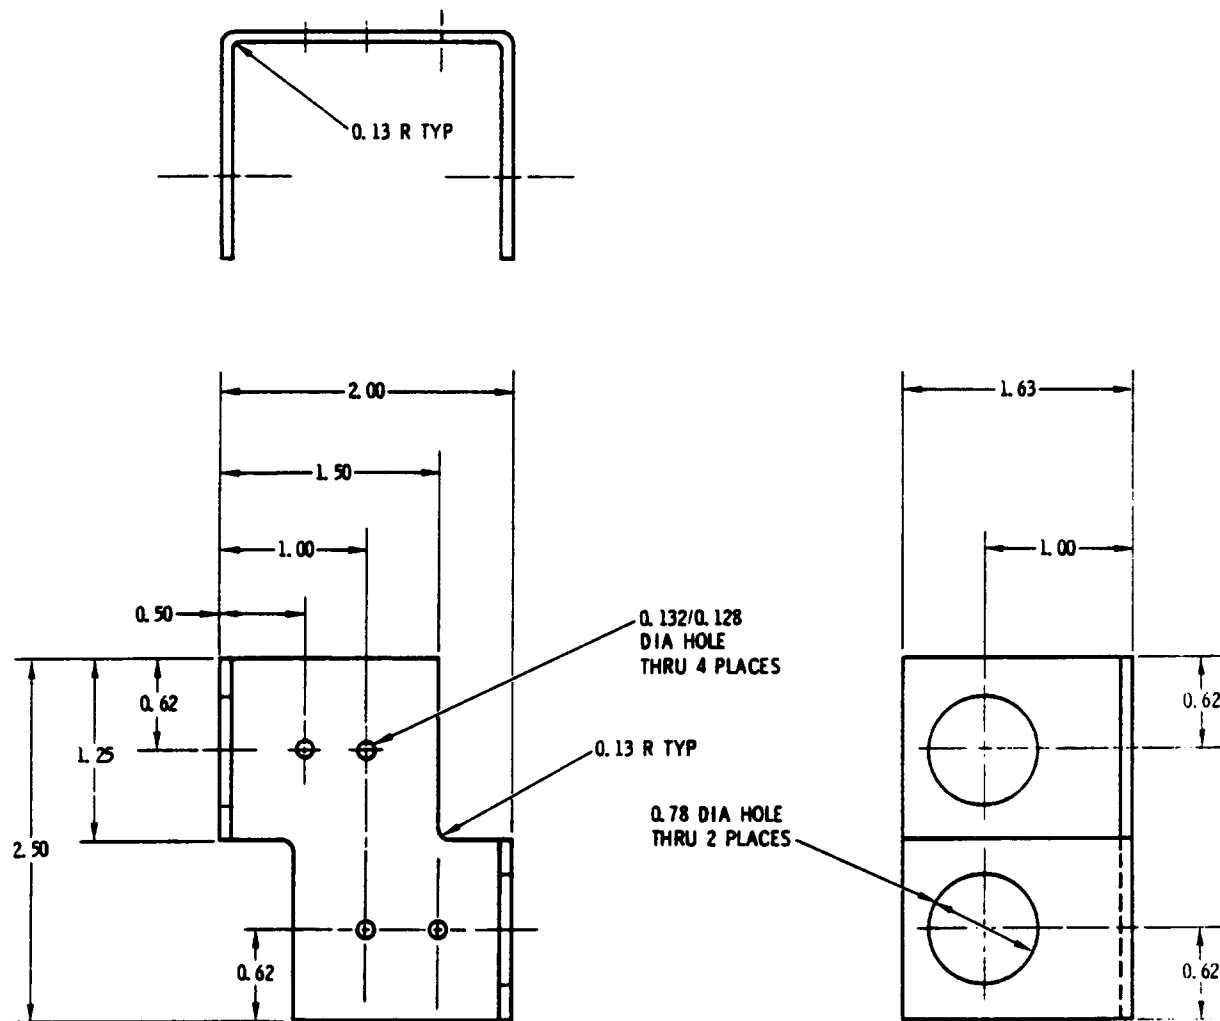
88-613

-11 BRACKET

(TO BE MADE OUT OF 301 SHEET STEEL CONDITION A PER MIL-S-5059)

**PREFACE:** This Service Information Notice containing all required information for owners/operators of Hughes Helicopters to fabricate and install the 369D25701-11 Cooling Installation Bracket which replaces the 369D25701-3 bracket.

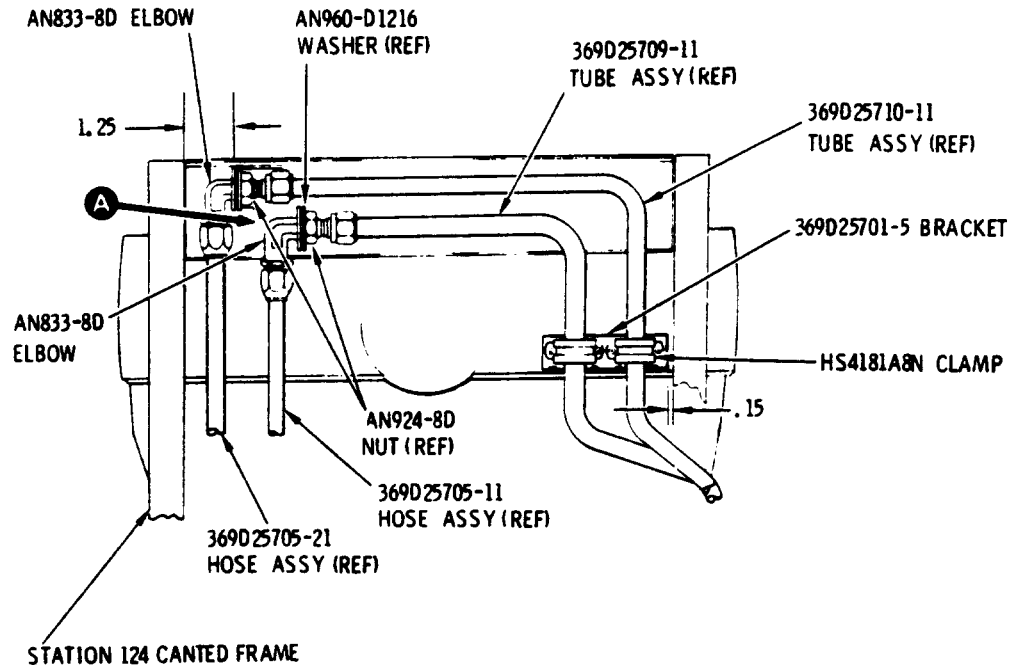
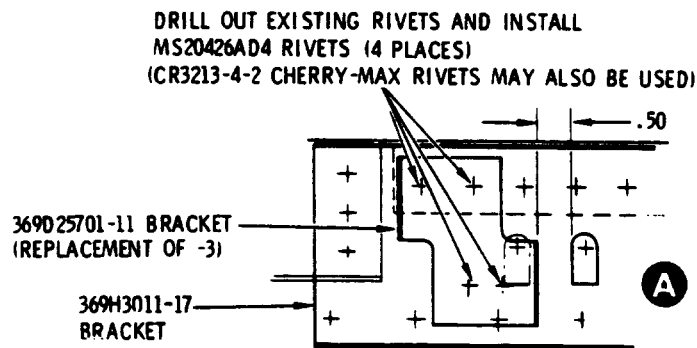
Figure 2. 369D25701-11 Bracket Installation Drawing

VIEW LOOKING AFT

- A. Remove sound insulation and transmission access cover (Section 2, HMI - Vol 1).
- B. Drain main transmission lubrication system (Section 2, HMI - Vol 1).
- C. Disconnect 369D25705-11 hose from AN833-8D elbow connected to 369D25709 tube assembly.
- D. Disconnect 369D25705-2l hose from AN833-8D elbow connected to 369D25710 tube assembly.
- E. Disconnect 369D25709-11 tube assembly from the 369D25701-3 bracket.
- F. Disconnect 369D25710-11 tube assembly from the 369D25701-3 bracket and loosen HS4181A8N clamp attaching tube assembly to 369D25701-5 bracket.
- G. Remove AN924-8D nuts from 369D25701-3 bracket.
- H. Drill out rivets attaching the 369D25701-3 bracket to structure and remove bracket. Apply zinc chromate to holes.
- I. Fabricate 369D25701-11 bracket per figure 1. (Optional)
- J. Install 369025701-11 bracket on 369H3011-17 bracket as shown in Figure 2, view A.

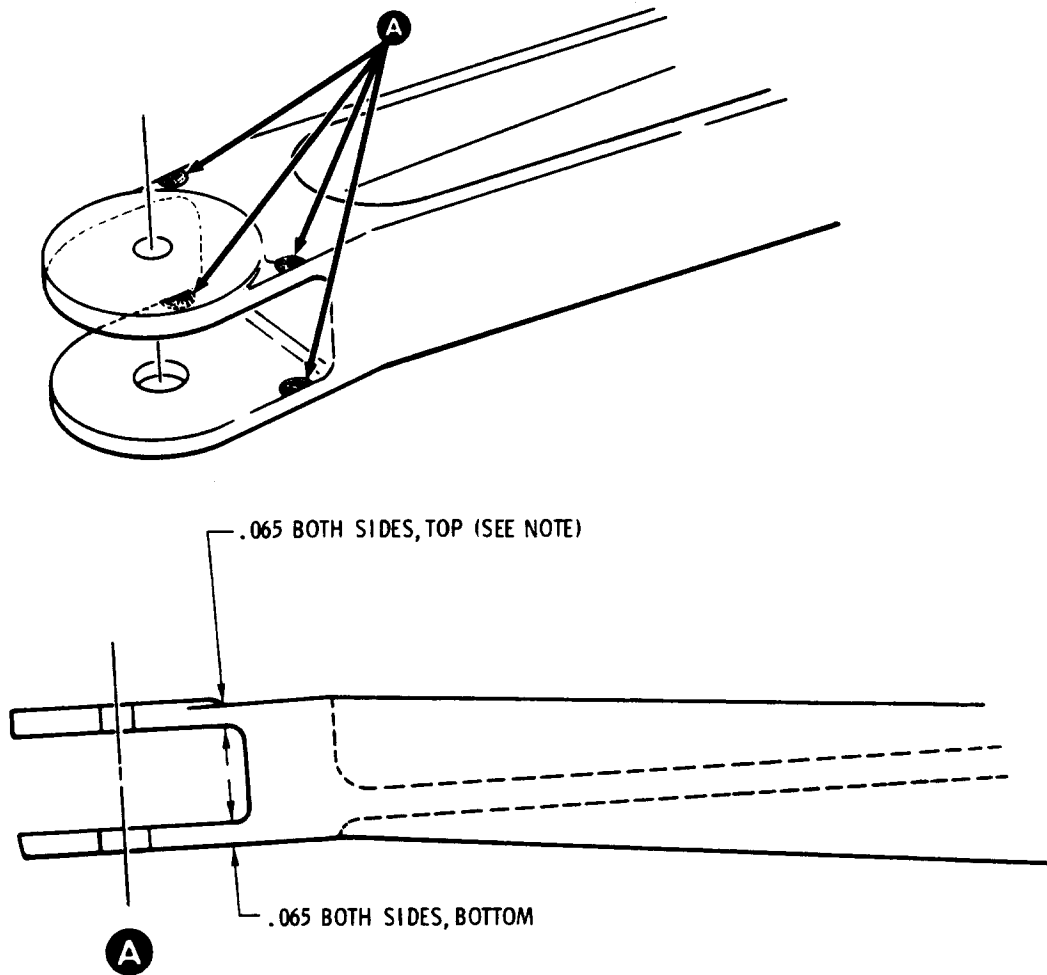
**PREFACE:** This Service Information Notice gives procedures for inspecting the thickness of the ear at the clevis end of the tail rotor bellcrank. Improper thickness may, cause failure and loss of control of the tail rotor during helicopter operation.

1. MINIMUM THICKNESS SHALL BE .065. WHEN MEASURING THE AREAS SHOWN, AVOID PLACING CALIPER ON INSIDE AND OUTSIDE RADIUS OF BELLCRANK TO ENSURE PROPER READING.
2. ALL DIMENSIONS SHOWN IN INCHES.

- A. Remove tail rotor push rod from bellcrank per Section 8, HMI Vol 1.
- B. Using caliper, measure thickness of the ears at the clevis end of tail rotor bellcrank as shown in figure 1.
- C. Minimum thickness shall be 0.065 inches. If minimum thickness is not found at points shown in Figure 1, replace bellcrank.
- D. Reinstall tail rotor push rod and bolt per Section 8 of Vol. 1 in HMI.
- E. Record compliance to this Service Information Notice in the appropriate section of the Helicopter Log Book.

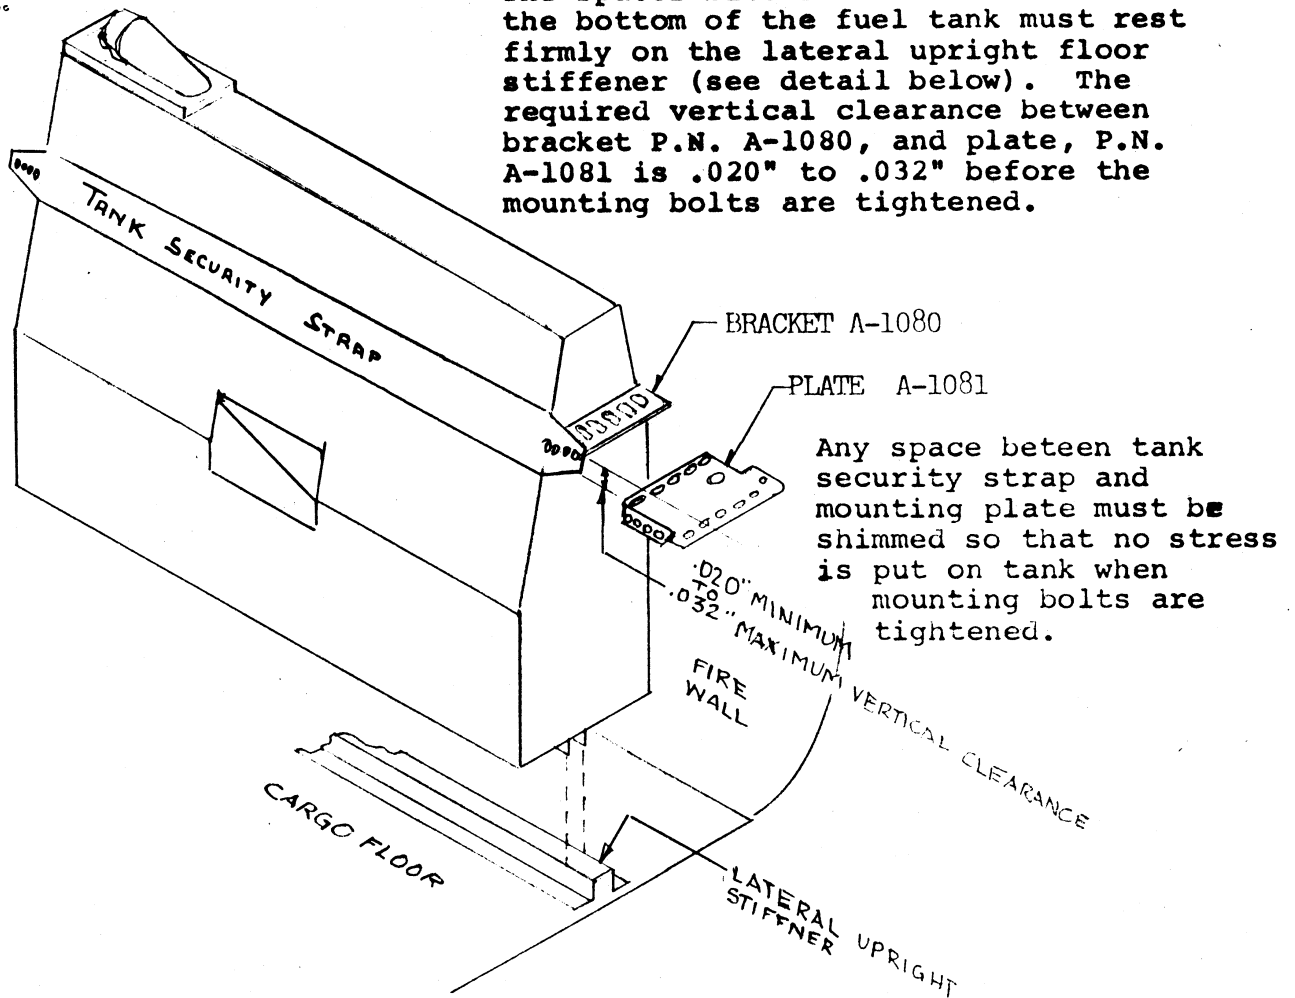
FWD

BACKGROUND: Leaks have been reported in Fargo Auxiliary Fuel Tanks. An investigation of those leaks reported indicates that insufficient contact of the tank bottom with the cabin floor can cause these leaks to develop. Specifically, if the spacer blocks located on the underside of the tank do not rest firmly on the lateral upright (hat-section stiffener) of the cabin floor, leaks can develop with continued service.

The spacer blocks in the "U" channel on the bottom of the fuel tank must rest firmly on the lateral upright floor stiffener (see detail below). The required vertical clearance between bracket P.N. A-1080, and plate, P.N. A-1081 is .020" to .032" before the mounting bolts are tightened.

- L. After the glue has cured, install the tank in the aircraft.
- M. If there are gaps between the right and/or left stainless steel mounting plates and tank security strap, these gaps must be shimmed so no preloading or stressing of the tank occurs.

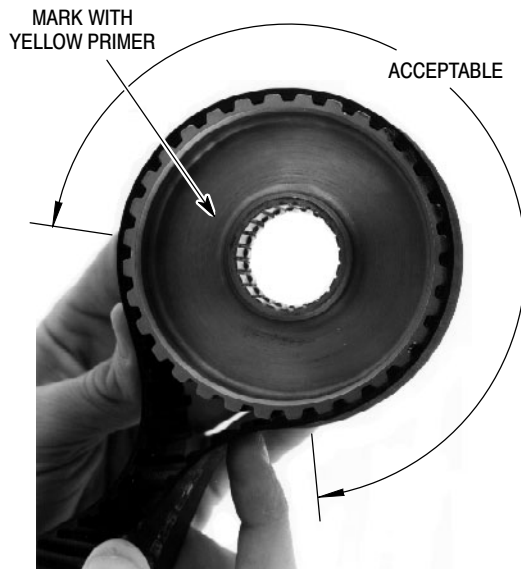
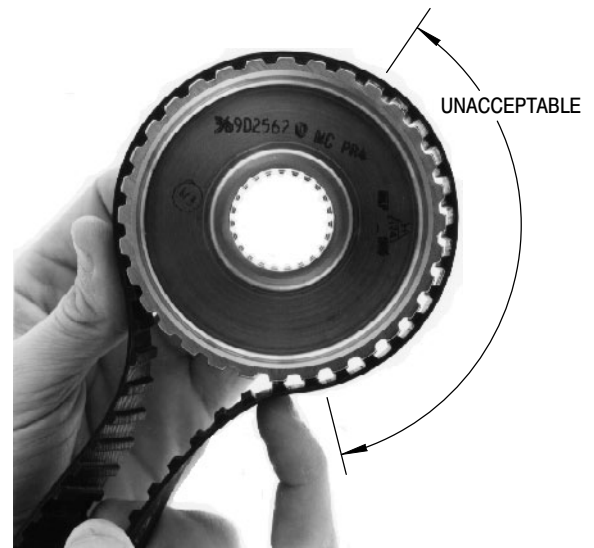
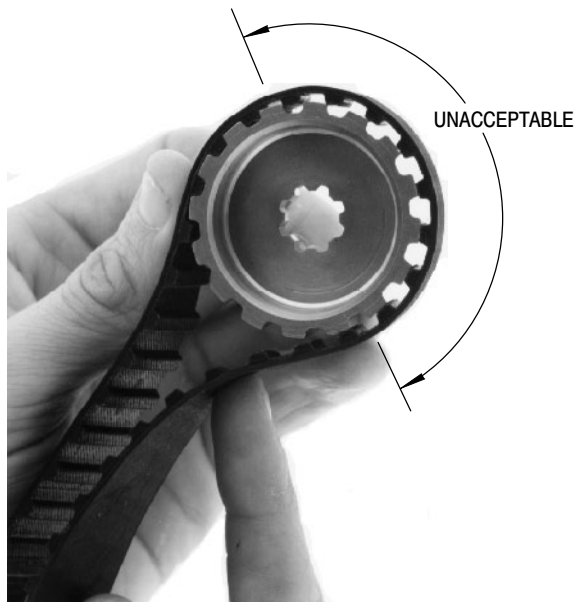
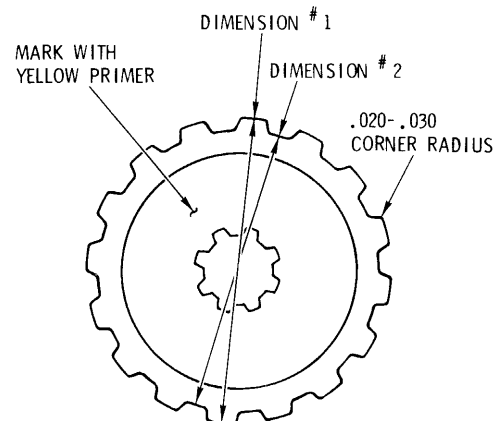
Figure 1. Cooling Fan Assembly Pulley Inspection/Rework

Signs of excessive wear include frayed belts showing white fibers, extremely worn belt teeth and heavy amounts of debris in the area of the smaller pulley.

- B. If there are no signs of excessive wear to the fan belt then proceed to Part II of this Notice within the next 75 hours of operation.
- C. If there are signs of excessive belt wear then proceed to Part II of this Notice immediately or before further helicopter operation.

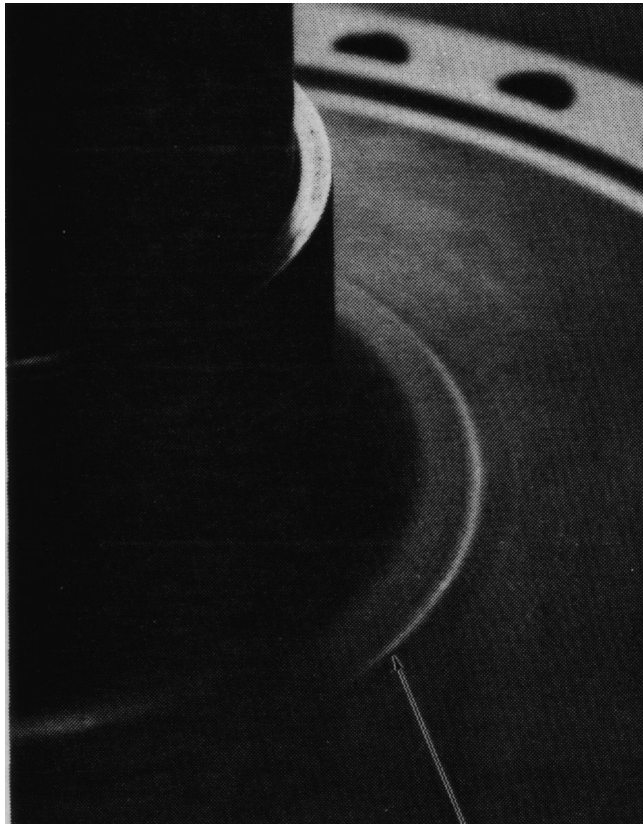
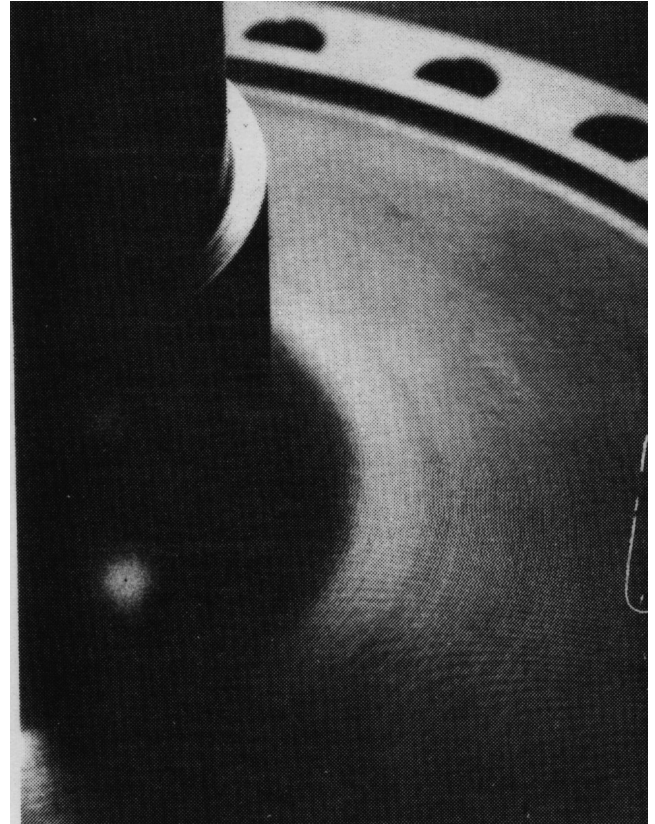
**UNACCEPTABLE**

**ACCEPTABLE**

ANY BULGING OR RAISED  
SURFACE IN THIS AREA  
IS NOT ALLOWED ON THE  
UPPER DISK SURFACE  
(INSPECT TOTAL  
CIRCUMFERENCE)

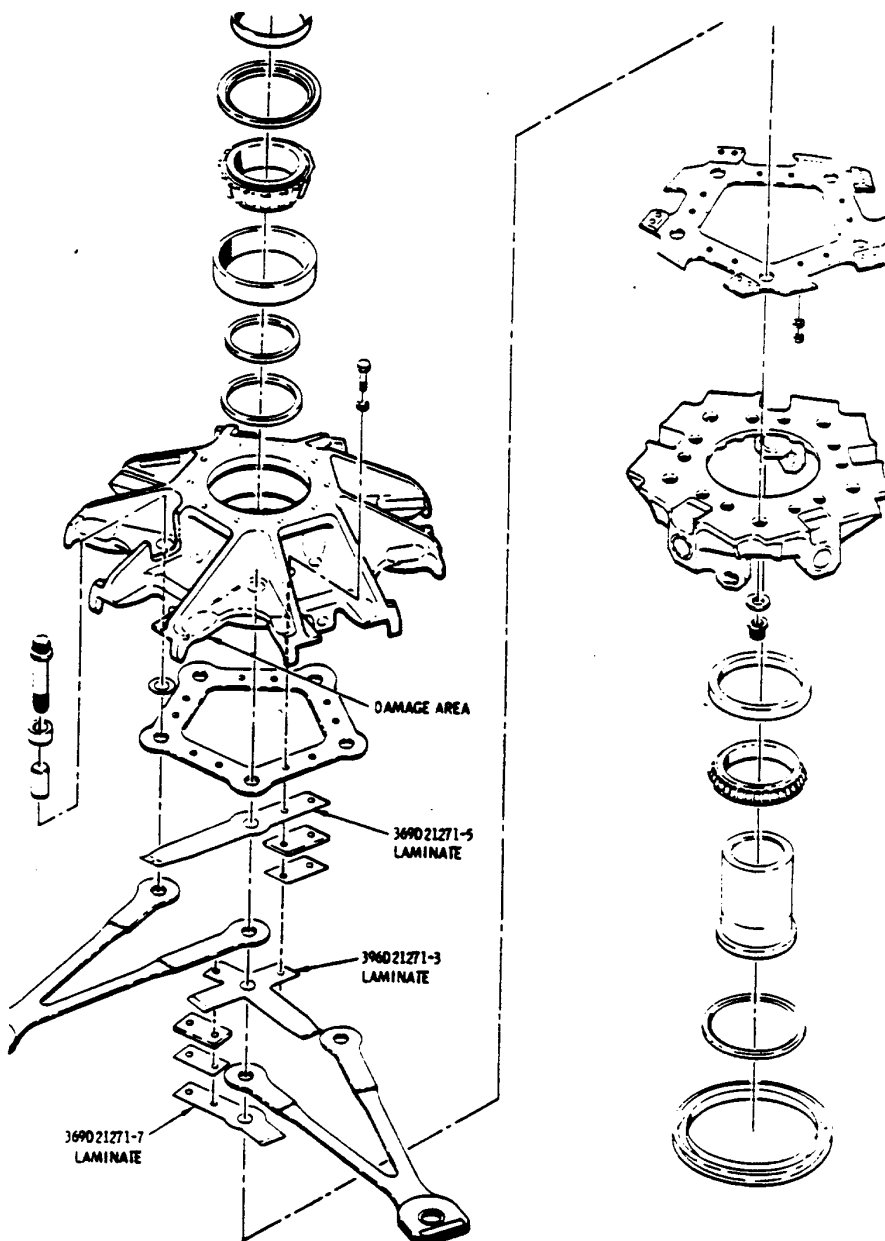
FAILED LAMINATE IF CRACK IS FOUND ON EITHER EDGE OF LAMINATE. IF ONE LAMINATE IS FAILED, REMOVE HUB.

Do not disassemble strap pack or hub assembly. Hub assembly is shown separated only for clarification of location of possible cracks and damage.

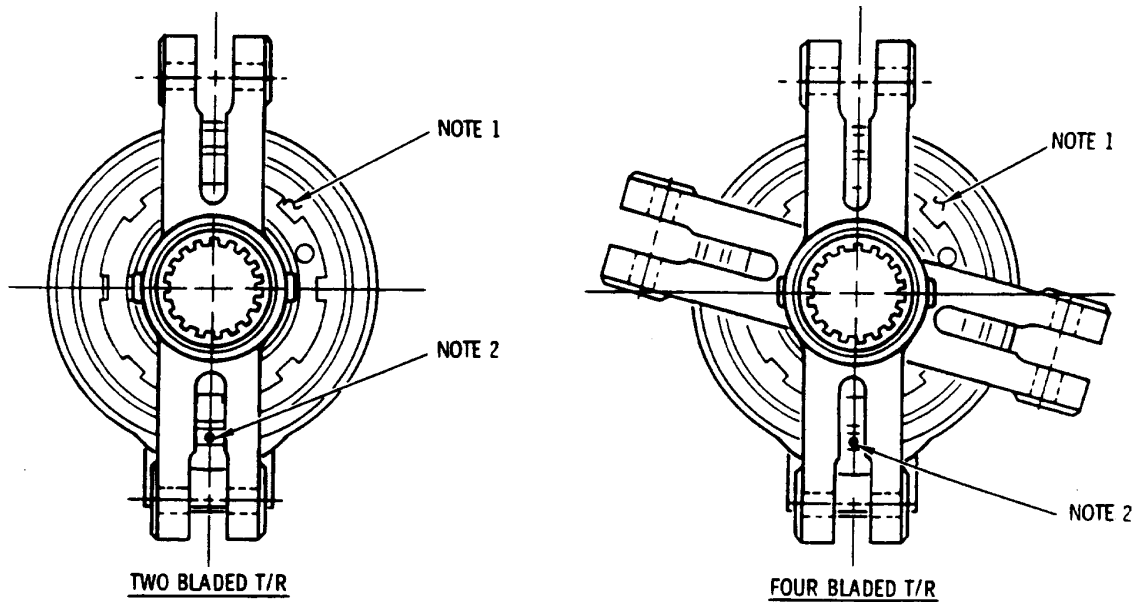
1. VERIFY BEARING SEAL IS GREEN OR YELLOW. BEARINGS WITH BLACK SEALS SHALL BE REMOVED AND REPLACED OR SUBJECTED TO THE 10-HOUR RECURRING INSPECTION.
2. APPLY A WHITE DOT TO PITCH CONTROL HOUSINGS WITH ACCEPTABLE BEARING WITH BLACK SEALS AS SHOWN.

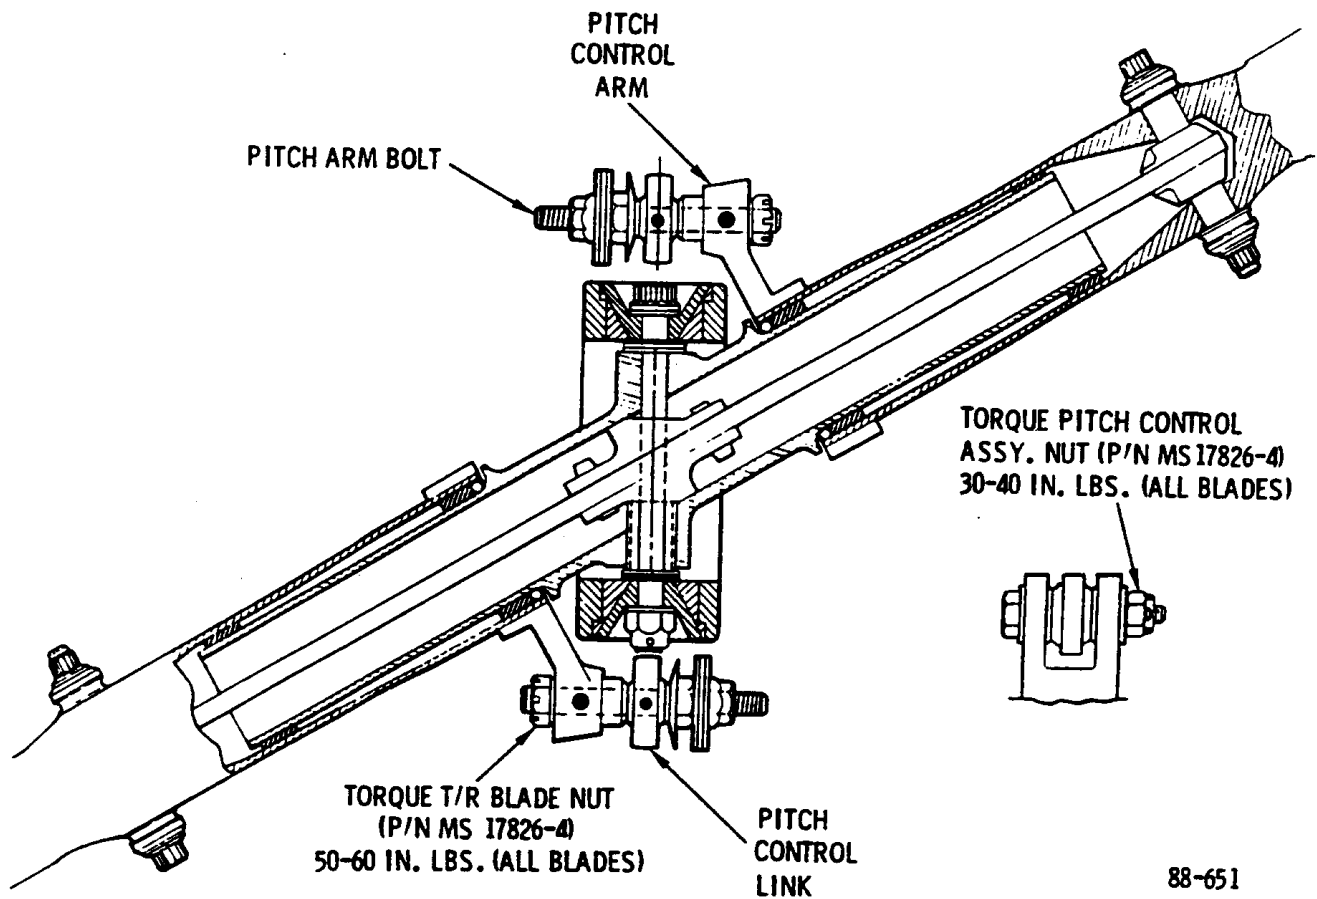
**PREFACE:** MDHI installation requirements were recently revised to lower the installation torque of the tail rotor pitch link nuts. Therefore, MDHI is requiring operators to replace the subject MS17826-4 nuts. MDHI will provide operators with replacement nuts, free of charge. Contact a MDHI Approved Service Center or Distributor for replacement nuts.

Figure 1. Replacement of Tail Rotor Pitch Link Nuts.

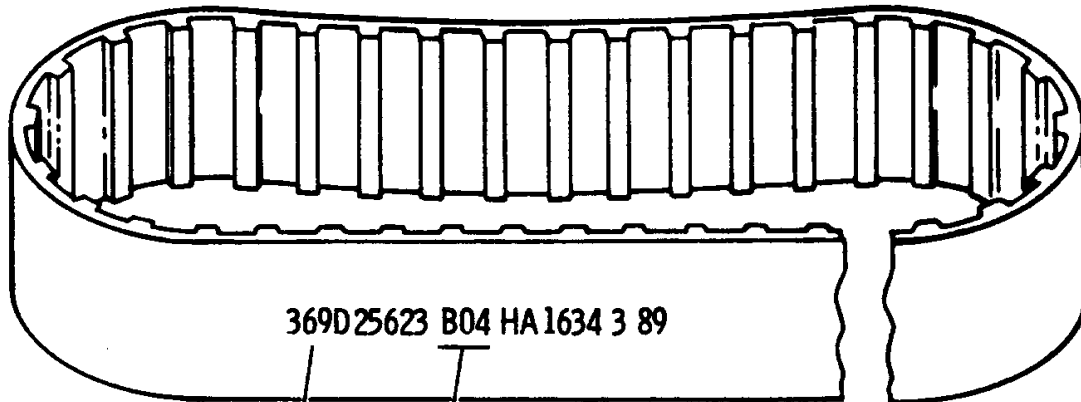
THREE-DIGIT MANUFACTURER'S CODE MUST BE PRESENT  
WHITE MARKINGS ACCEPTABLE

- a. Gain access to the oil cooling blower assembly.
- b. Inspect oil cooler blower belt as follows:
  1. Acceptable blower belts are identified by white PN 369D25623 followed by a three-digit code (see sample shown in Figure 1) with 3/16 to 1/4 inch high lettering along with some other numbering. In order to be acceptable the three digit code must be present.
  2. Blower belts identified with green part numbers and letters (refer to Figure 1) or belts without three-digit codes immediately after the part number must be replaced with acceptable belts per instructions contained in the appropriate Maintenance Manuals.
  3. Remove unacceptable blower belts from Spares Inventories. Return unacceptable belts to MDHC Warranty and Repair Department for warranty consideration/replacement.

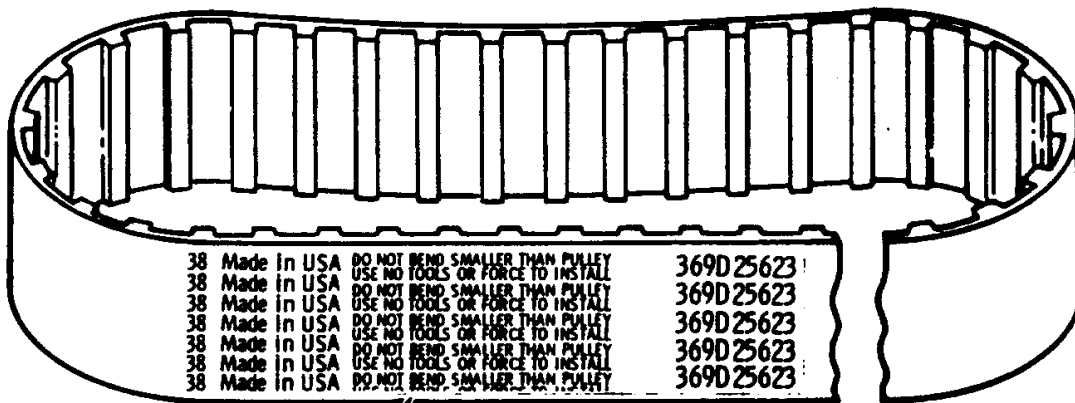
Unacceptable belts can track improperly and damage other components of the cooling fan assembly.

GREEN MARKINGS UNACCEPTABLE

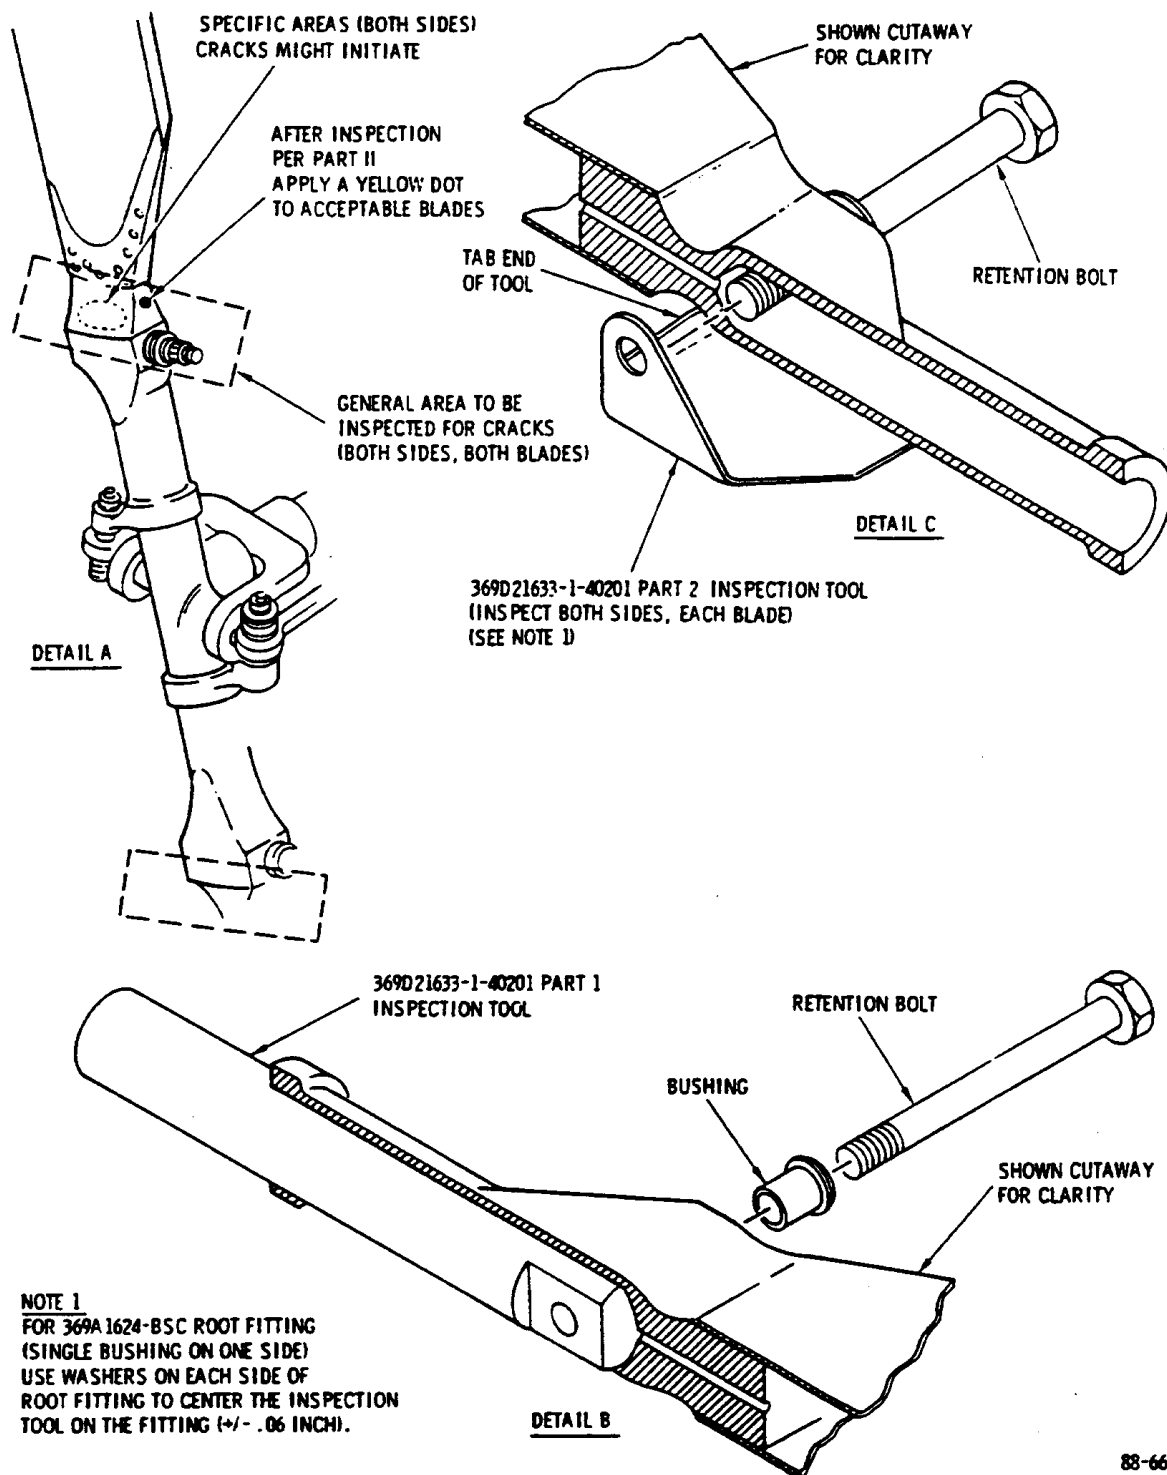
88-666

**SUMMARY:** Due to a failure of a tail rotor blade root fitting, MD Helicopters, Inc. (MDHI) is requiring operators to perform an inspection of all aluminum tail rotor blades to ensure that no crack exists in the tail rotor blade root fitting and that the tail rotor blade root fitting has proper wall thickness. Thin wall thickness in the tail rotor blade root fitting can lead to tail rotor blade failure.

Figure 1. Inspection of Tail Rotor Blade Root Fitting.

- Visually check both sides of each tail rotor blade in the area detailed in Figure 1, Detail A, for any indications of cracking.
- Tail rotor blades having indications of cracking shall be removed from service and returned to MDHI for further inspection and warranty consideration.
- As required, install acceptable tail rotor blades per the applicable maintenance manual.

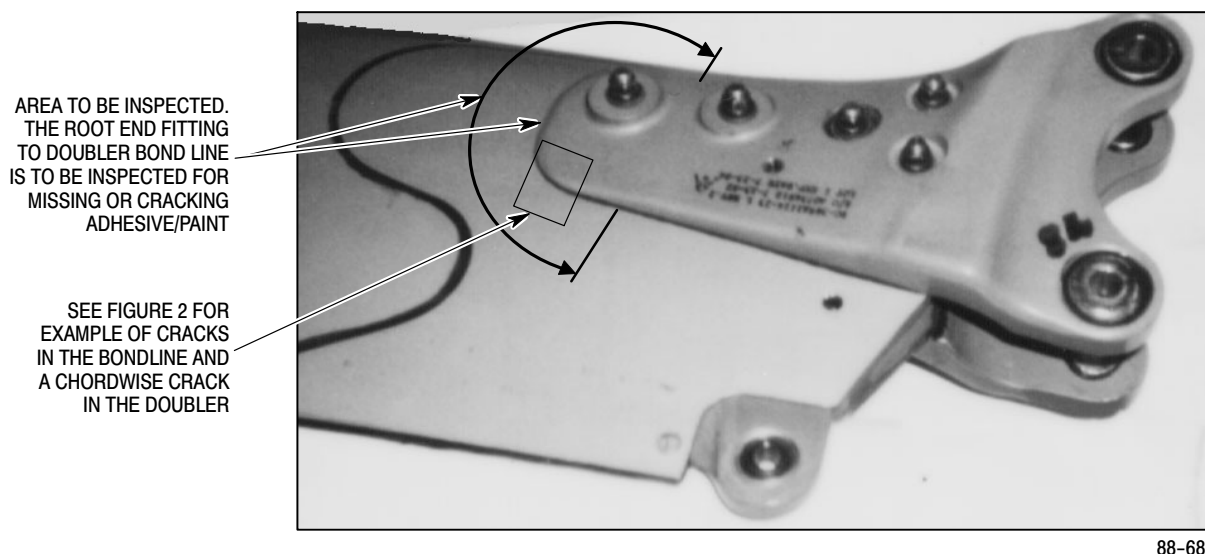
**Figure 1. Main Rotor Blade Root Fitting Inspection.**

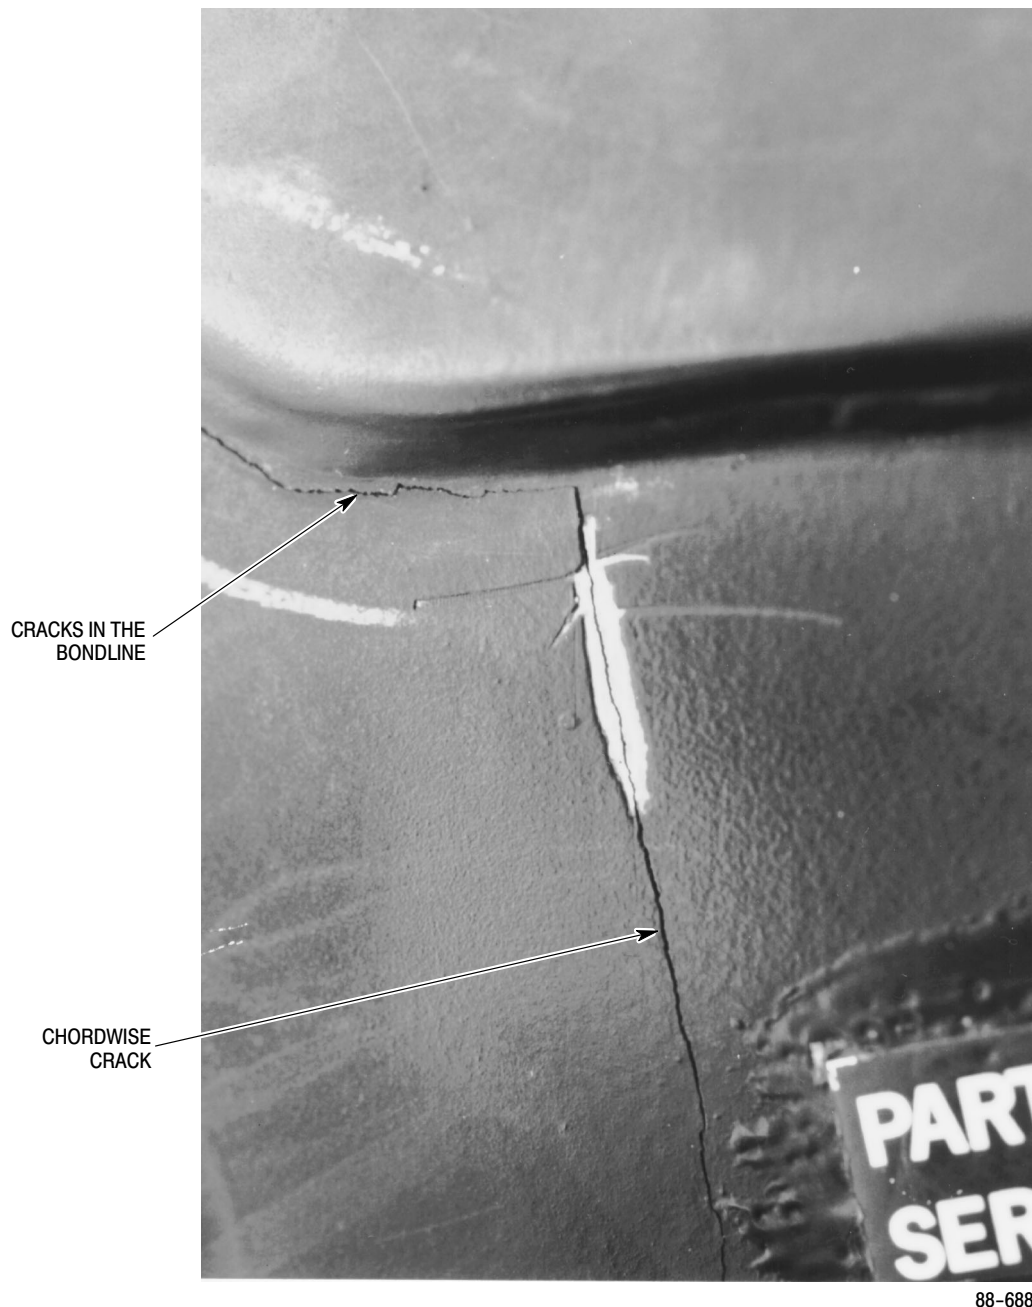
88-688

**Figure 2. Example of Main Rotor Blade Root End Cracking.**

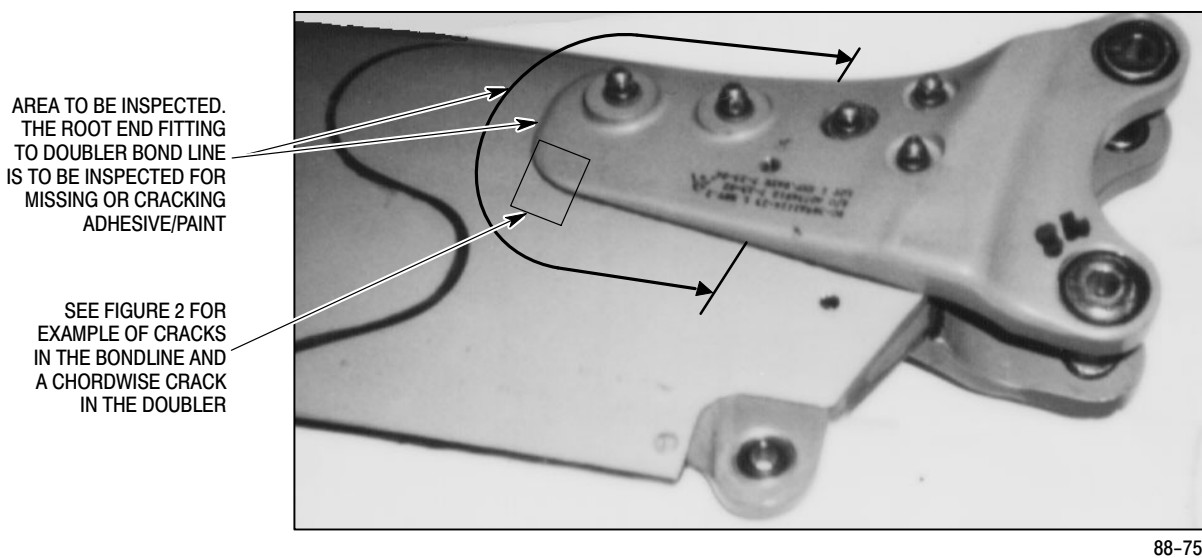
88-756

Cracked main rotor blade root end or lead-lag links may produce a sudden change or increase in helicopter vibration. If operators experience a sudden onset of unusual or excessive vibration, a precautionary landing must be made. No further flights shall be attempted until the cause of the vibration has been identified and corrected.

**Figure 1. Main Rotor Blade Lower Surface Root Fitting and Doubler Inspection.**

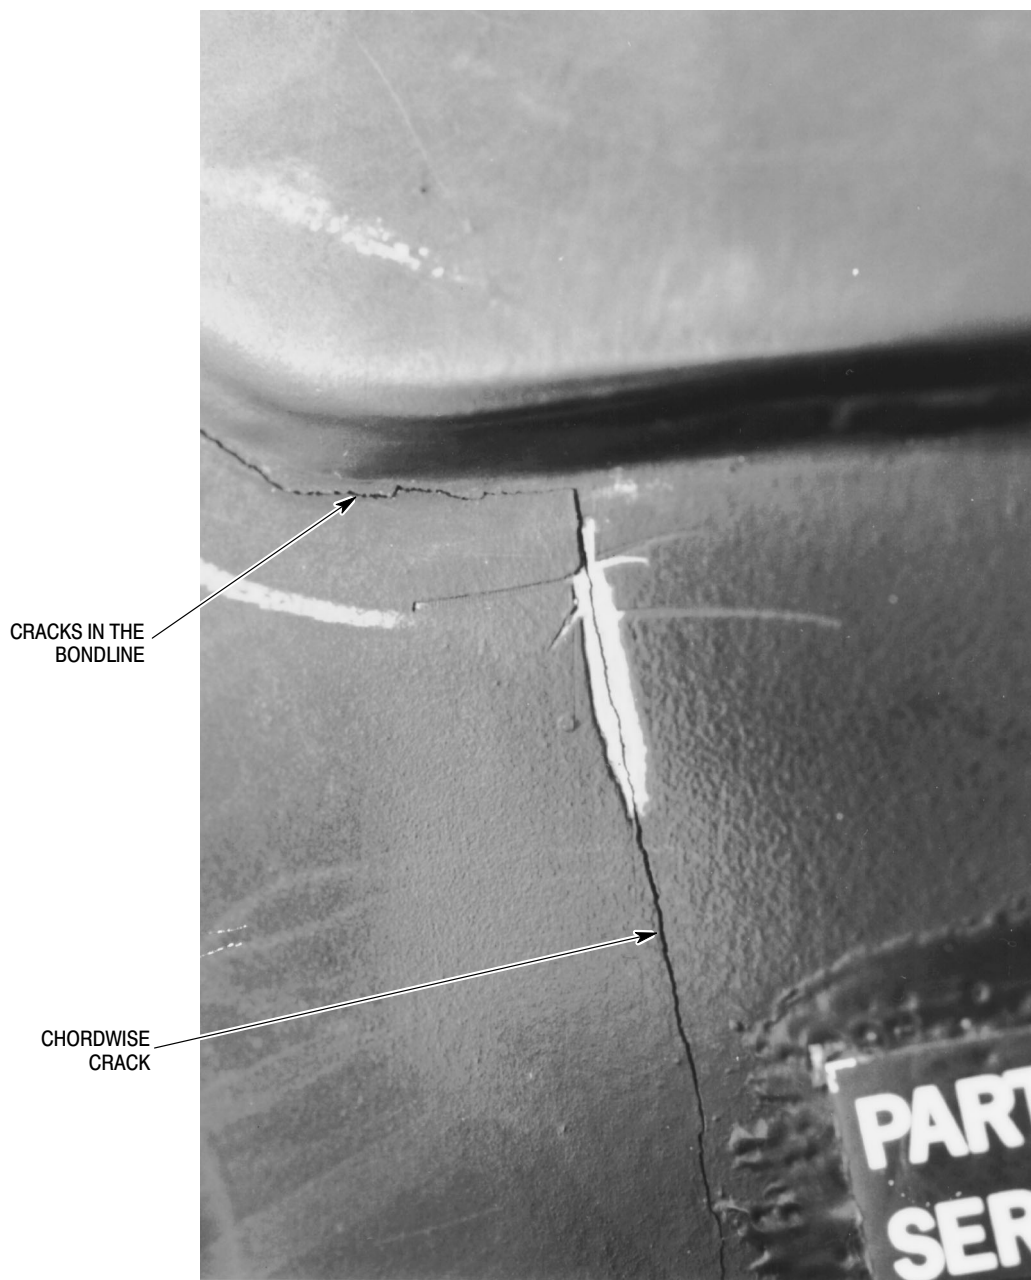
88-688

**Figure 2. Example of Main Rotor Blade Lower Surface Root End Cracking.**

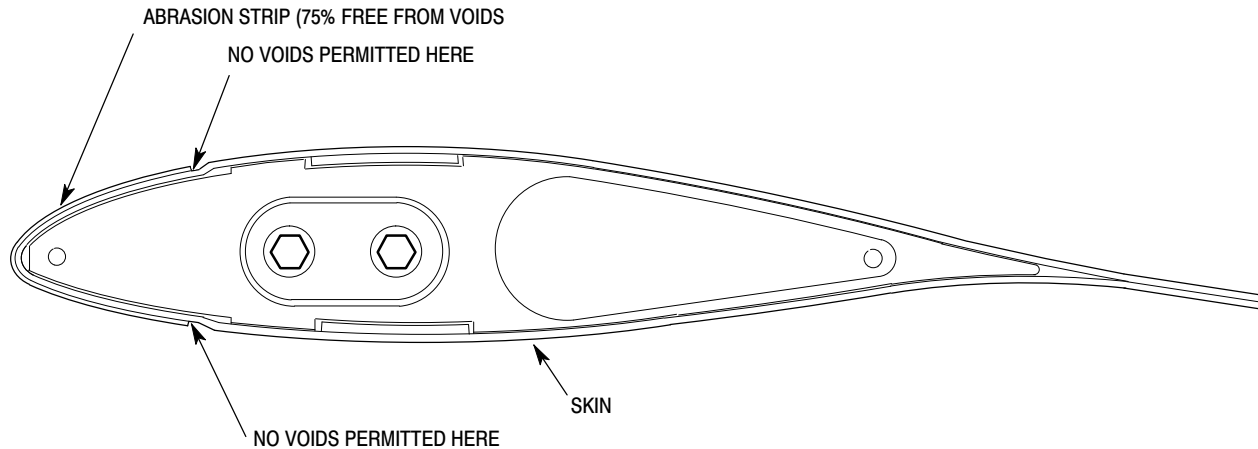
88-822

**Figure 1. Tail Rotor Blade Abrasion Strip Inspection**

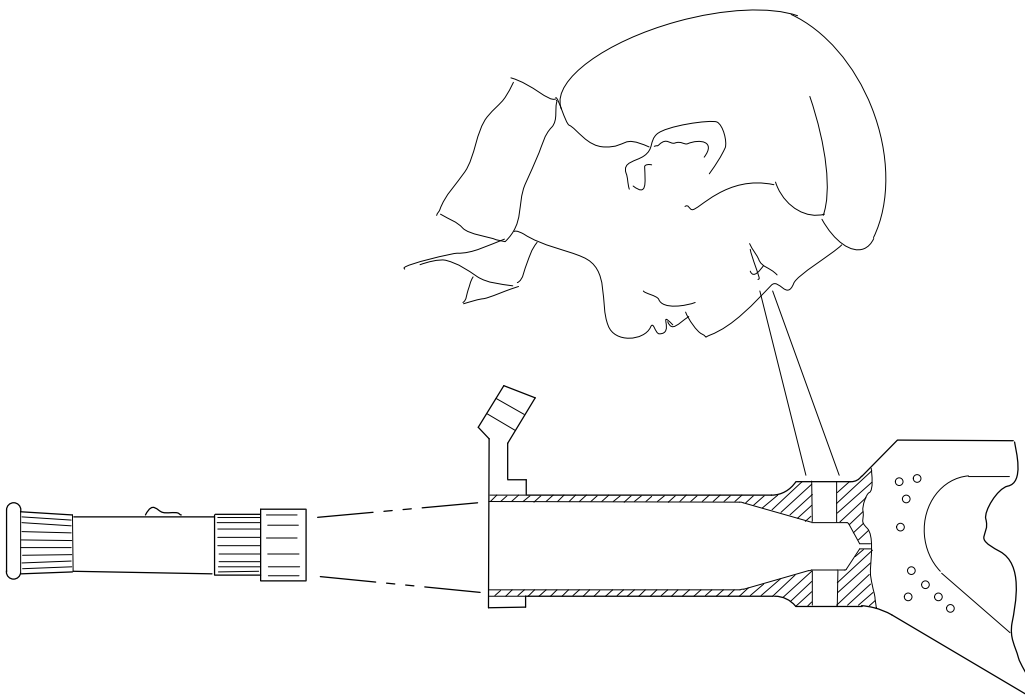
88-789

**Figure 1. Method for Visual Inspection of the Root Fitting**

- (4). Use a bright light to inspect the bore of the tail rotor blade root fitting (Ref. Figure 1). Make sure the transition from the bore to the tapered end has a smooth radius (Ref. Figure 2).
- (5). A tail rotor blade assembly that is not acceptable will have a sharp transition (Ref. Figure 2)
- (6). Replace all blade assemblies that are missing a smooth radius (Ref. Figure 2).
- (7). Install serviceable blade assembly on aircraft (Ref. CSP-H-2 or CSP-HMI-2, Sec. 64-10-00, and CSP-H-5 or CSP-COM-5, Sec. 64-20-10, 64-20-20).
- (8). Complete Part 3 of the Bulletin Compliance Recording Form and submit to MDHI.

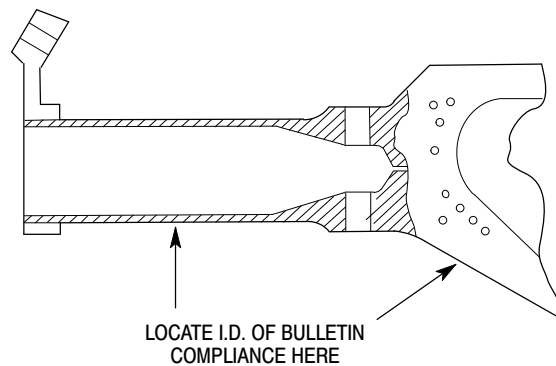
88-788

**Figure 3. Location of Bulletin Compliance I.D.**

- (1). Upon completion of Part 3 of this service bulletin, identify the serviceable tail rotor blade assembly with the service bulletin number applicable to the model of aircraft (Ref. Figure 3).
- (2). 369A operators identify compliance of this bulletin with “369A 4/XX/07”.
- (3). The identification will be made with CM312 Ink Stamp Permanent on the root end of the blade assembly adjacent to the blade assembly data plate and on the trailing edge of the root fitting (Ref. CSP-H-2 or CSP-HMI-2, Sec. 91-00-00).
- (4). Once the ink stamp has dried, coat the identification marking with CM314 Varnish, Moisture Resistant and allow to cure (Ref. CSP-H-2 or CSP-HMI-2, Sec. 91-00-00).

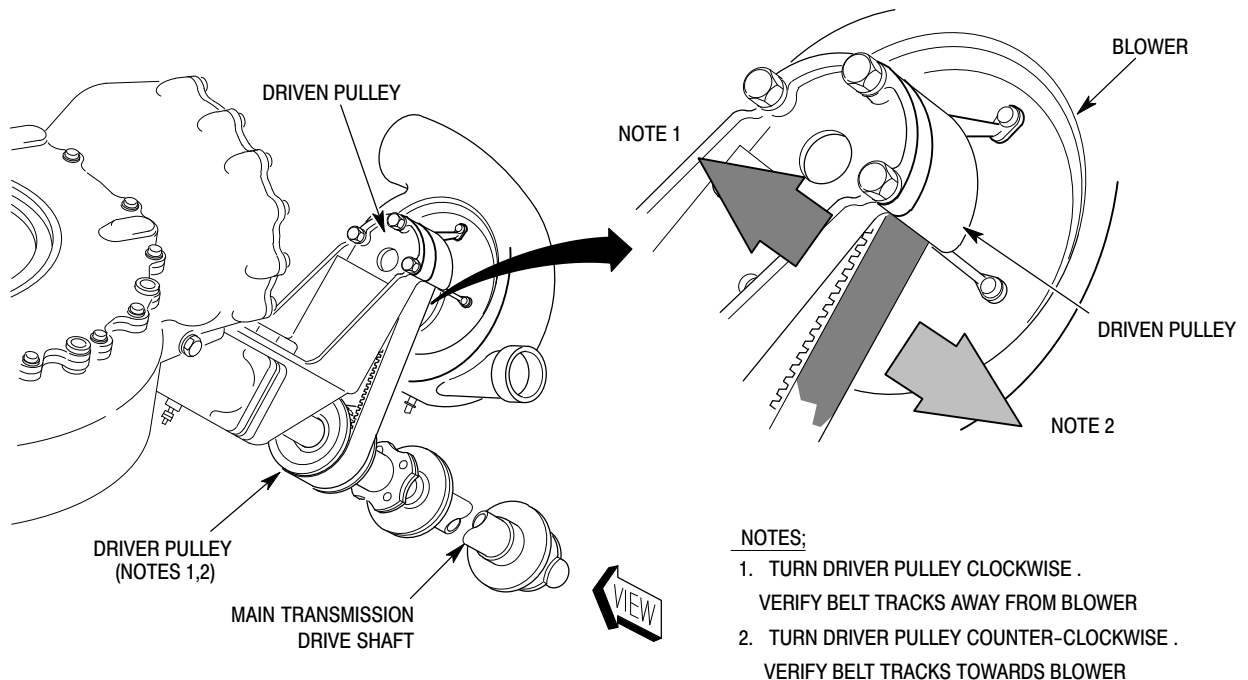
- (4). If the oil cooler belt does not track correctly, complete Bulletin Compliance Recording Form and go to step B.
- (5). In addition to checking the belt tracking, inspect the condition of the oil cooler belt and make sure it is otherwise serviceable Ref CSP-HMI-2, Sec 63-21-00 (369D/E/F/500N) or CSP-H-2, Sec 9 (369H Series).

**Figure 1. Belt Tracking**

- (6). If the belt is serviceable and tracks correctly, no further maintenance action is required. Complete Bulletin Compliance Recording Form and return to MD Helicopters, Inc.
