***MD Helicopters, LLC***

***MD500/600 Series***  
***Service Bulletins Package***

## MODEL 369D, 369E, 369F/FF, 500N, 600N HELICOPTERS (500D, 500E, 530F, 520N, 600N) SERVICE BULLETIN PACKAGE TABLE OF CONTENTS

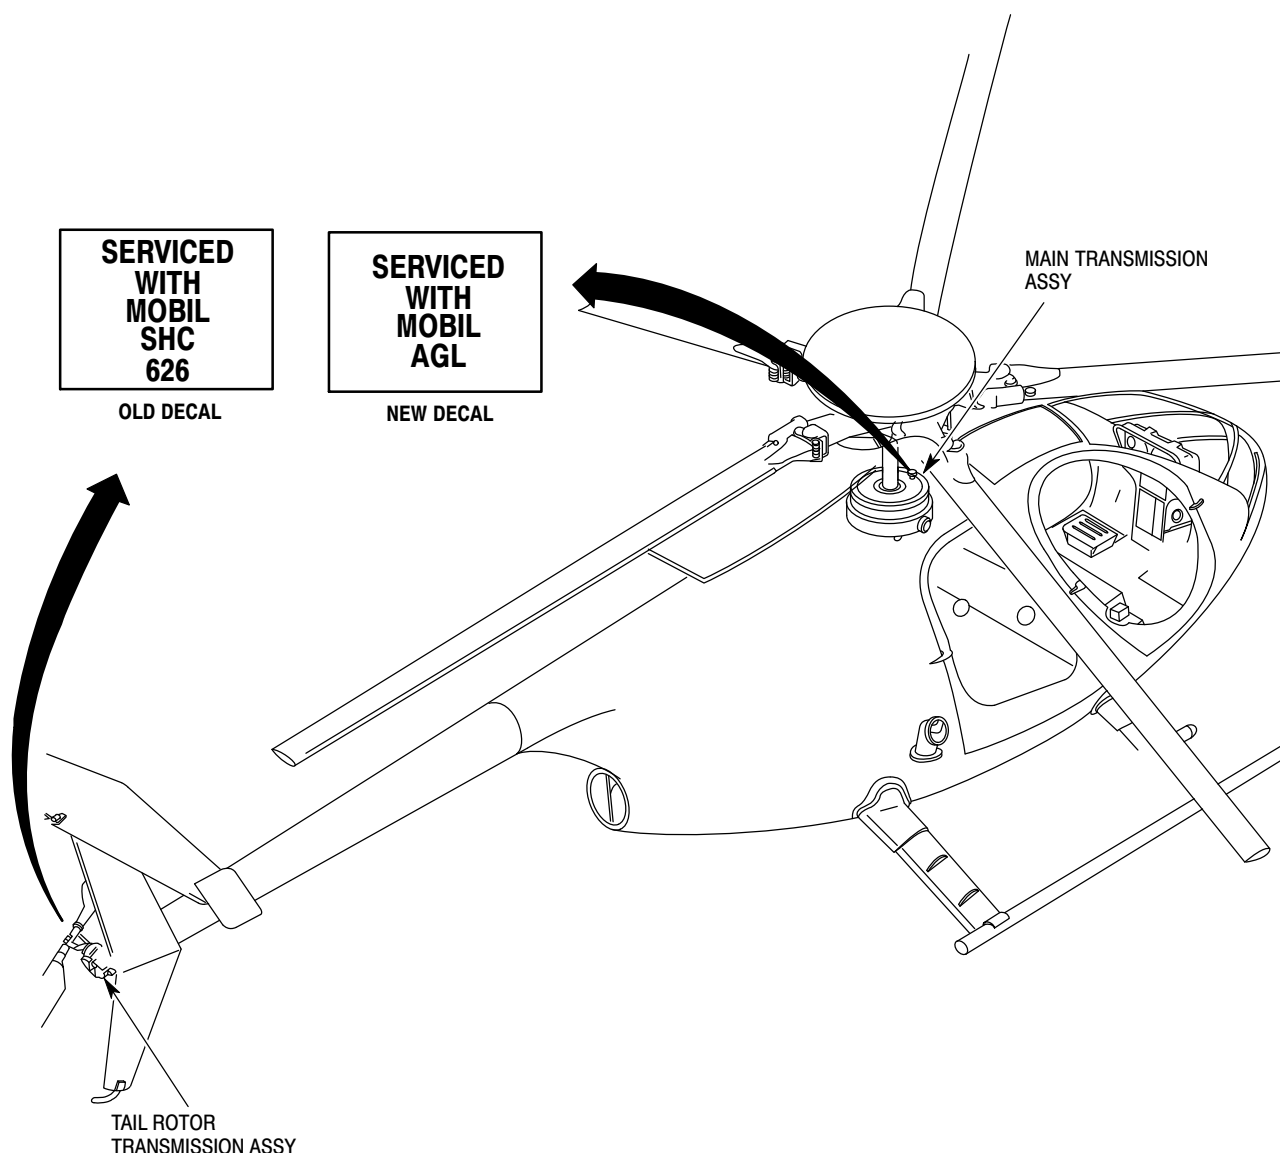
88-821

Failure to comply with this bulletin can result in the incorrect use of a lubrication oil (Mobil SHC 626 with the label "NOT FOR AVIATION USE") in the transmission assembly which can cause damage to the transmission assembly.

**Figure 1. Removal and Replacement of Mobil SHC 626 References**

Procedures in this Bulletin give owners and operators information on the introduction and use of Mobil AGL and to remove and replace the old Mobil SHC 626 decals with the new Mobil AGL decals.

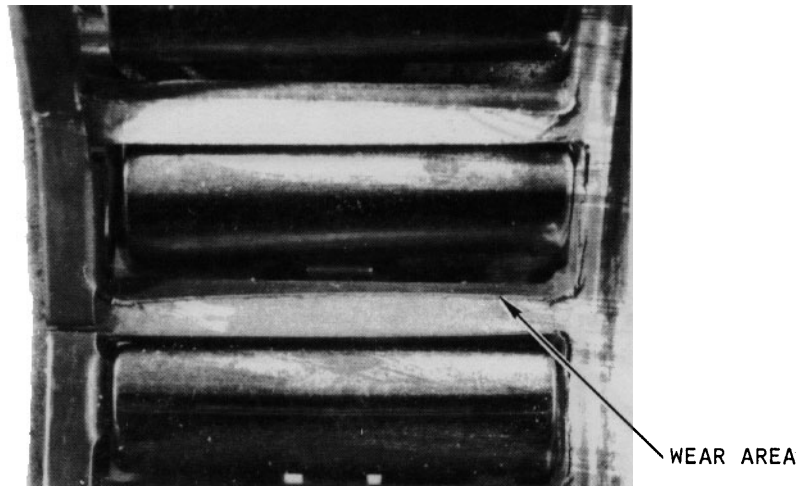
88-473

d. Inspect cages for peening or wear; maximum permissible width across inner cage and outer cage windows is 0.208 inch.. (See Figure 1 and Figure 2. ) If maximum is exceeded, replacement of sprag assembly is required. Note in Figure 2 that the most pronounced inner and outer cage wear occurs in the outside diameter corners of the crossbars. Wear should be measured at the worst point. Inspect for any wear on inner cage face opposite the flange end.

## Figure 2. Excessive Cage Wear

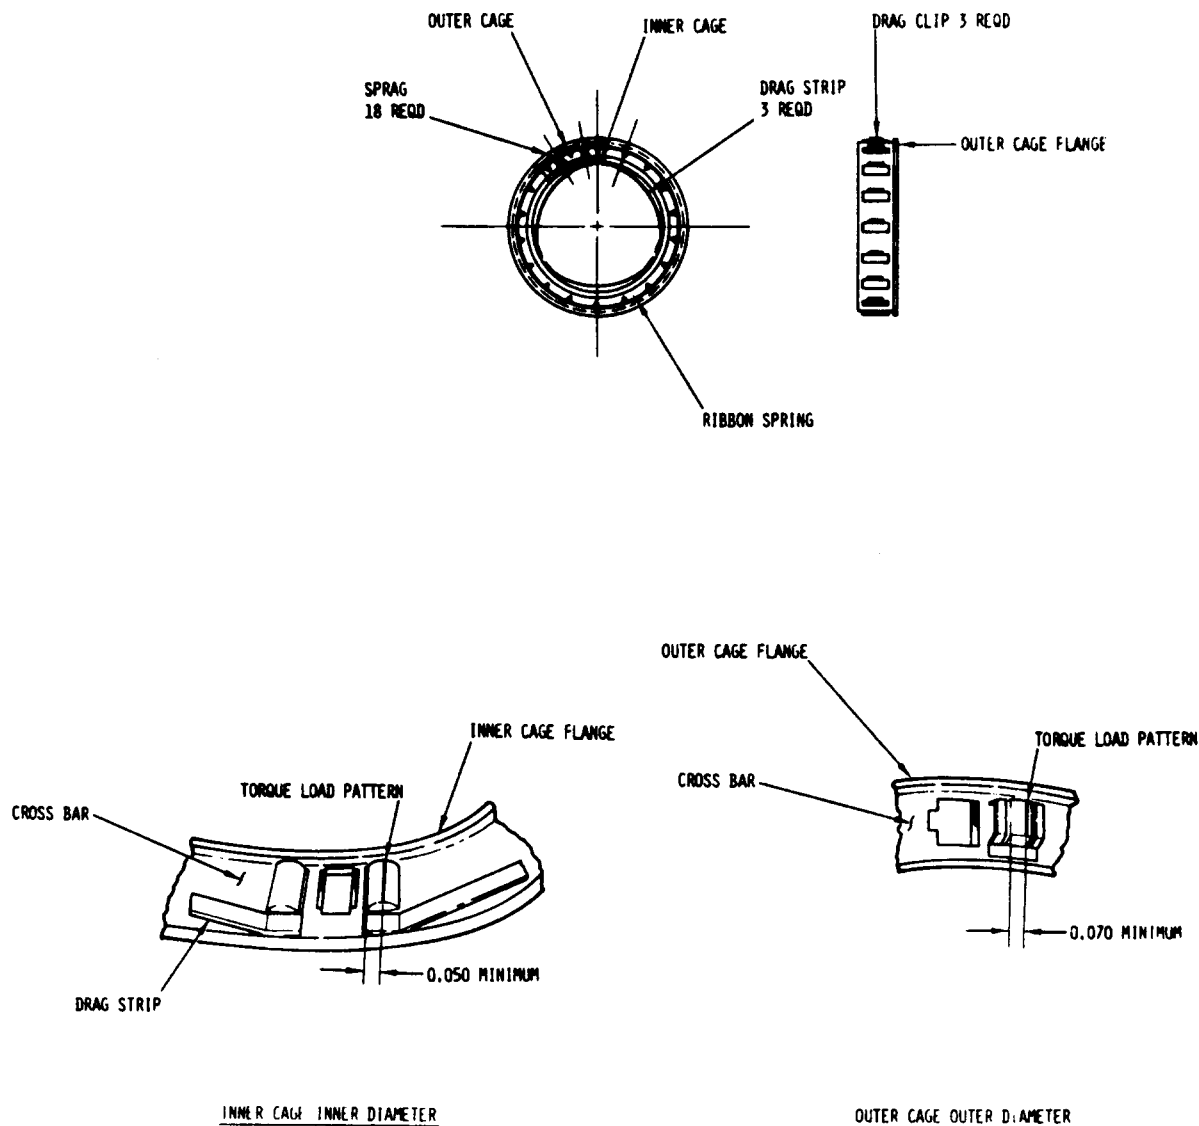
88-466

e. Using 4X magnifying lens, inspect sprag load surfaces. If any flats, scoring, heavy pitting or heavy scratches are found on sprag inner or outer surfaces, the sprag assembly must be replaced. (See Figure 3. )

f. Measure distance from edge of sprags to load pattern. Should the inner surface measurement be less than 0.050 inch minimum or the outer surface measurement be less than 0.070 inch minimum, the sprag assembly must be replaced. (See Figure 3. ) On the sprag inner contact surface of all the sprags in a sprag assembly the variation in distance from edge of sprag to load pattern should not exceed 0.030 inch. If this figure is exceeded, replace sprag assembly.

**Figure 3. Sprag Torque Load Pattern**

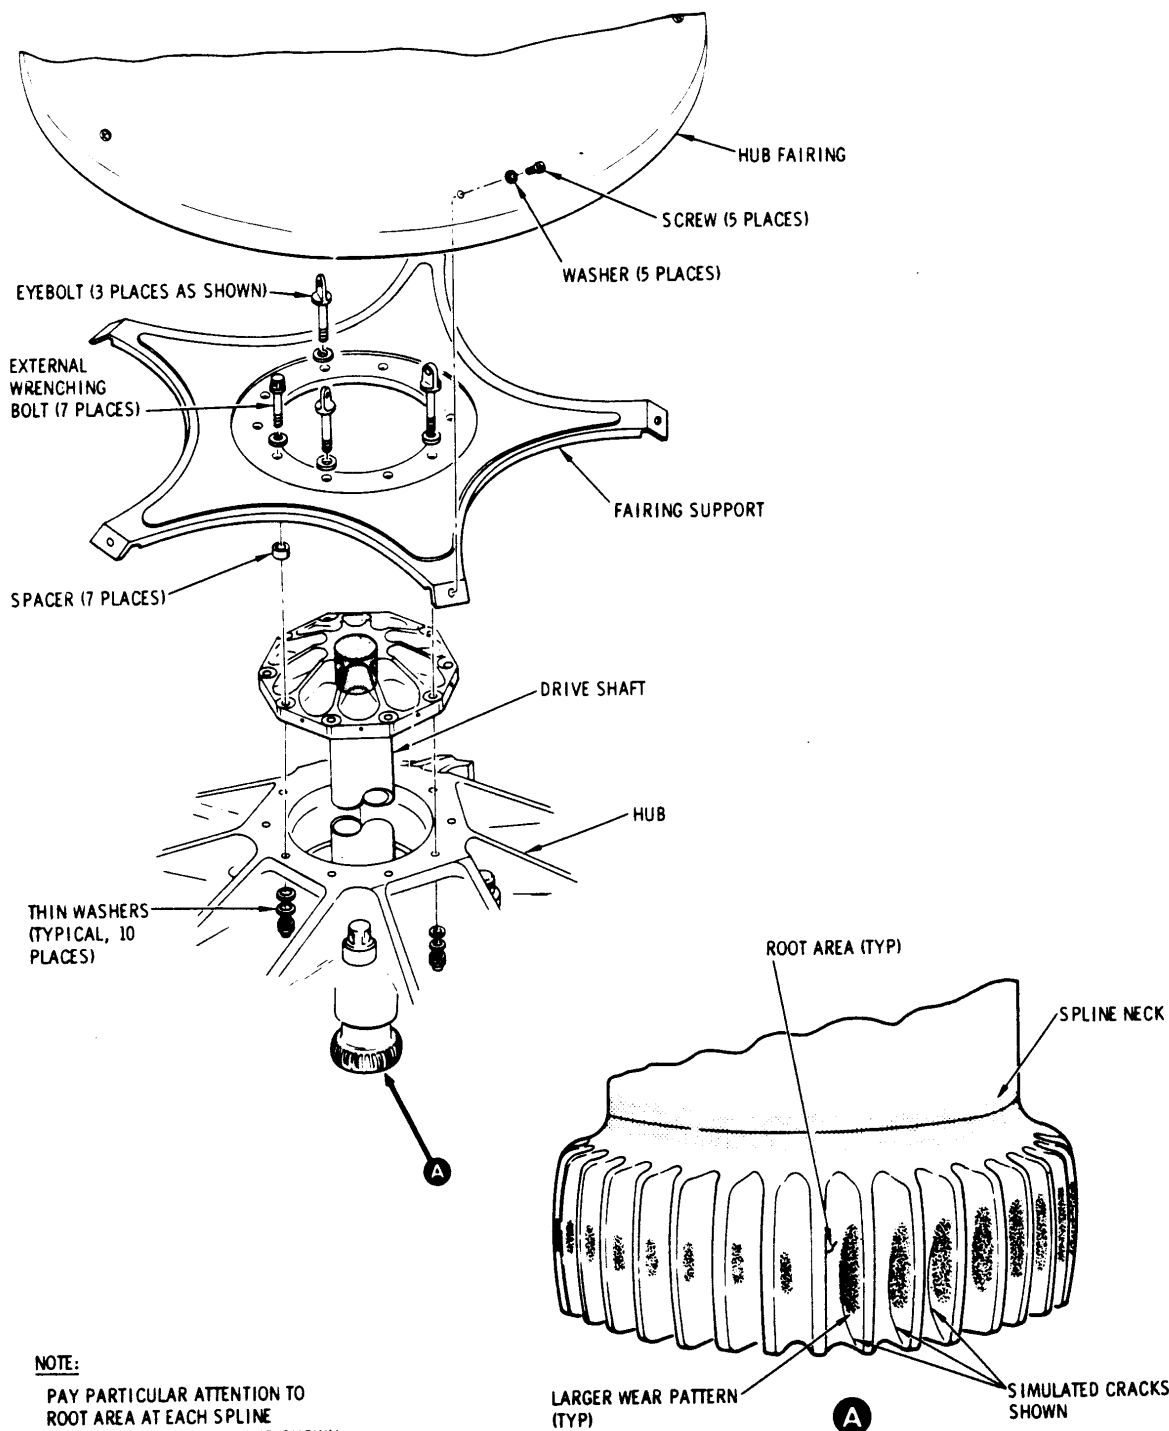
88-541

- (1). Remove main rotor drive shaft (refer to Section 9 of HMI-Vol I).
- (2). Perform a visual inspection of the shaft spline as follows:
  - (a). Thoroughly clean with cleaning solvent to remove oil, dirt, etc.
  - (b). Use 5X to 10X magnifying glass and bright side light (45° or less; downward lighting may not define cracks).
  - (c). Pay particular attention to side of (each) tooth with larger wear pattern. Hairline cracks appear crescent-shaped and at the center and bottom of tooth in the root area (see Figure 1). Also, inspect neck (shaded area) of spline for cracks.

**Figure 1. Inspection of Main Rotor Drive Shaft Spherical Spline**

- If cracking is suspected, perform magnetic particle inspection of shaft spline and teeth.
- If cracking or damage is found, the shaft is no longer airworthy. Discard drive shaft and return it to HHI Customer Service Department.
- Inspect replacement drive shaft per steps (2). and (3). of this Notice, prior to installation of shaft on helicopter.

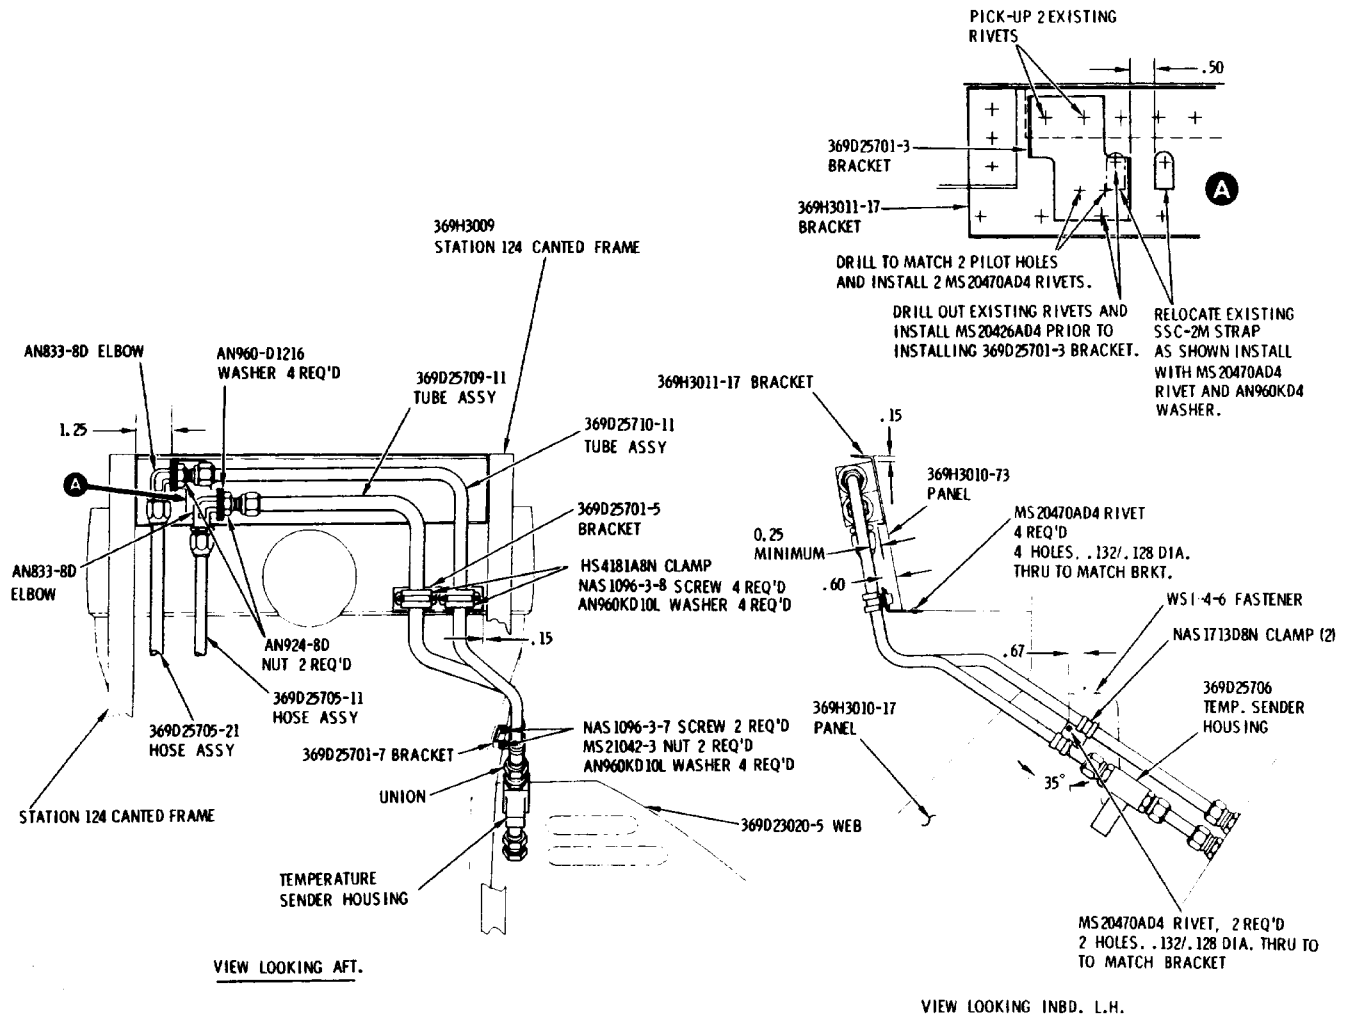
88-582

**Figure 2. Installation of 369D25709-11 and 369D25710-11 Main Transmission Oil Lines**

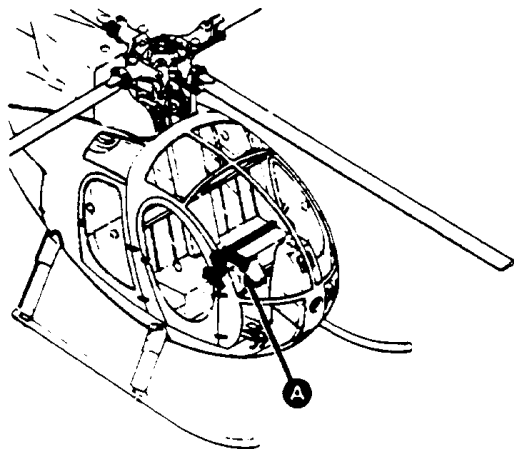
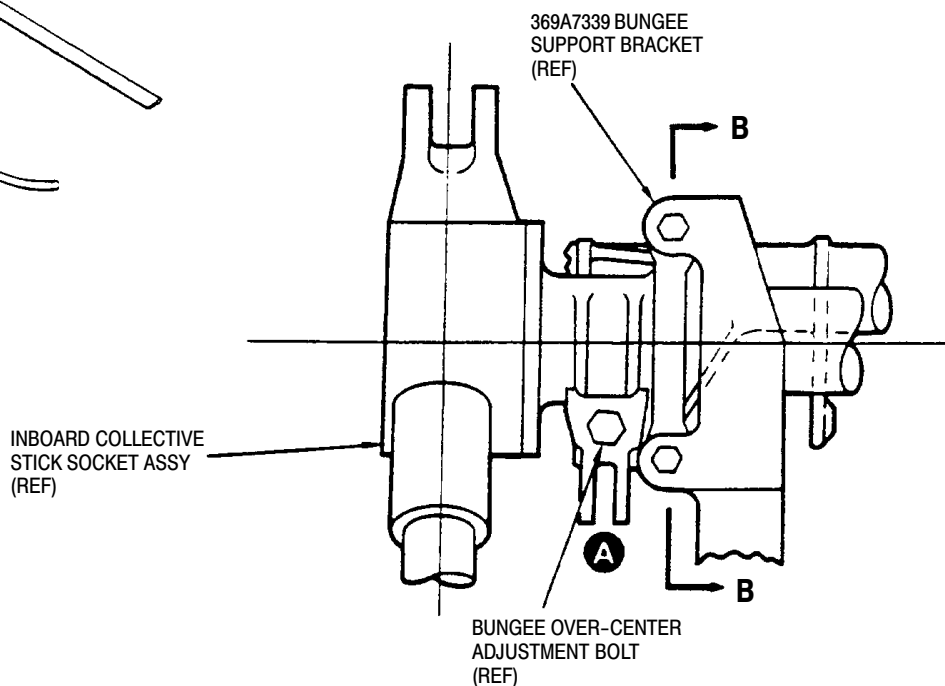
88-564A

**Figure 1. Installation of Collective Stick Support Bracket Reinforcement Strap**

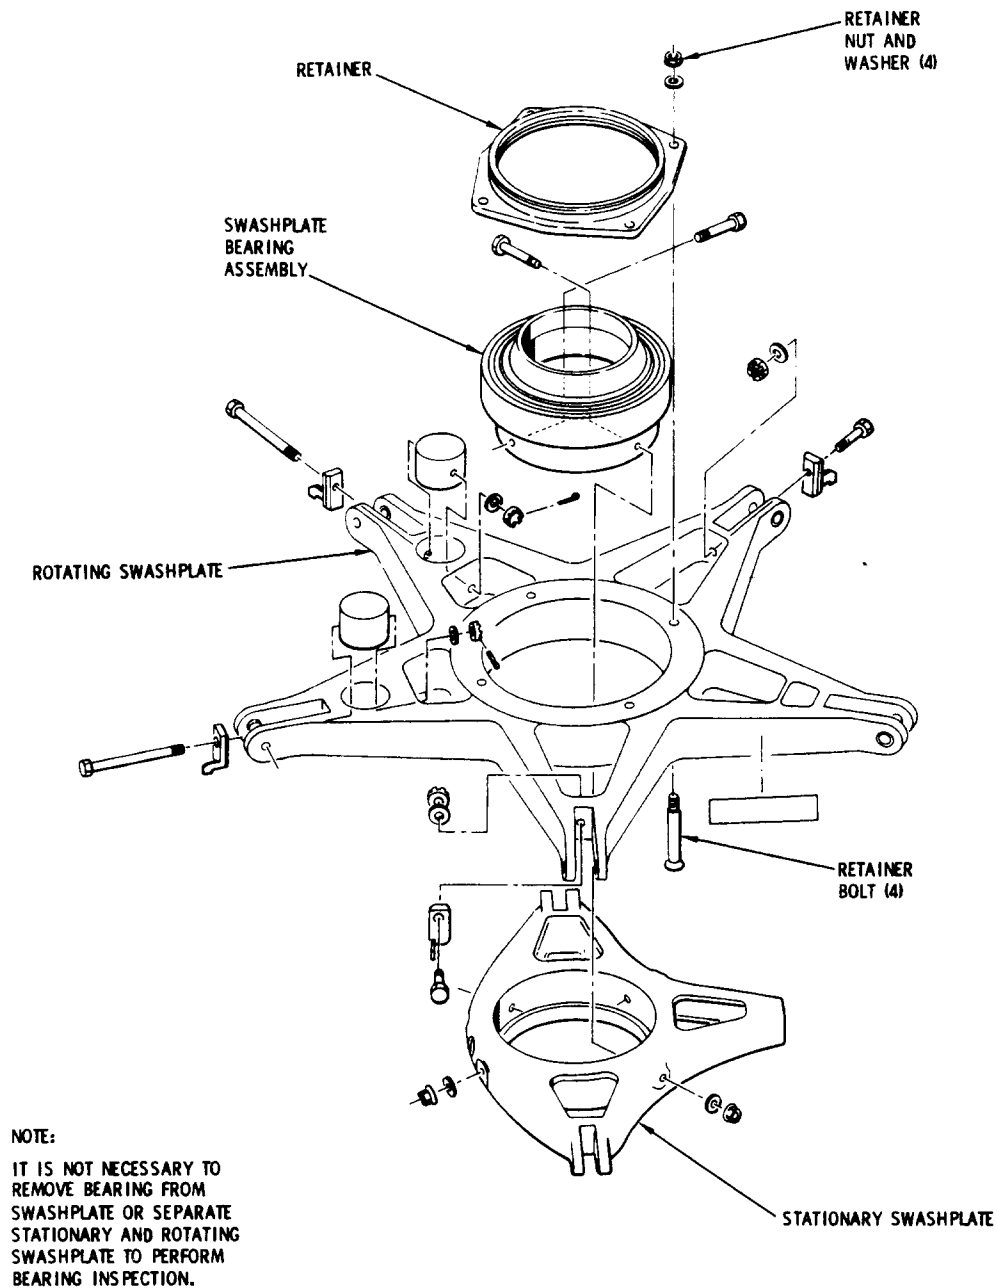
88-596

**Figure 1. Main Rotor Swashplate Assembly (Exploded View)**

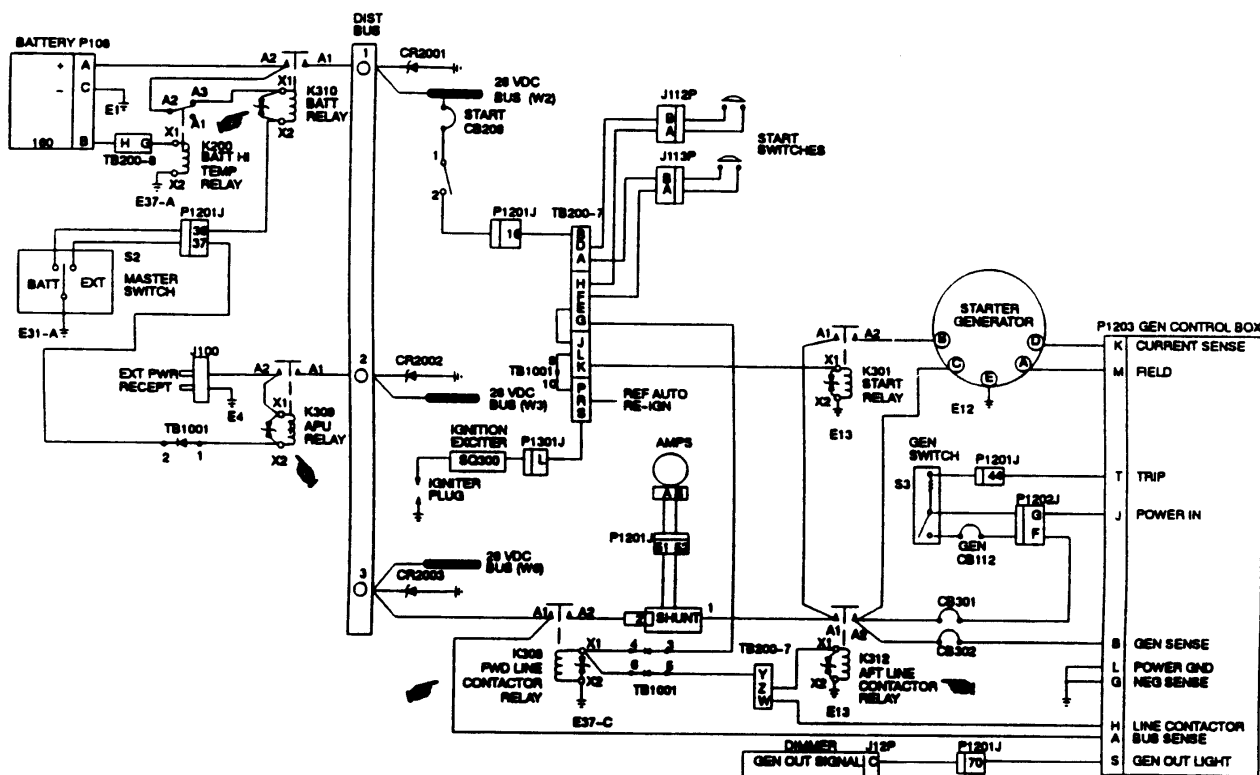
Q98-1008-2

**Figure 1. Transzorb Installation (K308, K309, K310, K312).**

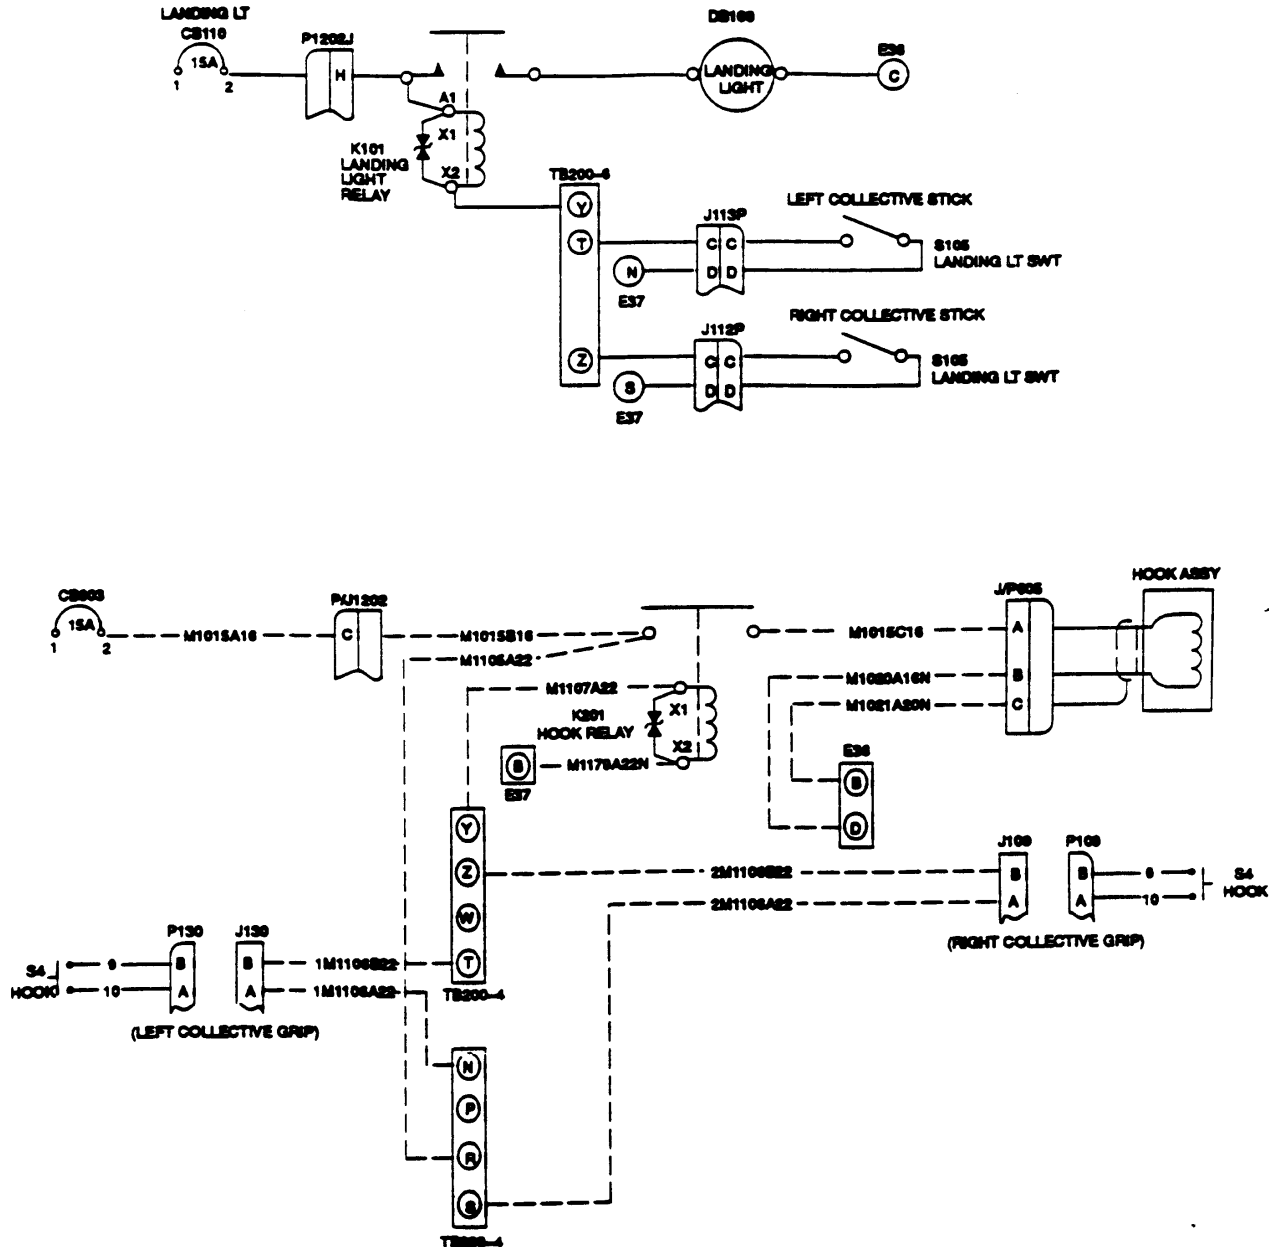
88-697

**Figure 2. Transzorb Installation (K101, K201).**

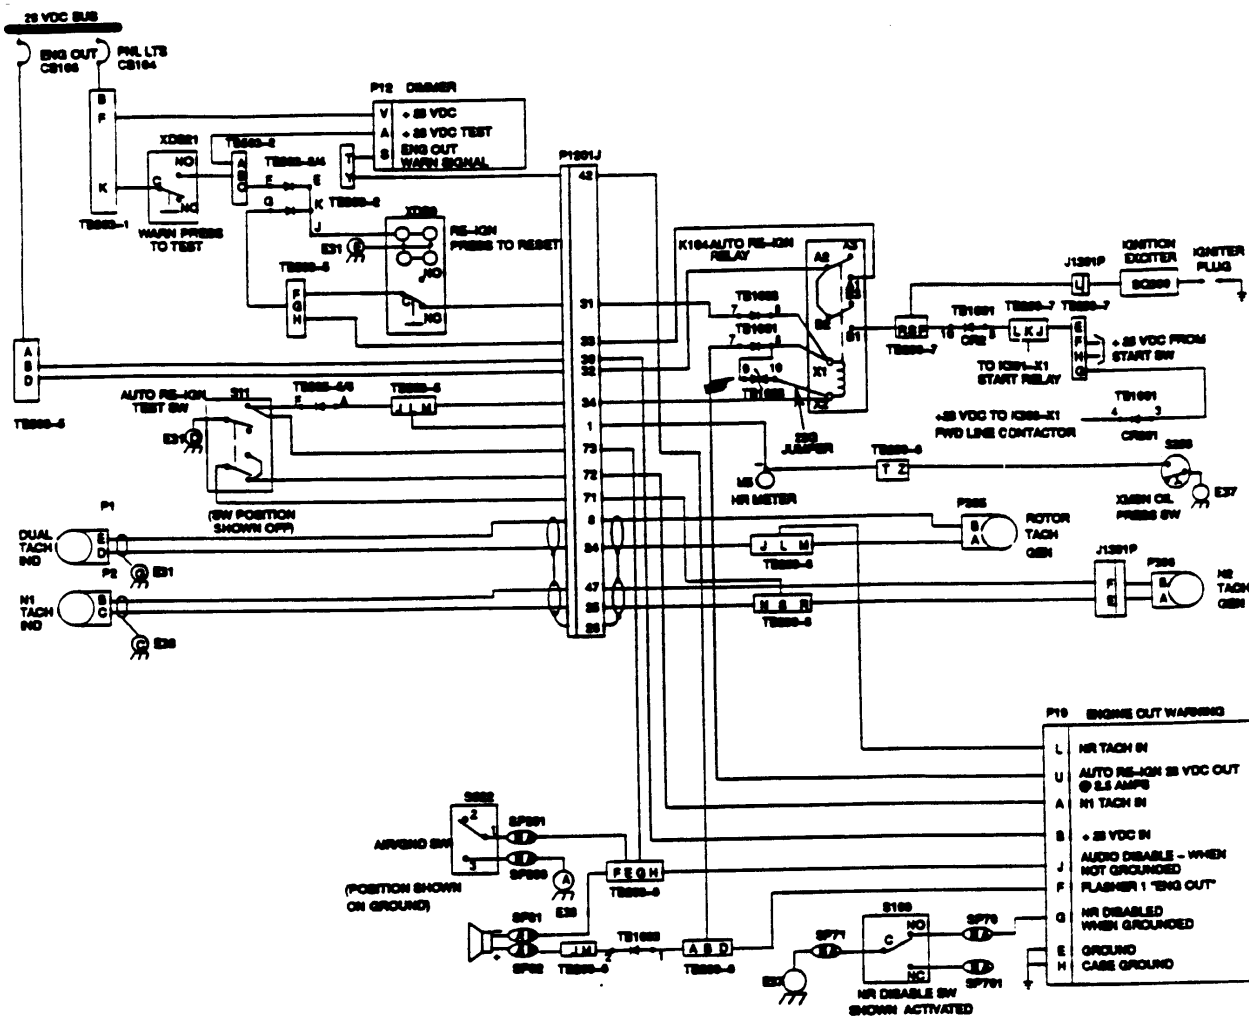
88--698

**Figure 3. Transzorb Installation (TB1001, TB1003, K104).**

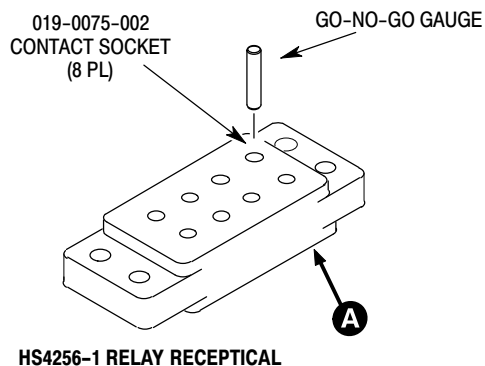
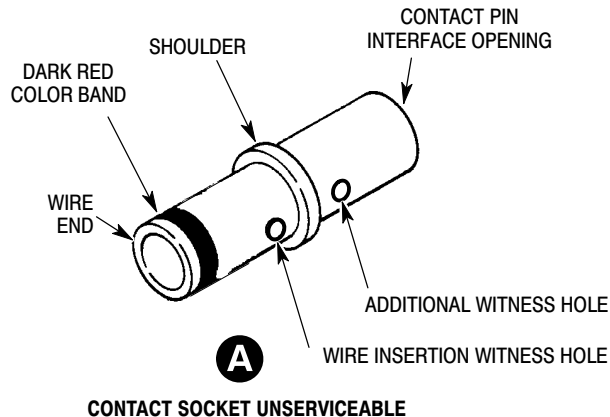
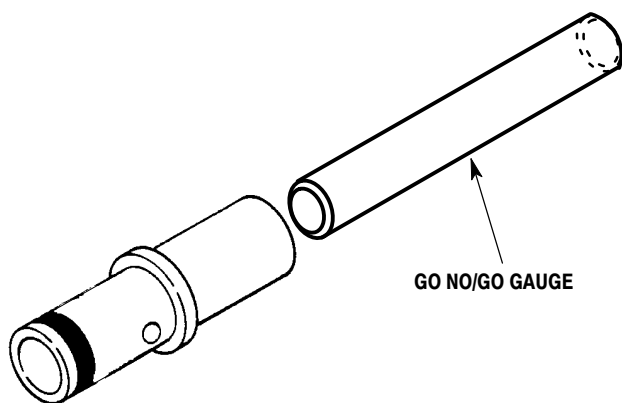
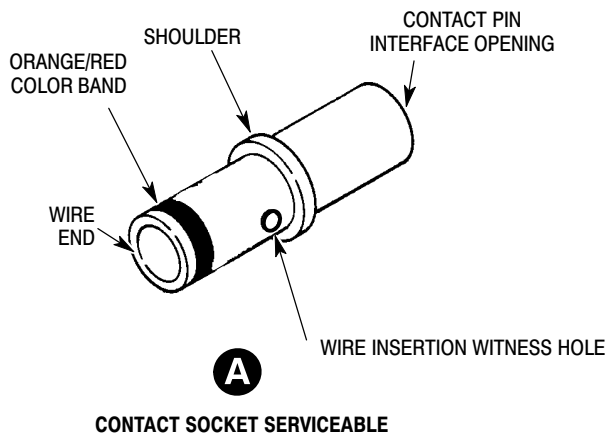
88-761

**Figure 1. Contact Socket Inspection**

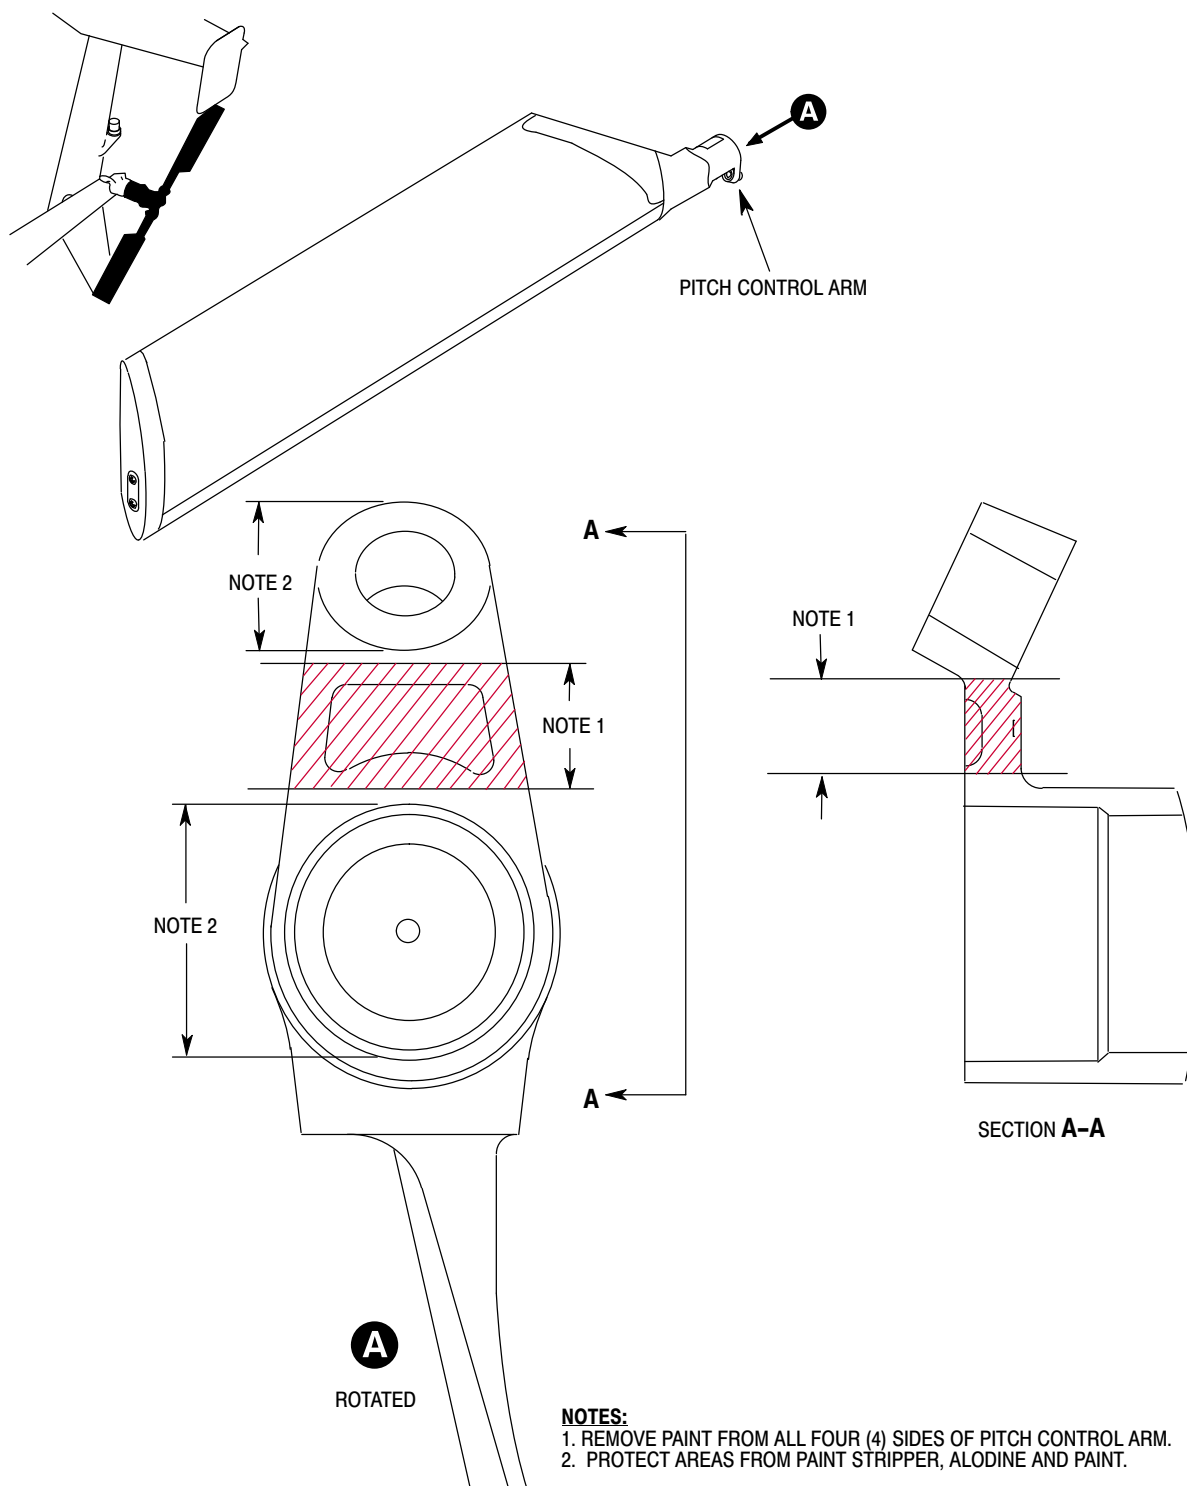
64-001

**Figure 1. Tail Rotor Pitch Control Arm**

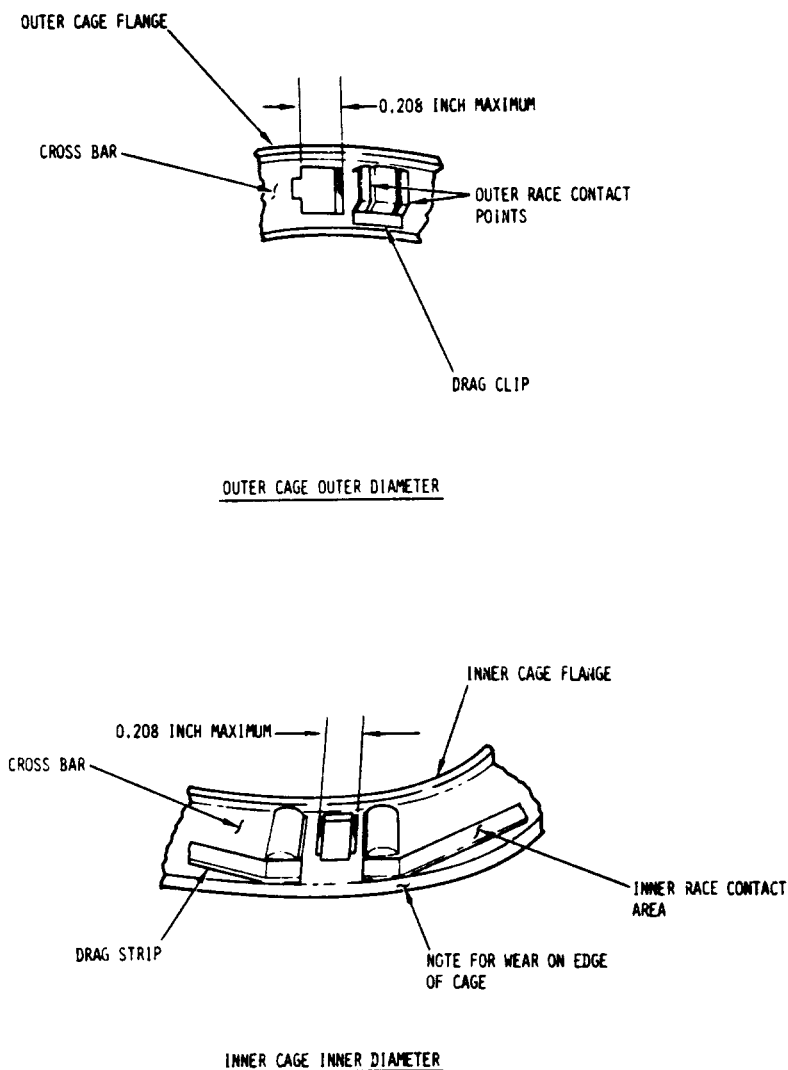
88-467

**Figure 1. Cage Wear Limits**

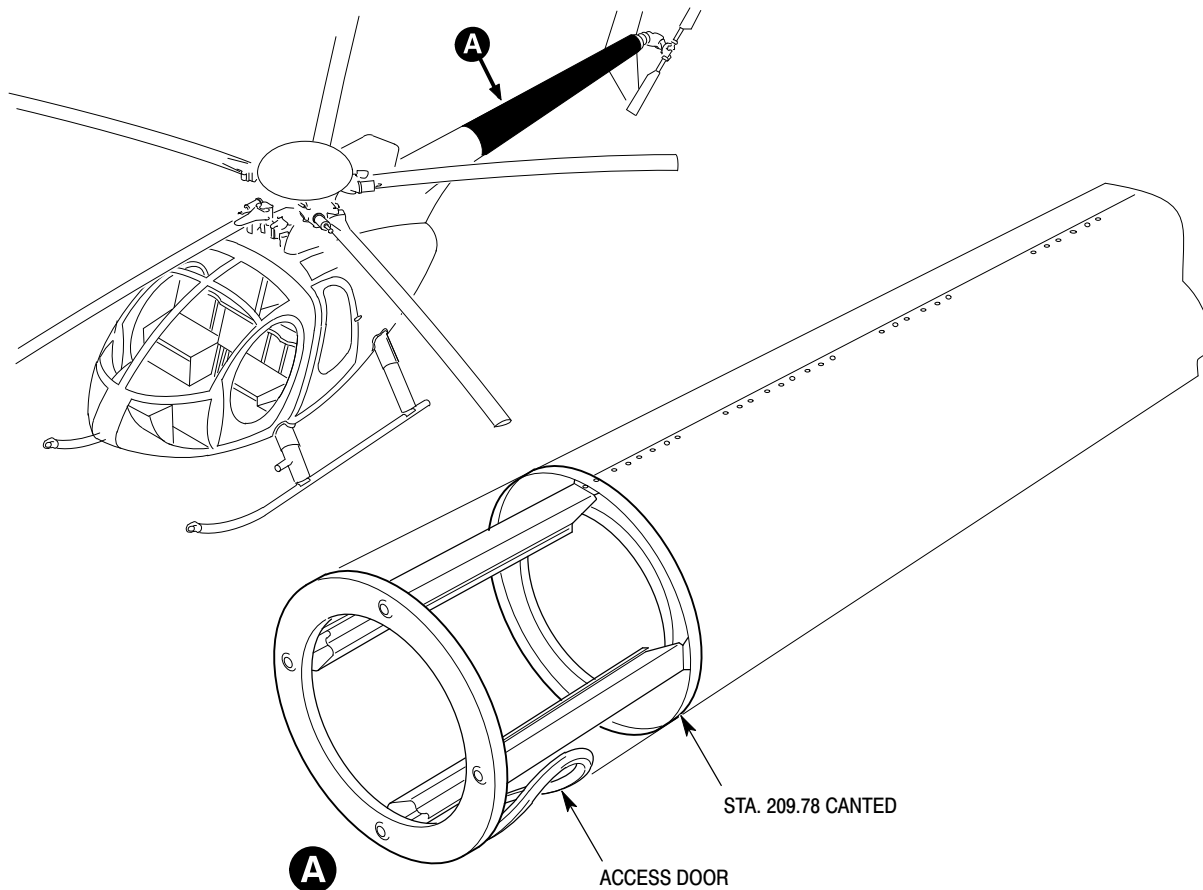
88-795

**Figure 1. Tailboom Assembly**

- (3). Remove tail rotor control rod (Ref. CSP-HMI-2, Section 67-20-10).

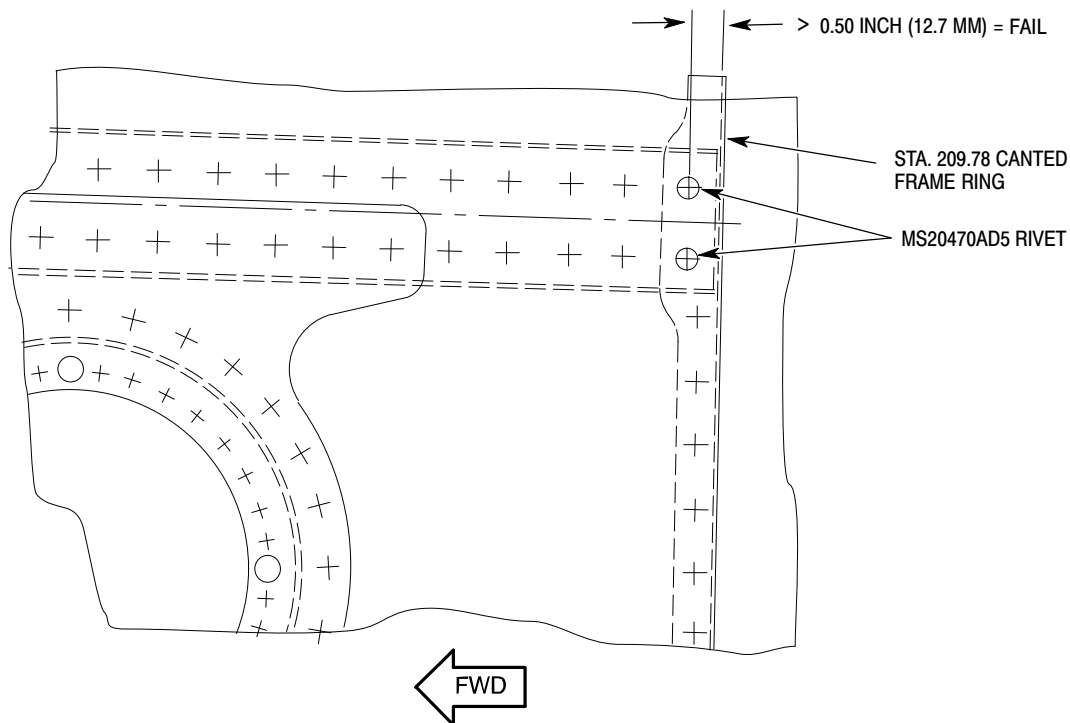
88-796

**Figure 2. STA 209.78 Frame Ring to Rivet Measurement**

- Measure the distance from the forward face of the STA 209.78 frame ring to the center of the two aft rivet locations on each longeron.

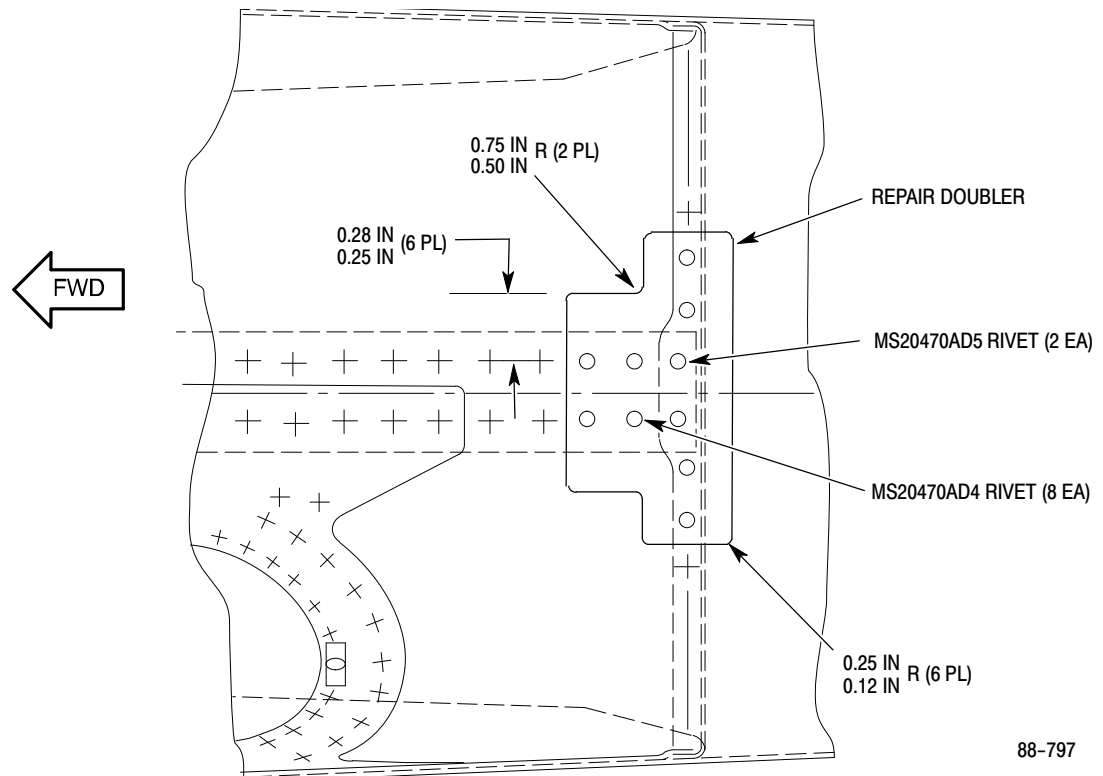
88-797

**Figure 3. Repair Doubler**

- (7). Clean and deburr all hole locations on the repair doubler and tailboom assembly.
- (8). Remove paint from tailboom, clean area and prepare surfaces for bonding.

- (9). Apply chemical coating (CM206) to all areas of the repair doubler and any exposed material of the tailboom assembly, per CSP-HMI-2, Section 20-40-00.

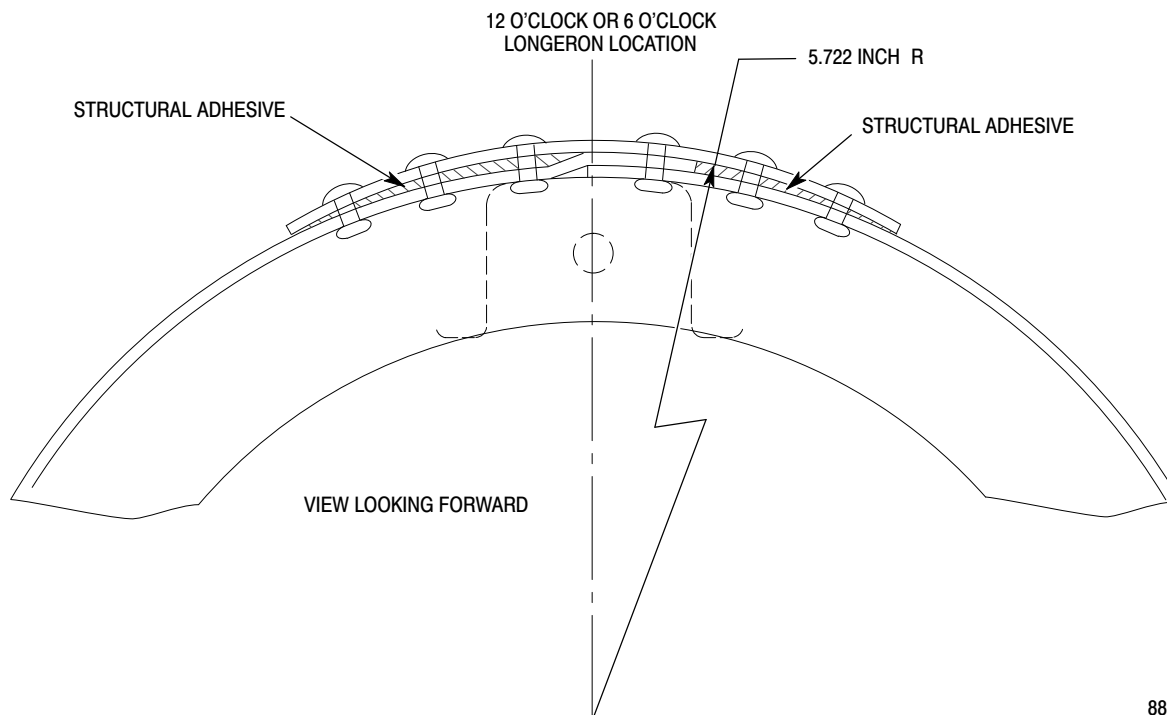
88-798

**Figure 4. Repair Doubler Installation**

- (10). Apply primer (CM318) to all non faying surfaces of the repair doubler.
- (11). Apply structural adhesive (EA9394) to the faying surfaces of the repair doubler.
- (12). At the 6 O'Clock and 12 O'Clock longeron location, apply structural adhesive (EA9394) to the tailboom surface as shown in Figure 4.
- (13). Install the repair doubler with eight (8) MS420470AD4 rivets and two (2) MS20470AD5 rivets. Install all rivets with wet primer (CM318) and allow adhesive and primer to cure.
- (14). Fillet seal the edges of the repair doubler with structural adhesive (EA9394).
- (15). If necessary, touch up the finish of all parts per CSP-HMI-2, Chapter 20.

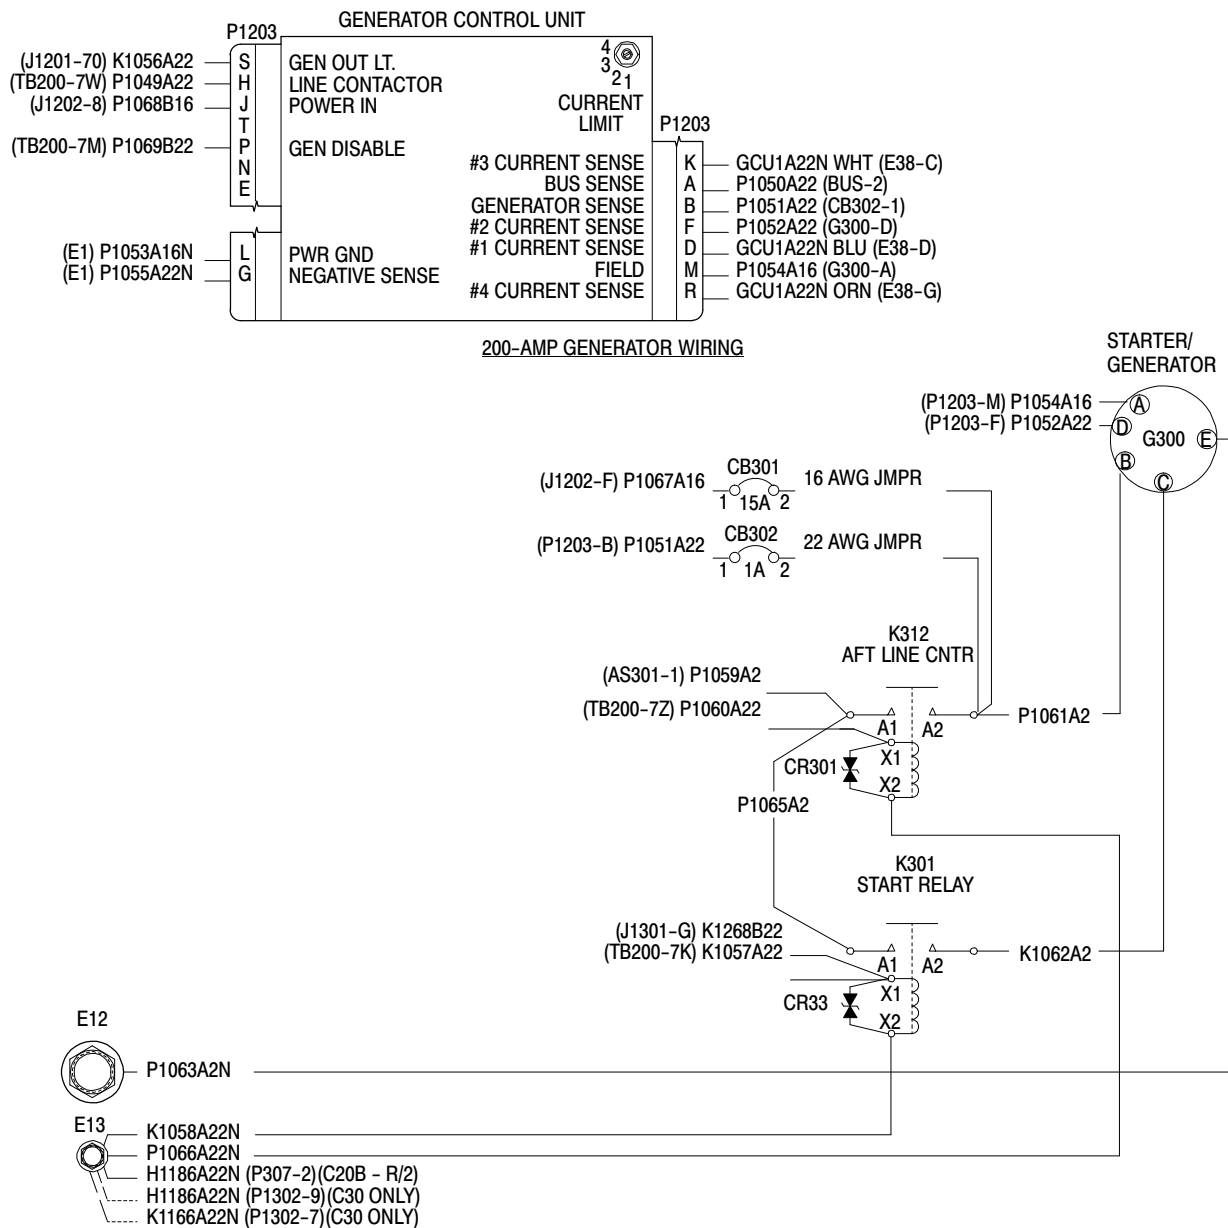
88-820

**Figure 1. GCU and Starter/Generator Wiring Diagram**
