***MD Helicopters, LLC***

***MD500/600 Series***  
***Service Bulletins Package***

## MODEL 369D, 369E, 369F/FF, 500N, 600N HELICOPTERS (500D, 500E, 530F, 520N, 600N) SERVICE BULLETIN PACKAGE TABLE OF CONTENTS

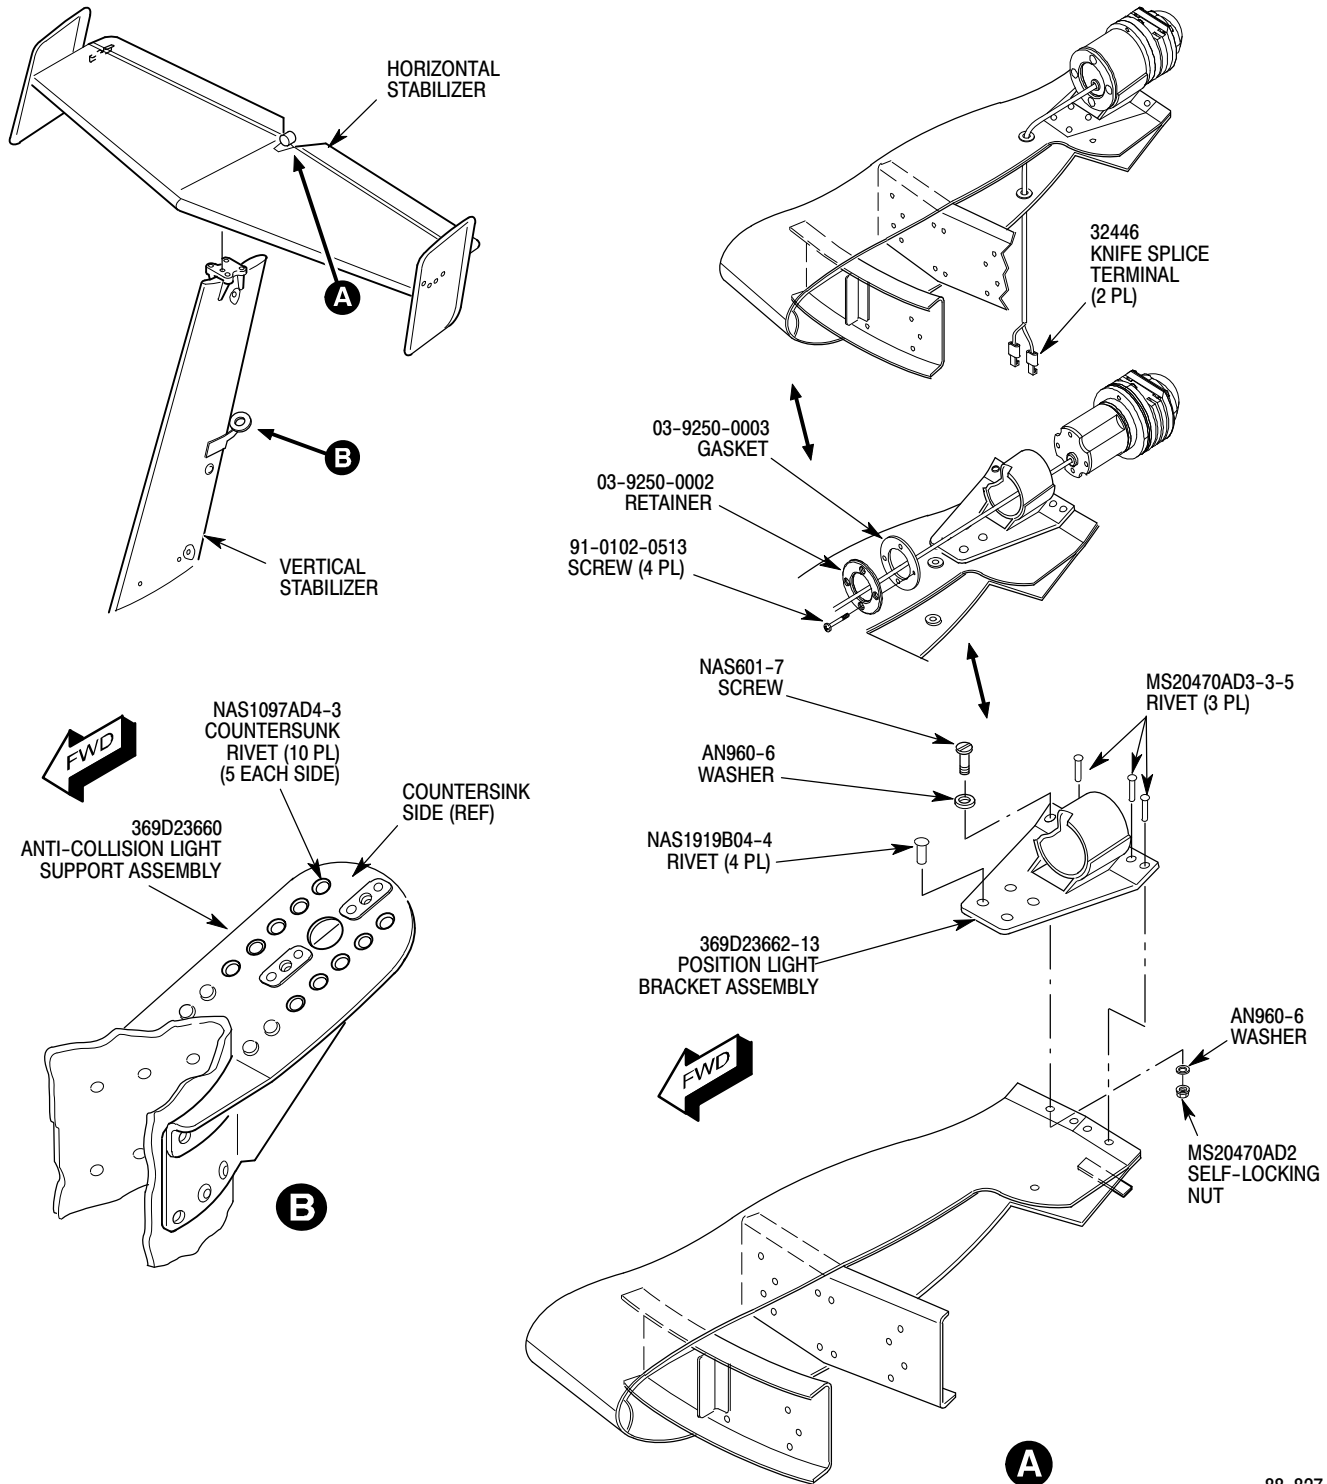
88-827

**Figure 1. LED Position and Anti-Collision Mount Assemblies**

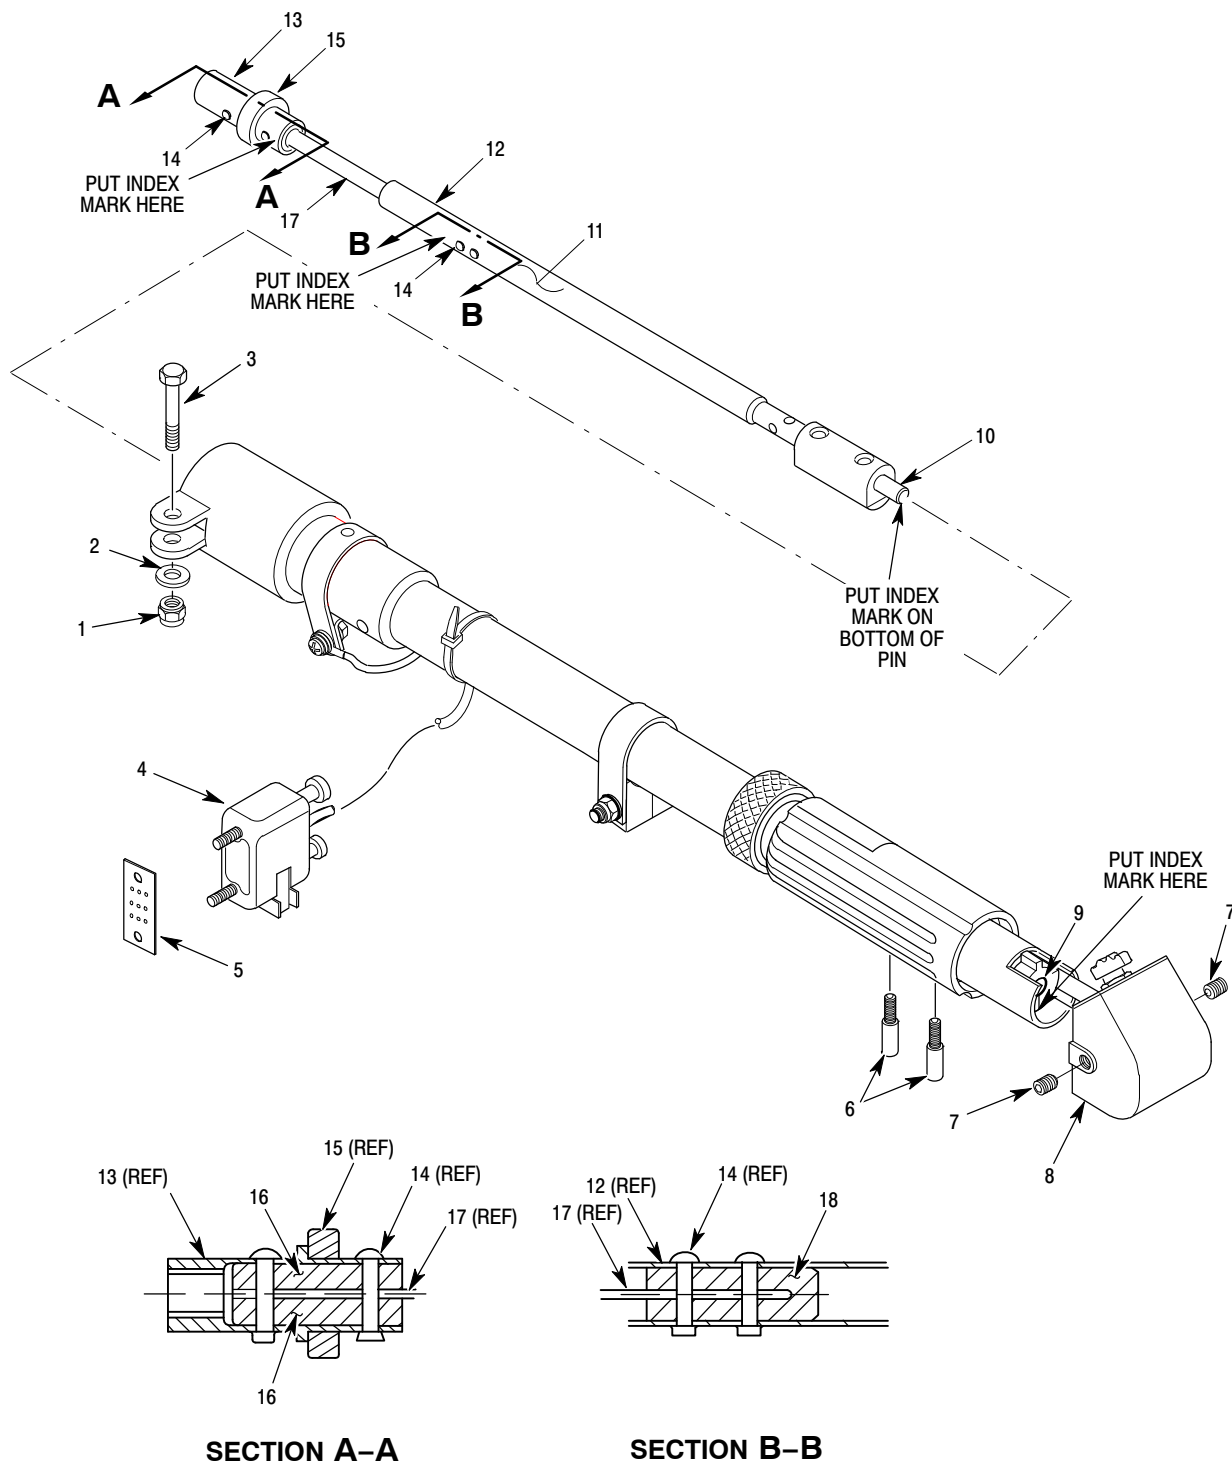
88-829

**Figure 2. Torsion Bar Replacement**

- (1). Align the replacement torsion bar (17, Figure 2) in the adapter (18), and install the torsion bar (17) and the adapter (18) in the removable collective stick gas producer control tube (12).
- (2). Align the rivet holes in the torsion bar (17) and the adapter (18) with the rivet holes in the removable collective stick gas producer control tube (12).
- (3). Secure the torsion bar (17) and the adapter (18) in the removable collective stick gas producer control tube (12) with two new rivets (14).

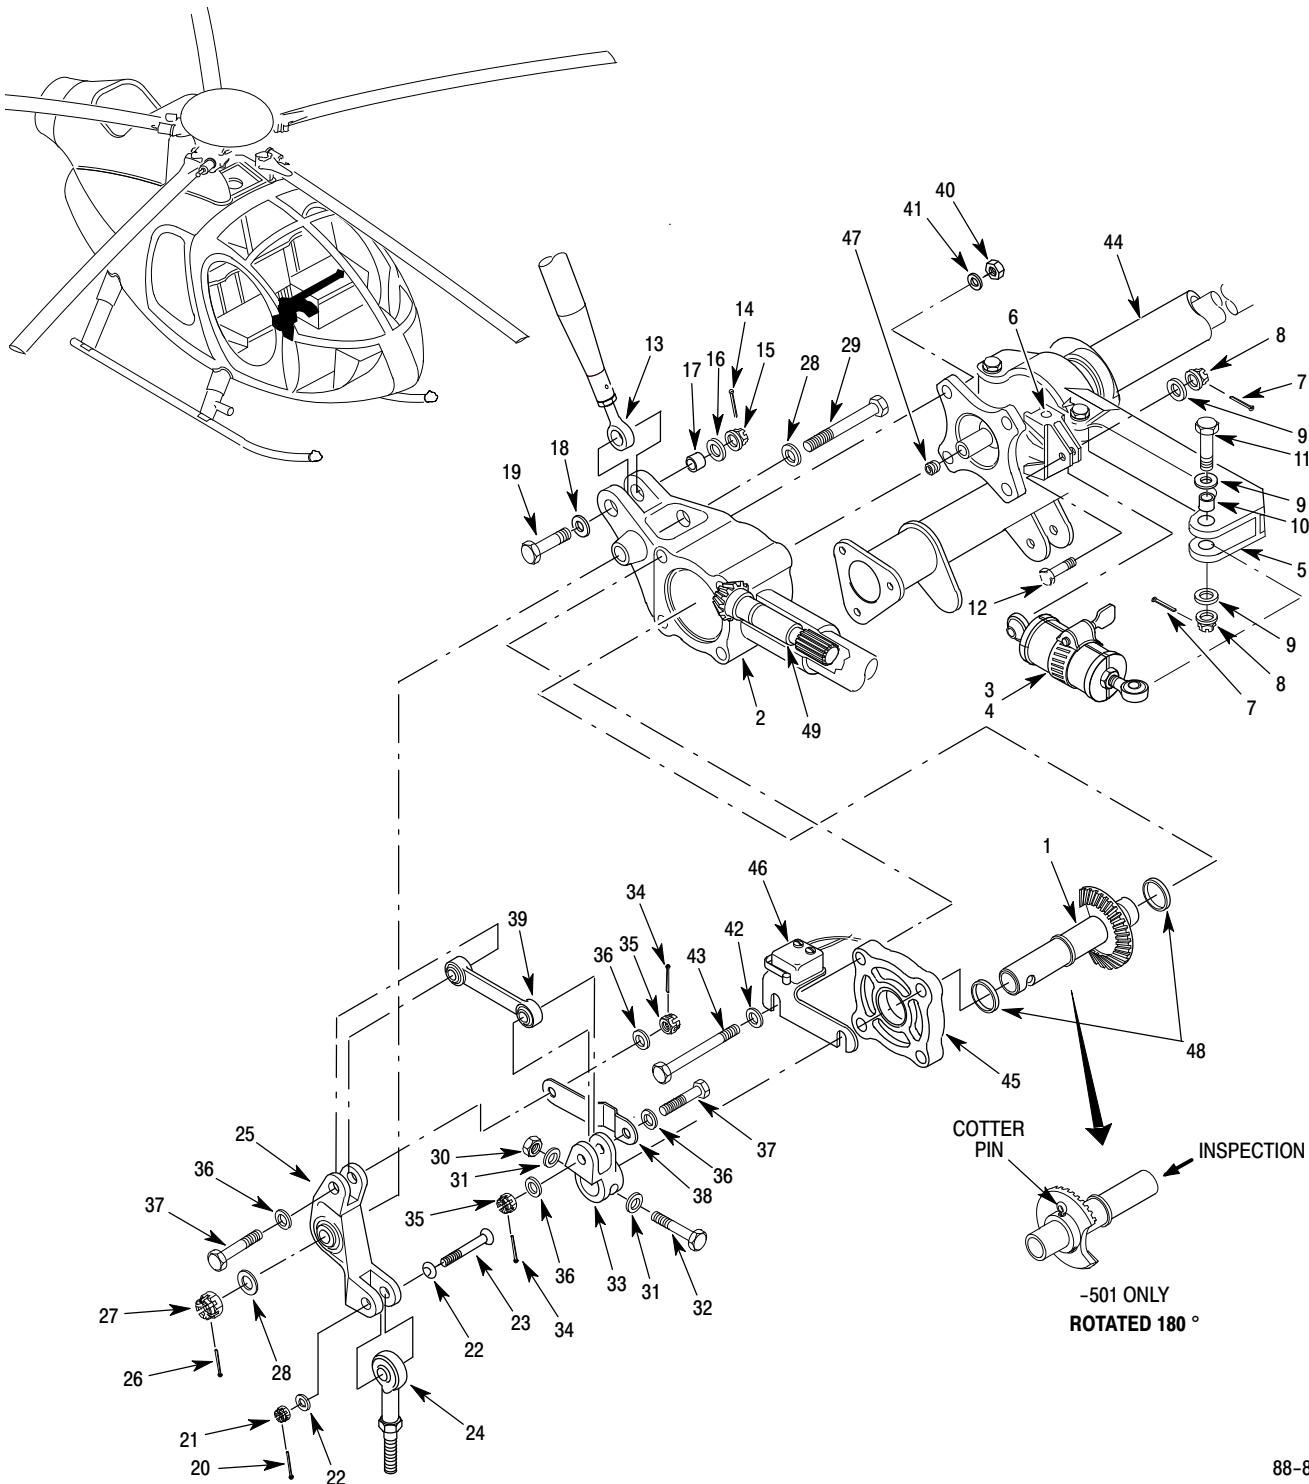
88-834

Copilot gear shaft assemblies have been found without the required Loctite® R/C #35 on the shaft and gear, which can cause the spring pins to loosen and fall out.

**Figure 1. Removal and Assembly of the  
(369D, 369E, 369FF, 500N) Copilot Gas Producer Control Gear Shaft Assembly**

- 1). Do a visual inspection at every 100-hour inspection to make sure the slippage mark has not split.
  - a). If the slippage mark has split, replace gear shaft assembly (1).
- (c). If there is Loctite, go to Procedure 2.G.(6).

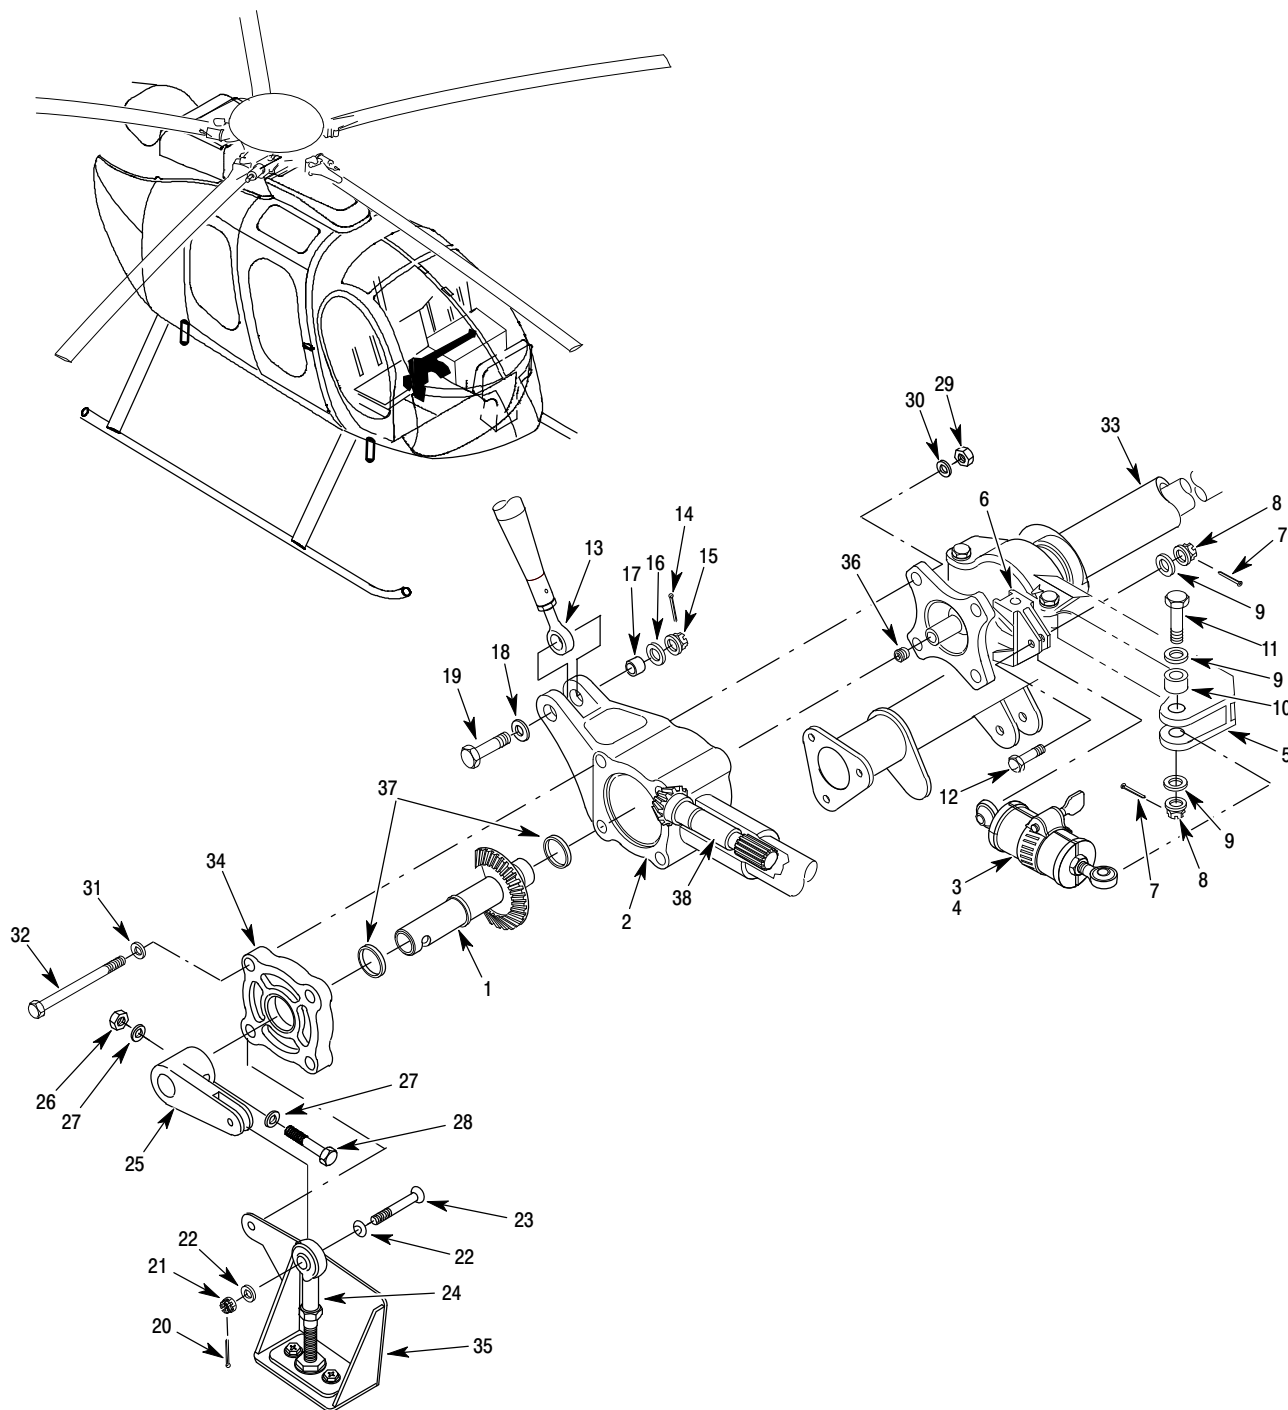
88-831

**Figure 2. Removal and Assembly of the  
600N Copilot Gas Producer Control Gear Shaft Assembly**

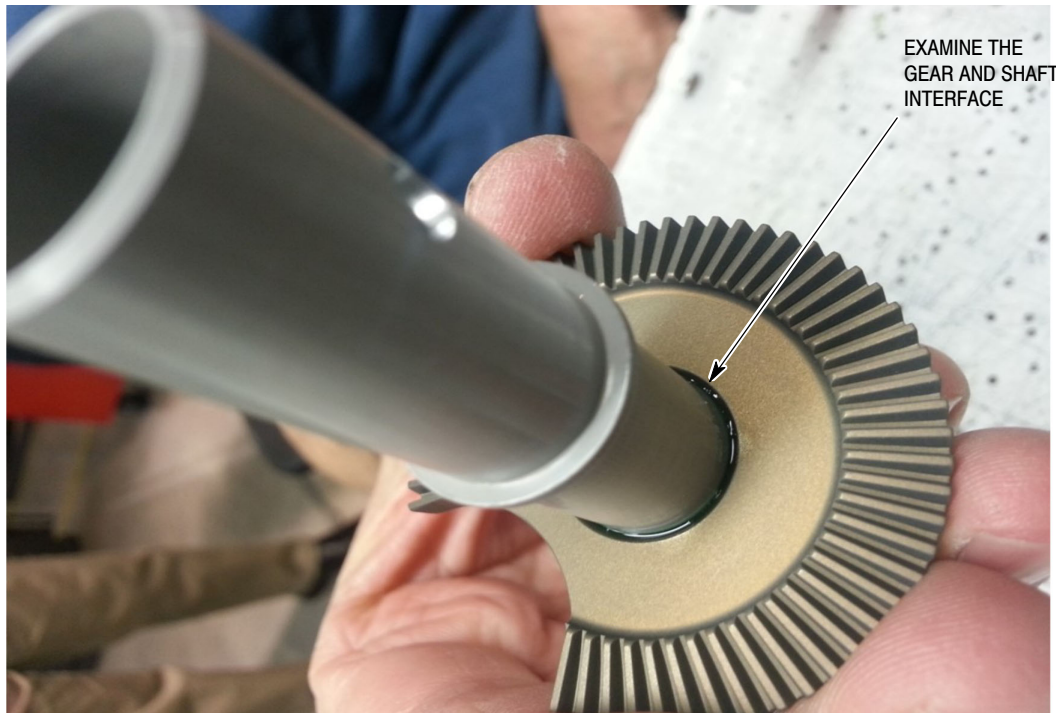
88-830

**Figure 3. Inspection of the Gear Shaft Assembly**

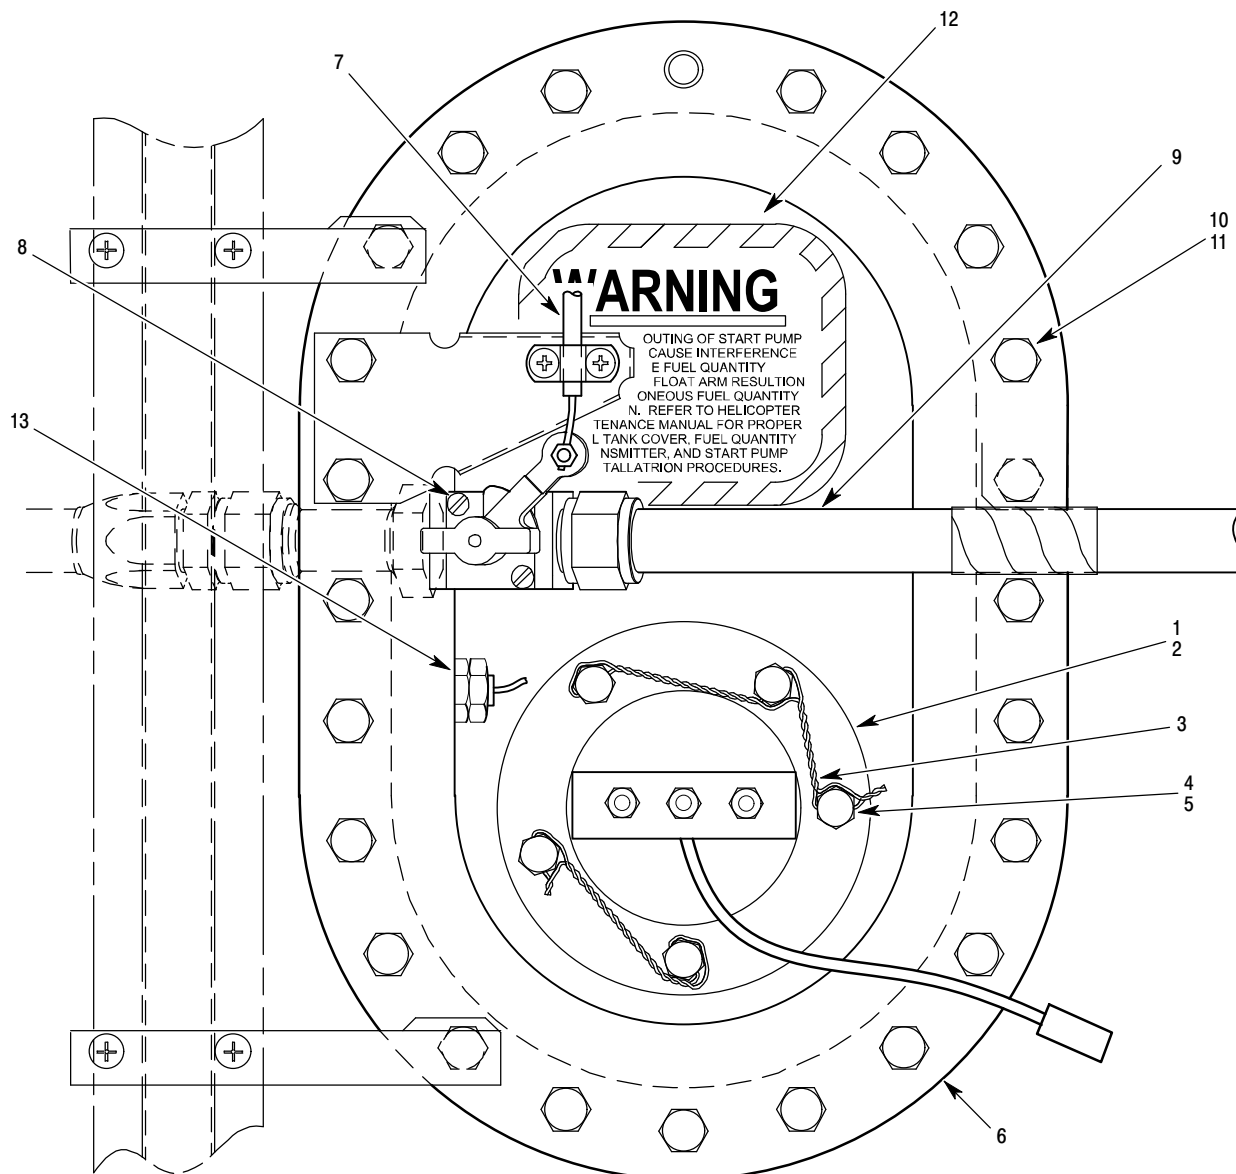
88-647

**Figure 1. Fuel Cell Cover and Components**

- (1). Loosen the nut on the cable clamp and disconnect control cable (7, Figure 1) from fuel shutoff valve (8).
- (2). Disconnect the LH fuel cell fuel inlet hose assembly (9) from the LH fuel cell fuel shutoff valve (8) assembly.
- (3). Disconnect the wiring harness connector from the auxiliary fuel pump wire (13) connector at the LH fuel cell cover (6).

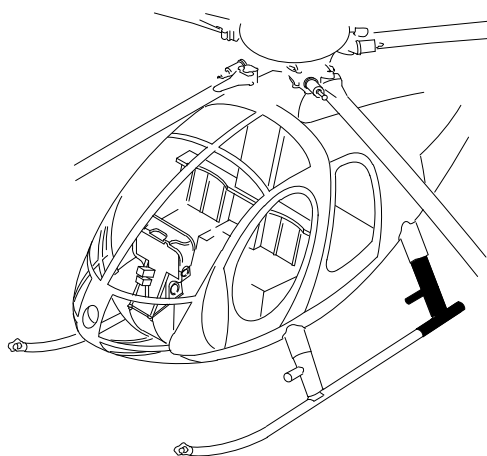
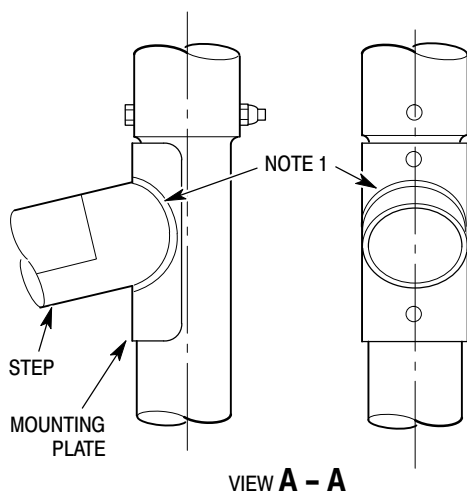
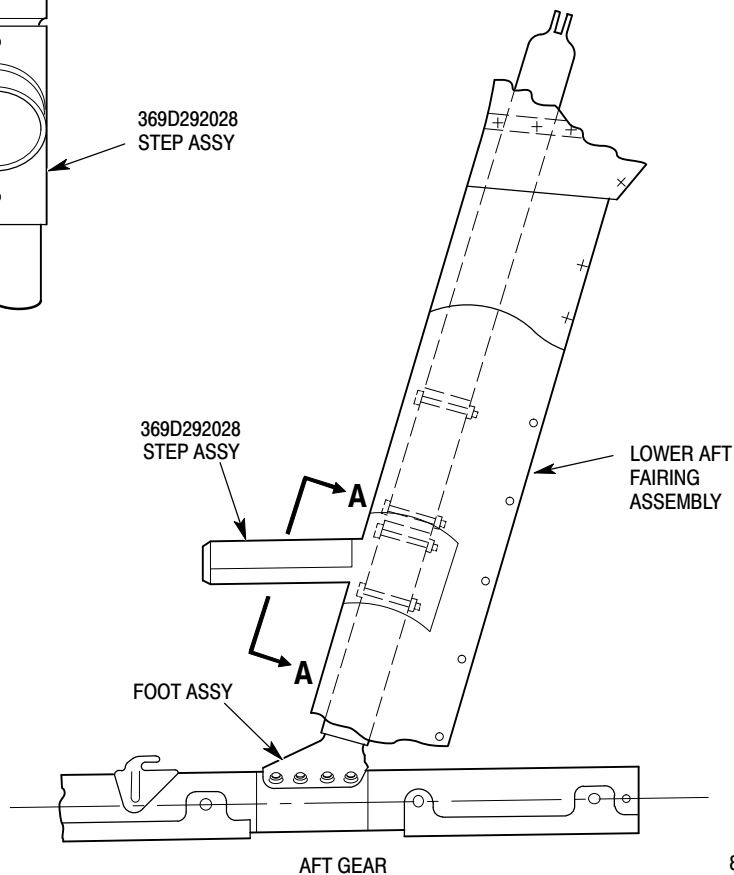
88-569C

1. CHECK AREA OF WELD WHERE STEP ATTACHES TO MOUNTING PLATE. USE 10X MAGNIFYING GLASS.

**Figure 1. Inspection of Aft Extended Landing Gear Step Assembly**

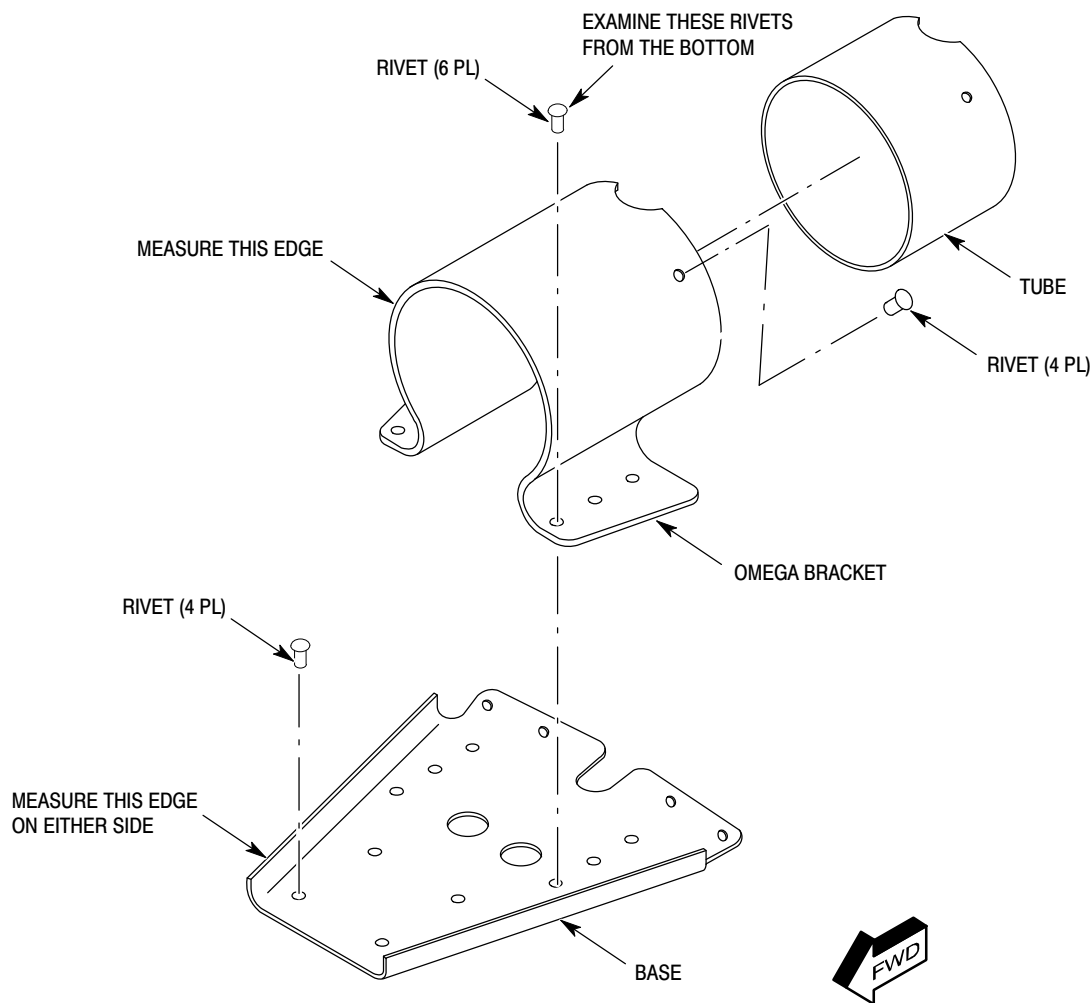
SB88-654

**Figure 2. Inspection of the Position Light Mounting Bracket Assembly (Exploded View)**

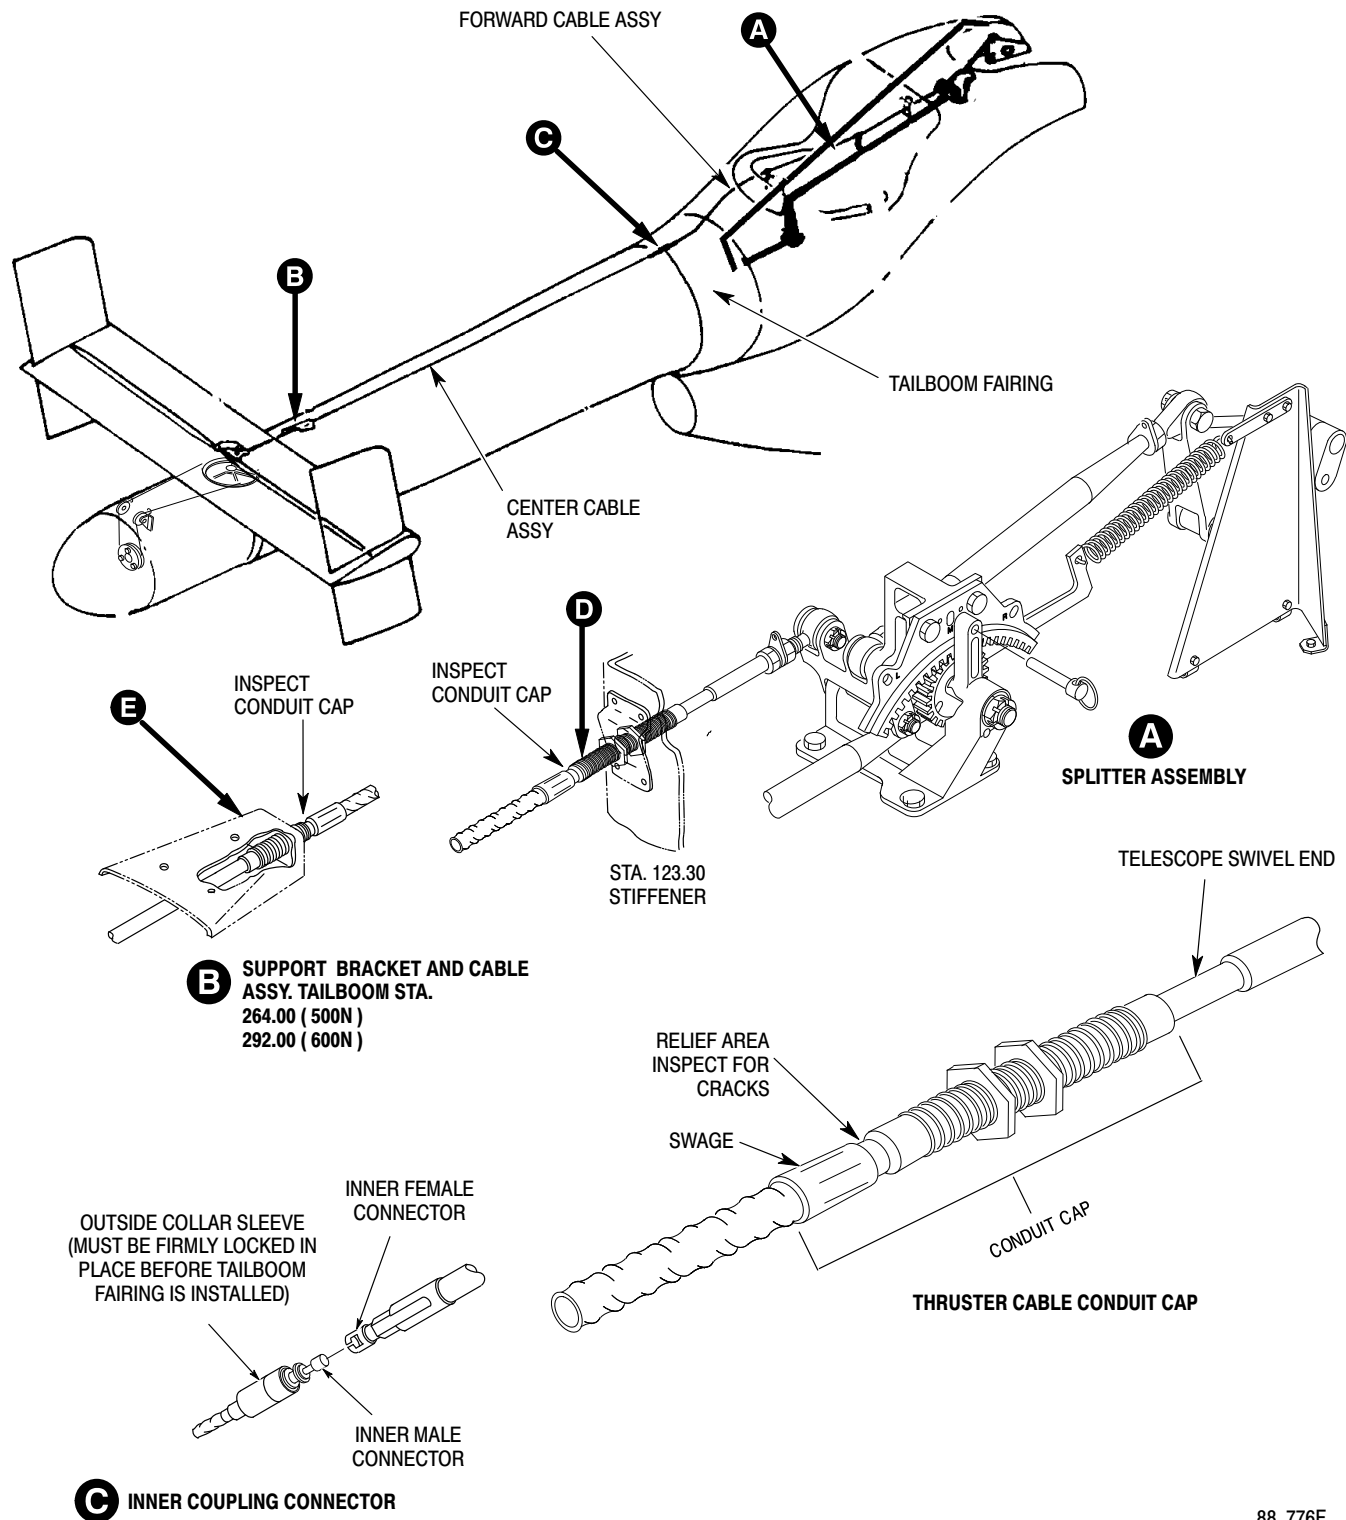
88\_776F

**Figure 1. Forward and Center Cable Relief Area Inspection (Sheet 1 of 2)**

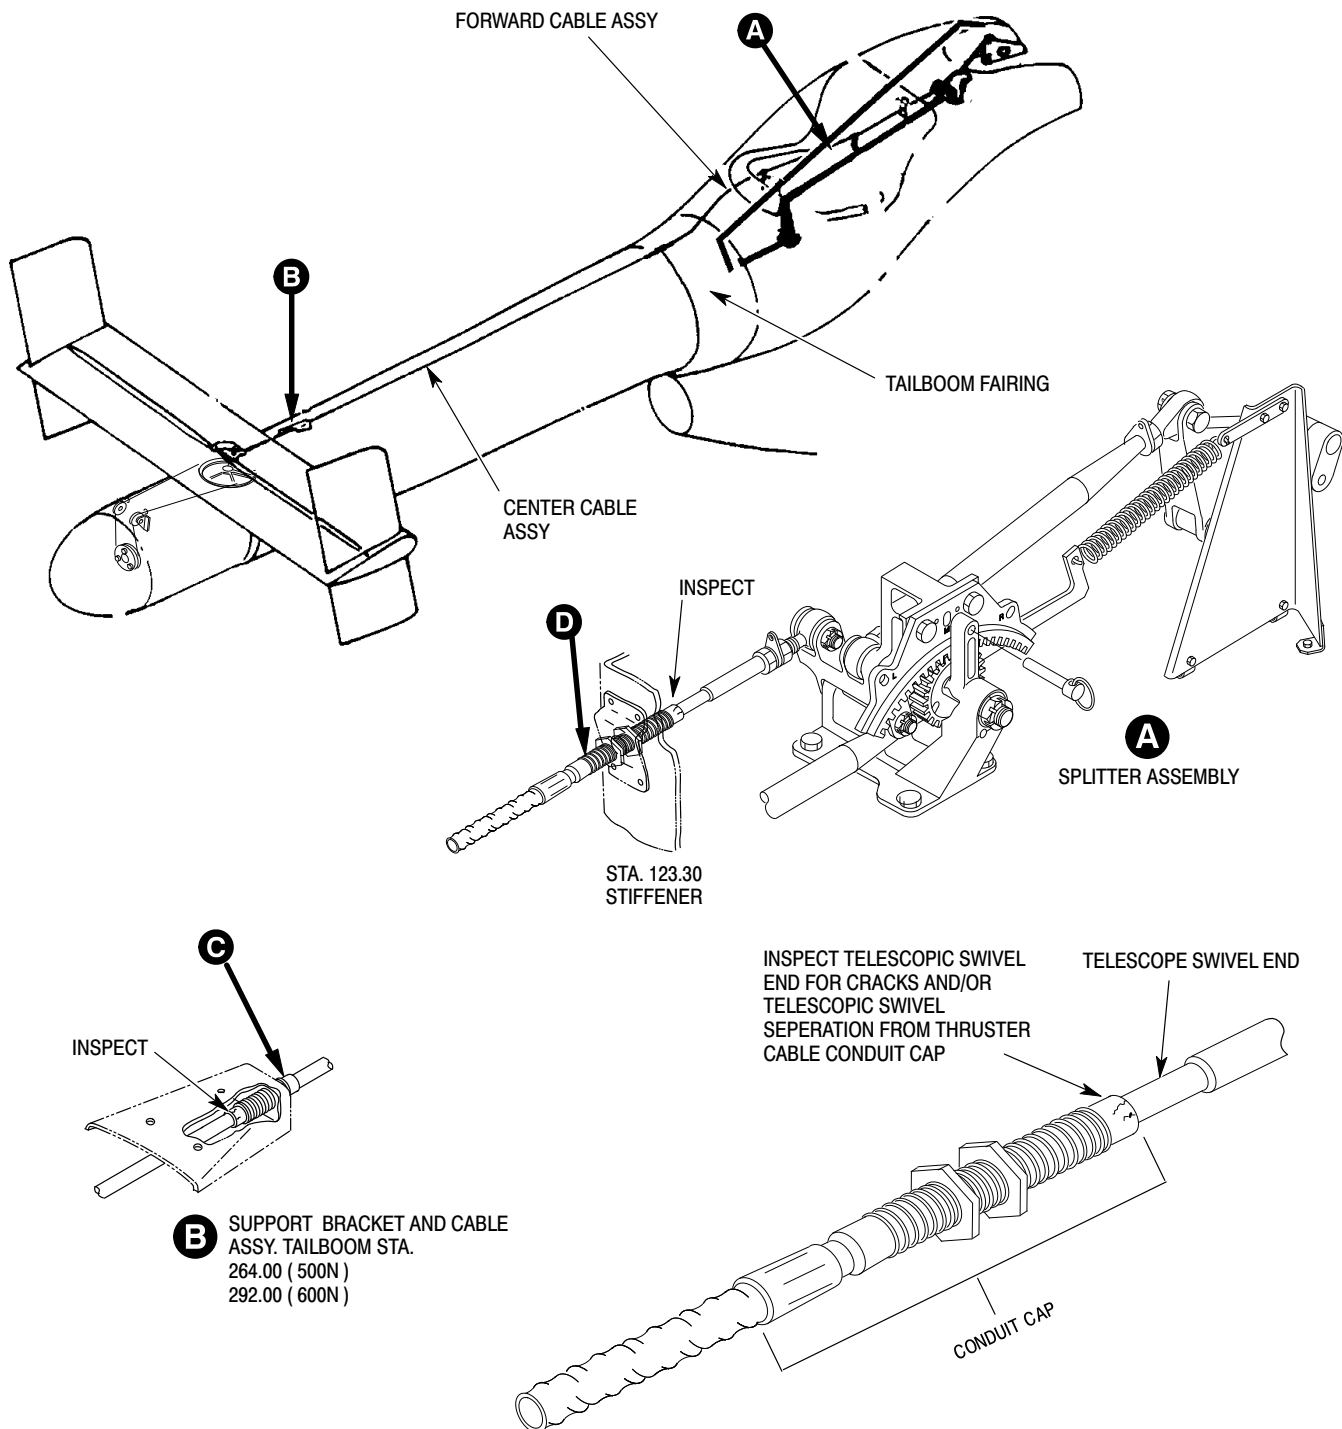
88\_776B

**Figure 1. Forward and Center Cable Relief Area Inspection (Sheet 1 of 2)**

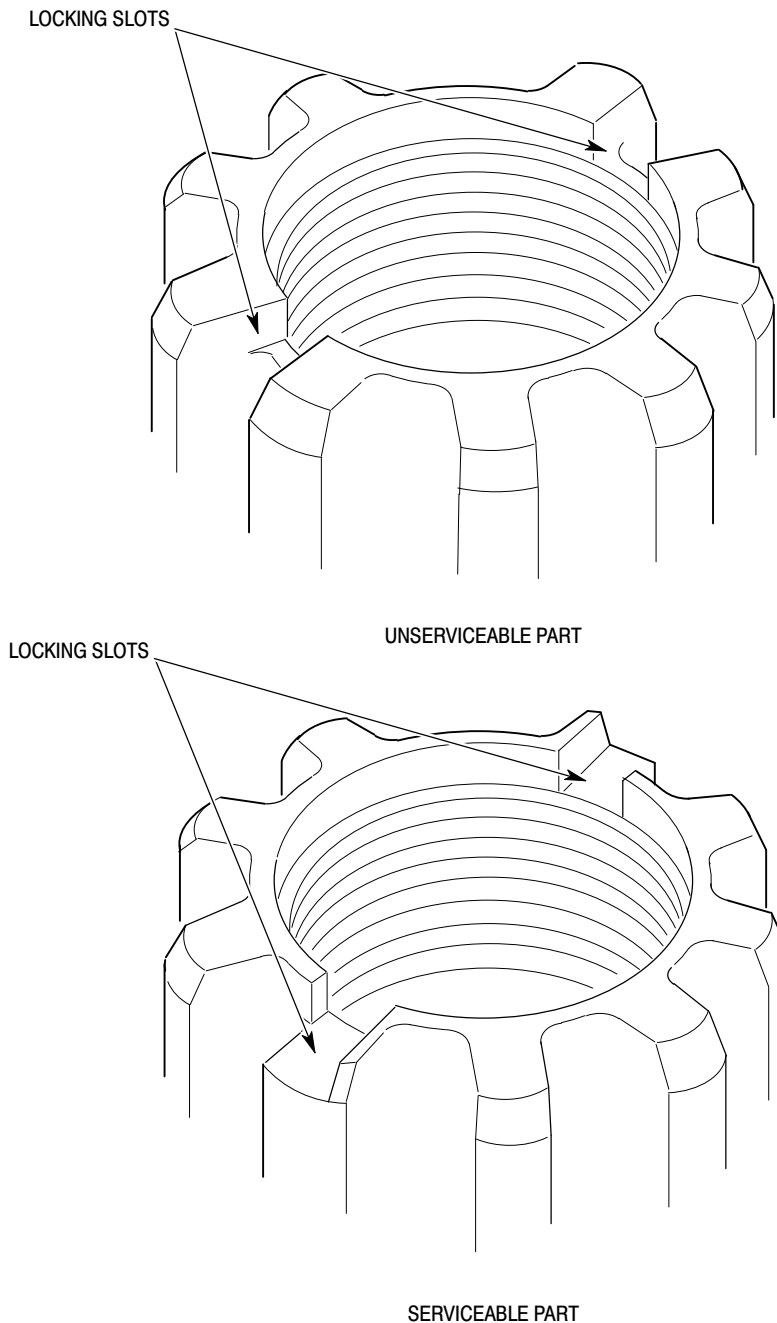
88-798

**Figure 2. Splined End of Aft Tube Assembly**

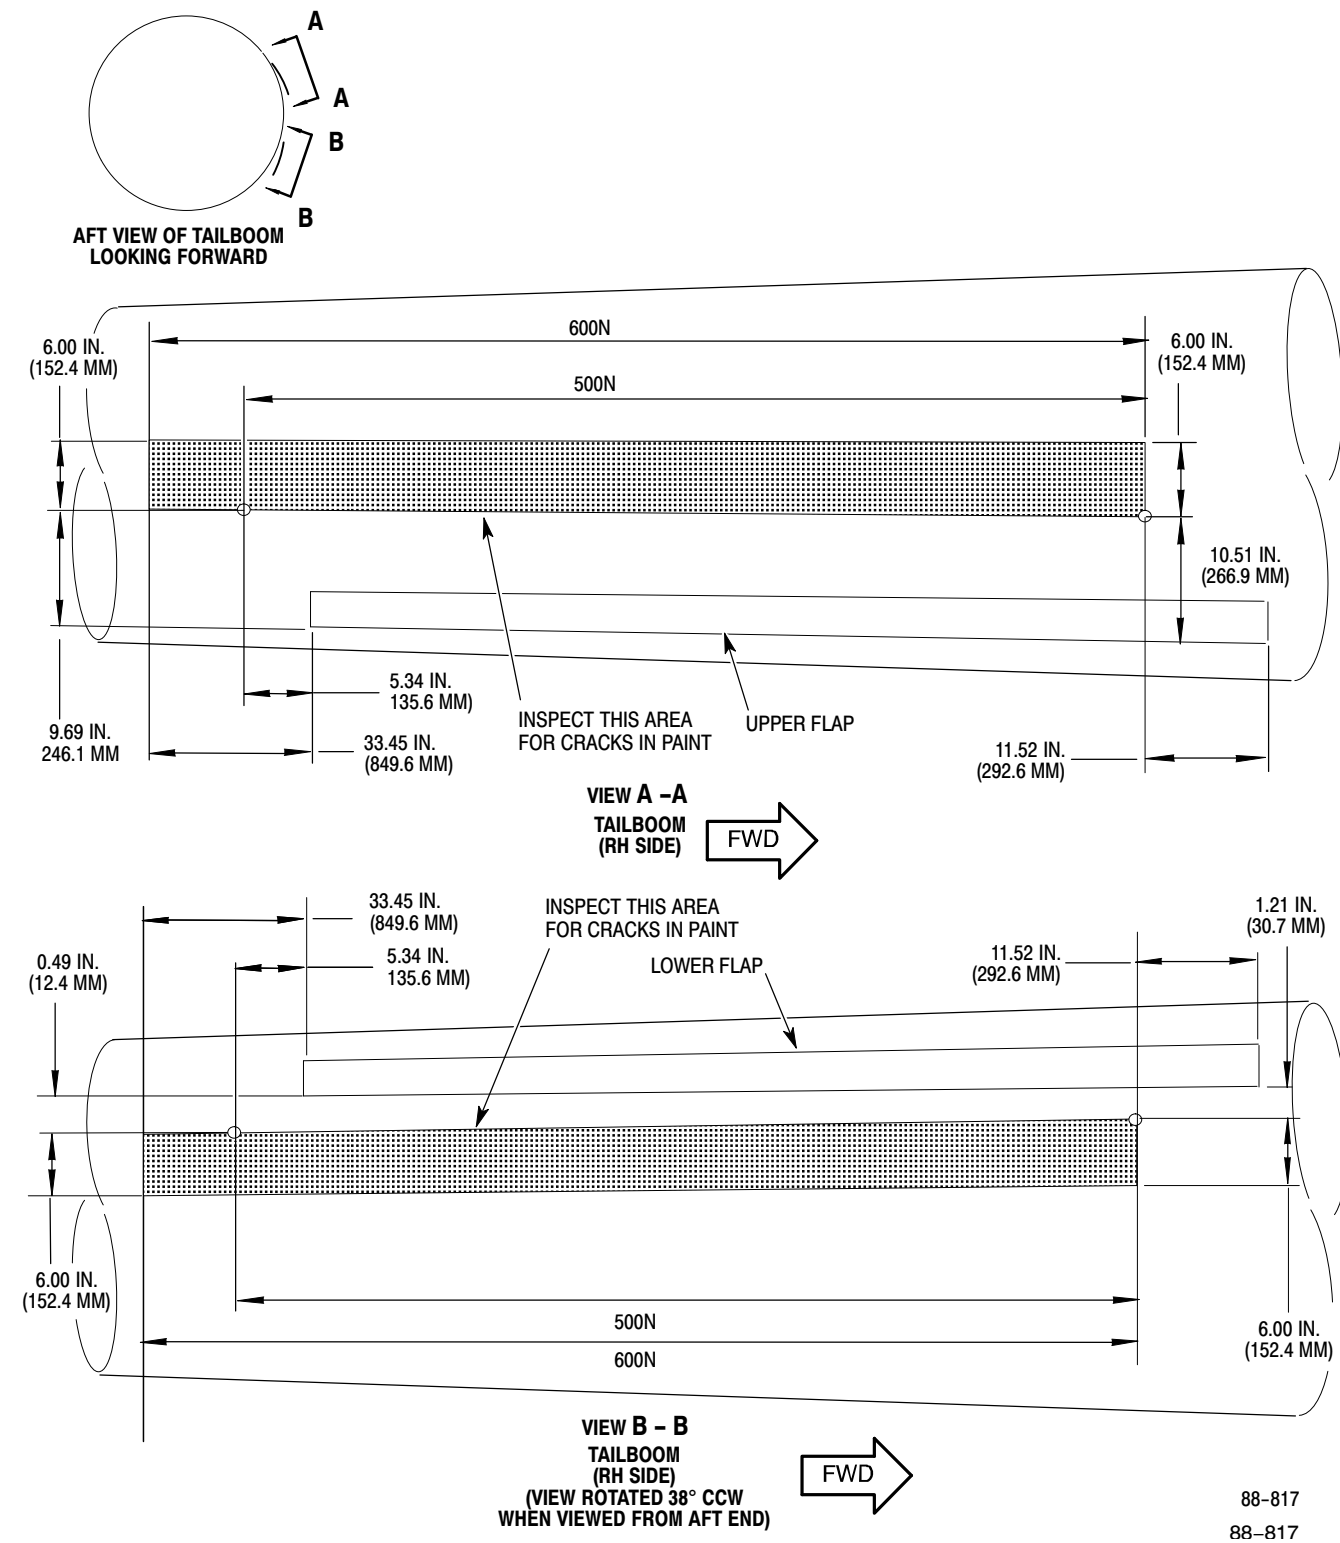
**Figure 1. Tailboom Assembly Inspection**

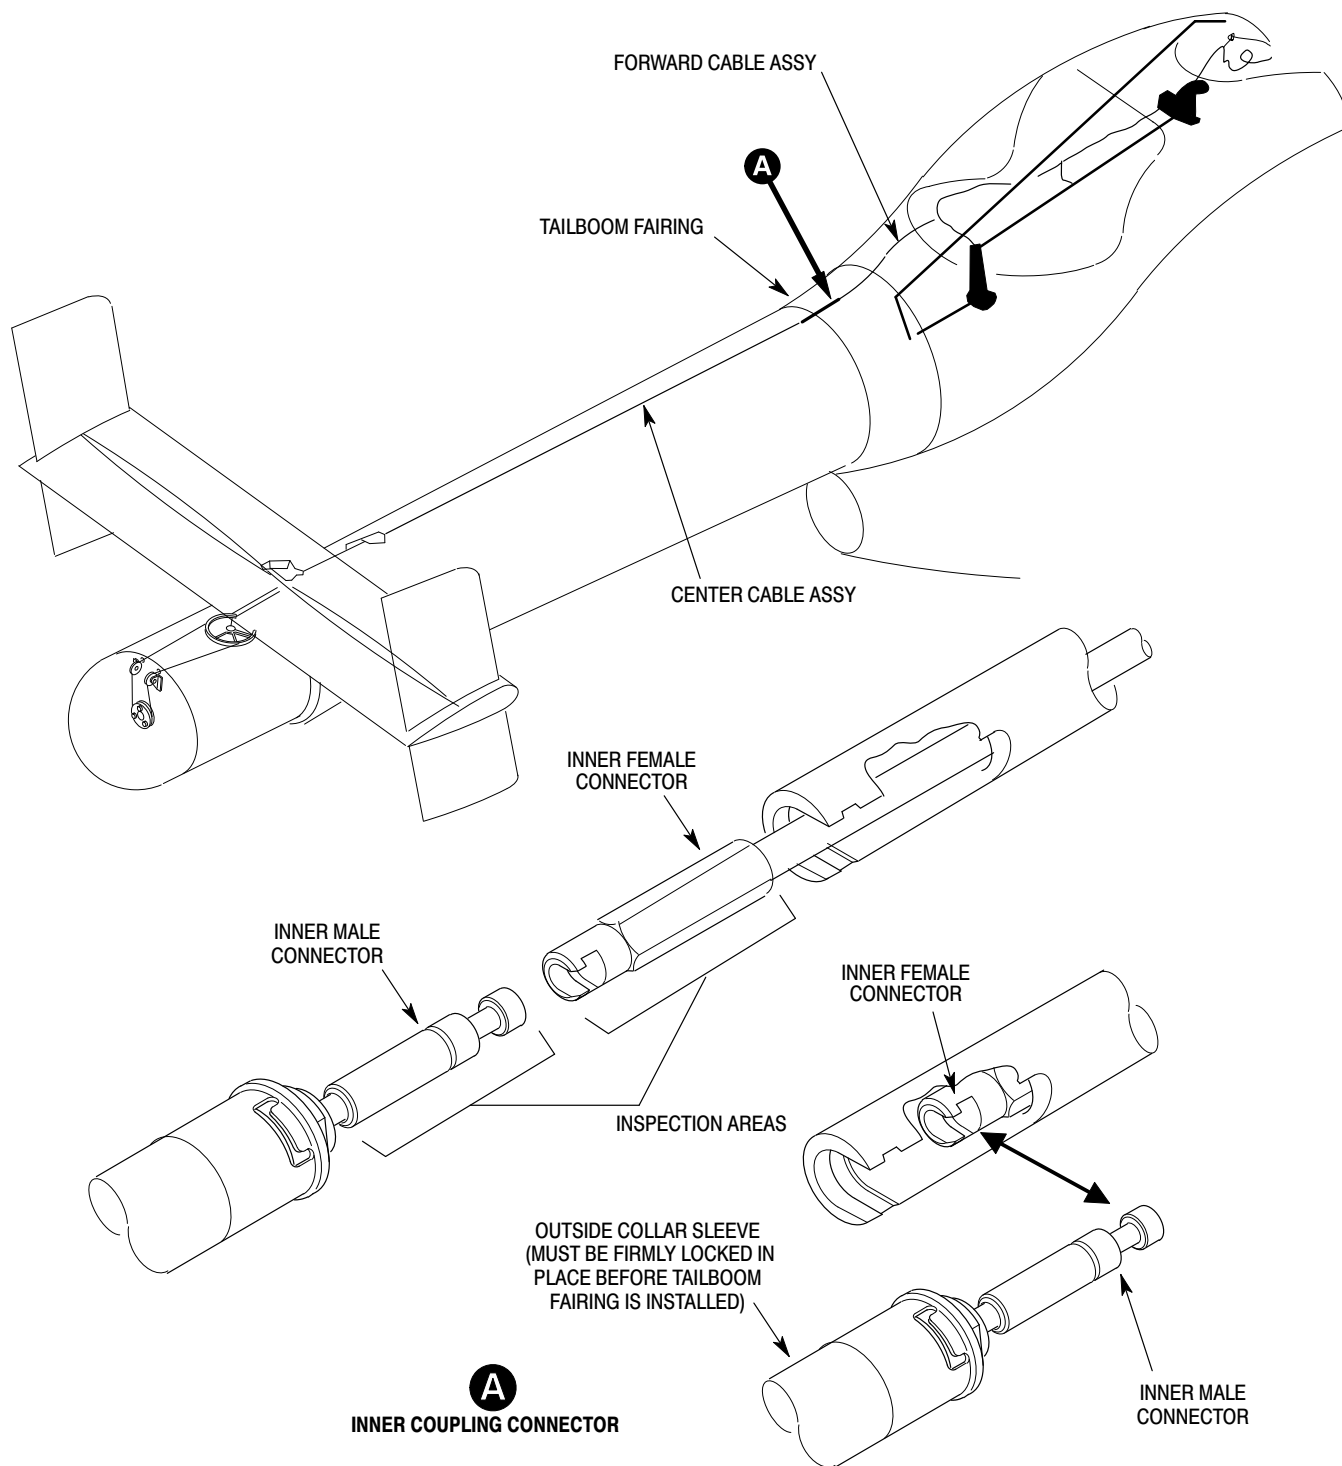
88-821

**Figure 1. Forward and Center Thruster Cable Assembly Connector Inspection**

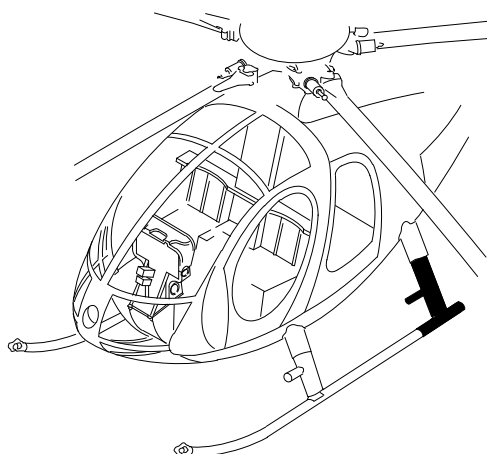
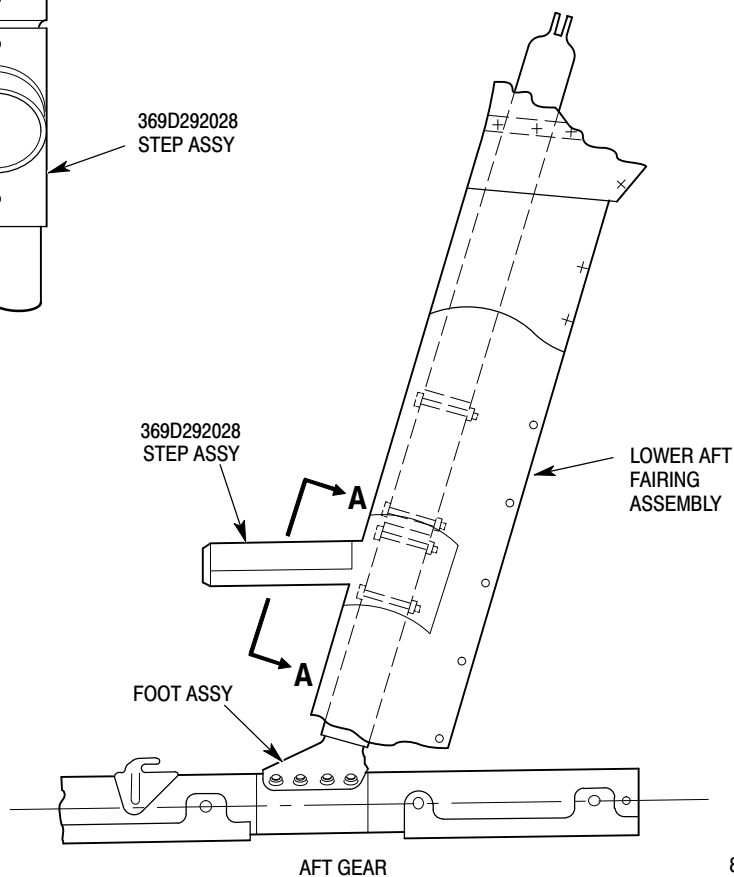
88-569C

1. CHECK AREA OF WELD WHERE STEP ATTACHES TO MOUNTING PLATE. USE 10X MAGNIFYING GLASS.

**Figure 1. Inspection of Aft Extended Landing Gear Step Assembly**
