***MD Helicopters, LLC***

***MD500/600 Series***  
***Service Bulletins Package***

## MODEL 369D, 369E, 369F/FF, 500N, 600N HELICOPTERS (500D, 500E, 530F, 520N, 600N) SERVICE BULLETIN PACKAGE TABLE OF CONTENTS

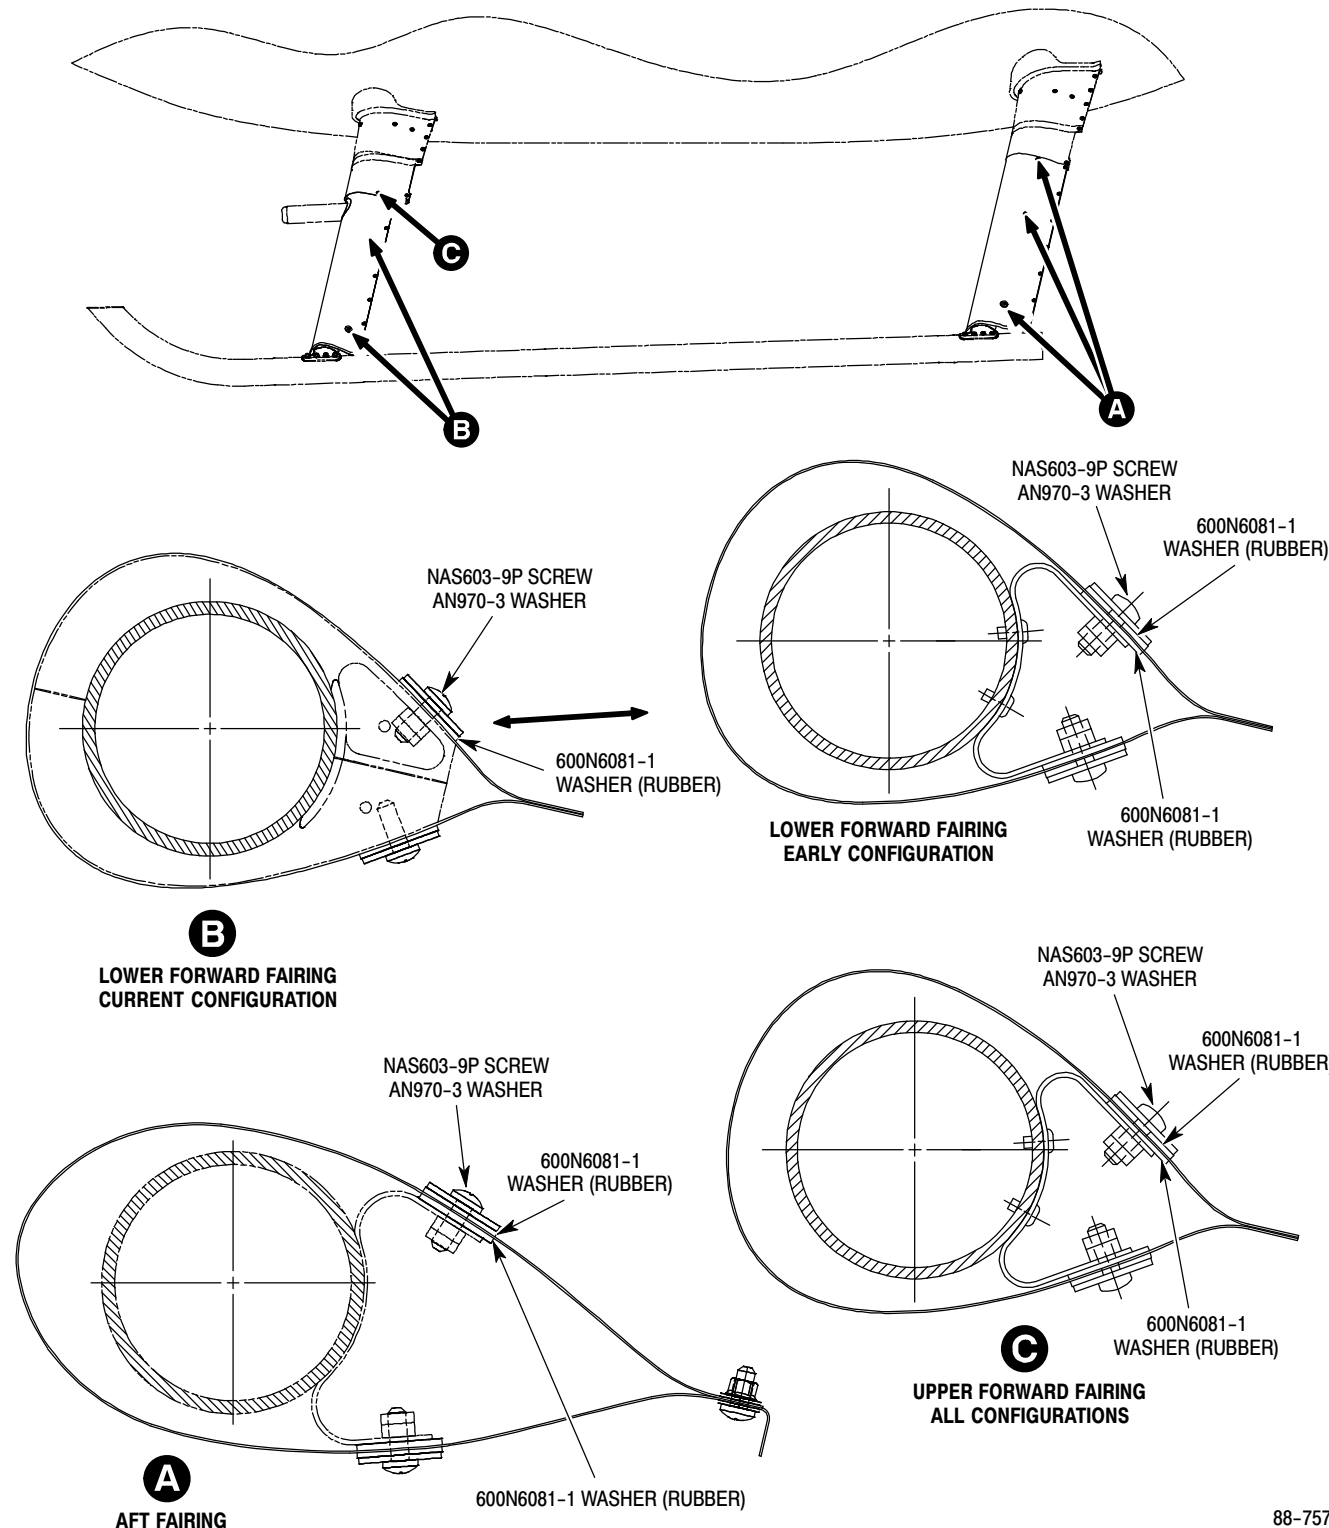
88-757

To prevent possible cracking of the landing gear fairing. Failure to comply with the requirement of this Bulletin may lead to the development of cracks in the landing gear fairings.

**Figure 1. Landing Gear Modification Hardware Installation**

- (1). Remove existing screws and washers from forward and aft landing gear struts at locations shown in Figure 1.
- (2). Install replacement hardware as shown in Figure 1.
- (3). Apply touch-up paint as required.
- (4). Record compliance to this Service Bulletin in the Compliance Record section of the helicopter Log Book.

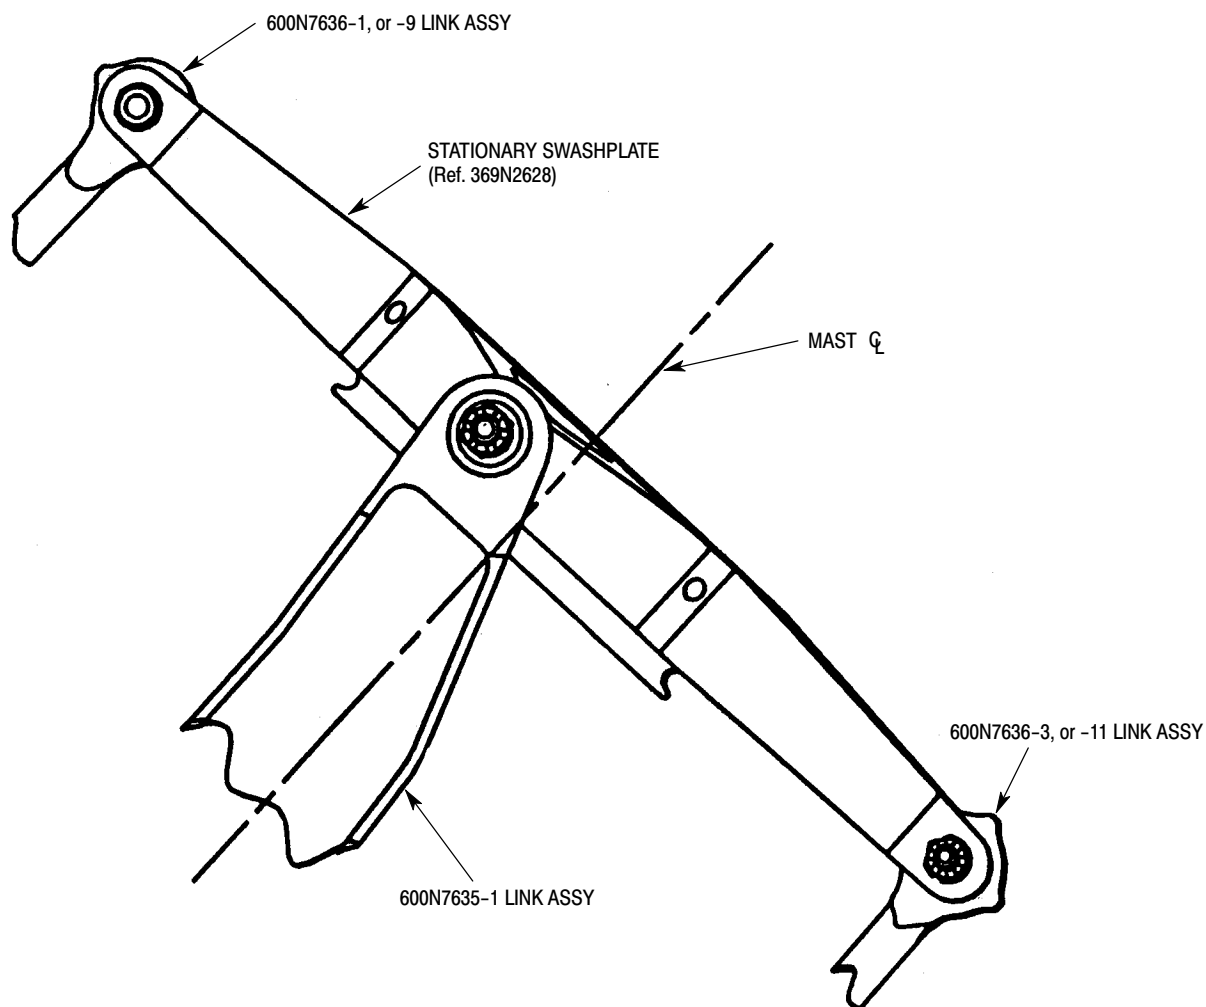
88-758

To recover the cyclic phase shift caused by adding the sixth blade to the main rotor system. Complying with the requirements of this Bulletin will result in reduced pilot workload.

**Figure 1. Cyclic Control Mixer Links Replacement.**

- (1). Replace cyclic control link assemblies as required per instructions contained in the Handbook of Maintenance Instructions (CSP-HMI-2/3, Section 62-30-00).
- (2). Record compliance to this Service Bulletin in the Compliance Record section of the helicopter Log Book.

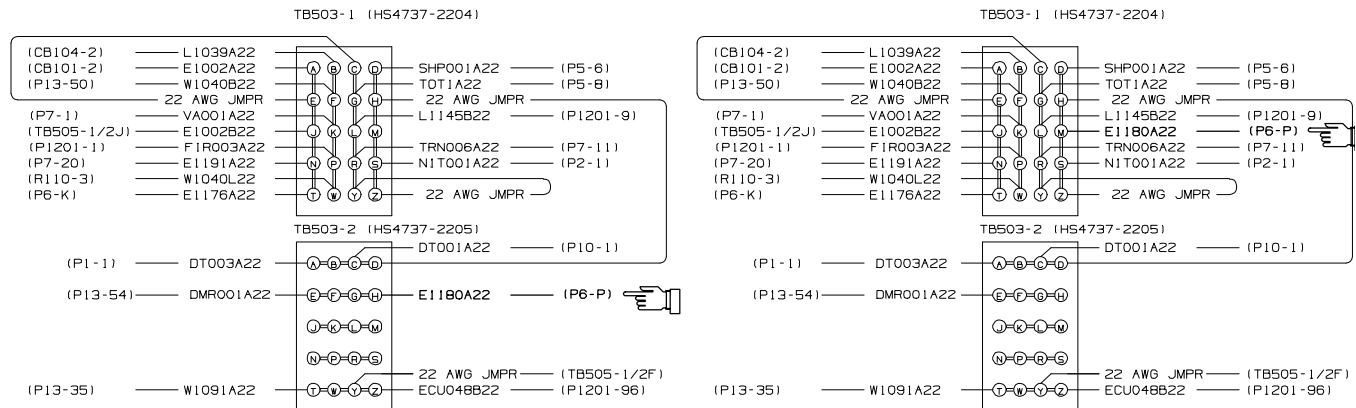
88-760A

**Figure 1. Low Fuel Level Warning Light Circuitry Modification**

- (1). Reconfigure the low fuel circuitry to the original configuration as shown in Figure 1.
  - (a). Relocate wire number "E1180A22" from TB503-1M into TB503-2H. (Ref. Figure 1.)
- (2). Remove fuel quantity indicator (600N8107-5) and replace it with a new configuration fuel quantity indicator (600N8107-13).
- (3). Perform fuel system calibration procedure per CSP-HMI-2, Section 28-00-60.
- (4). Return old configuration fuel quantity indicators to MDHI.
- (5). Record compliance to this Service Bulletin in the Compliance Record section of the helicopter Log Book. Additionally, return/fax the attached compliance form to MDHI.

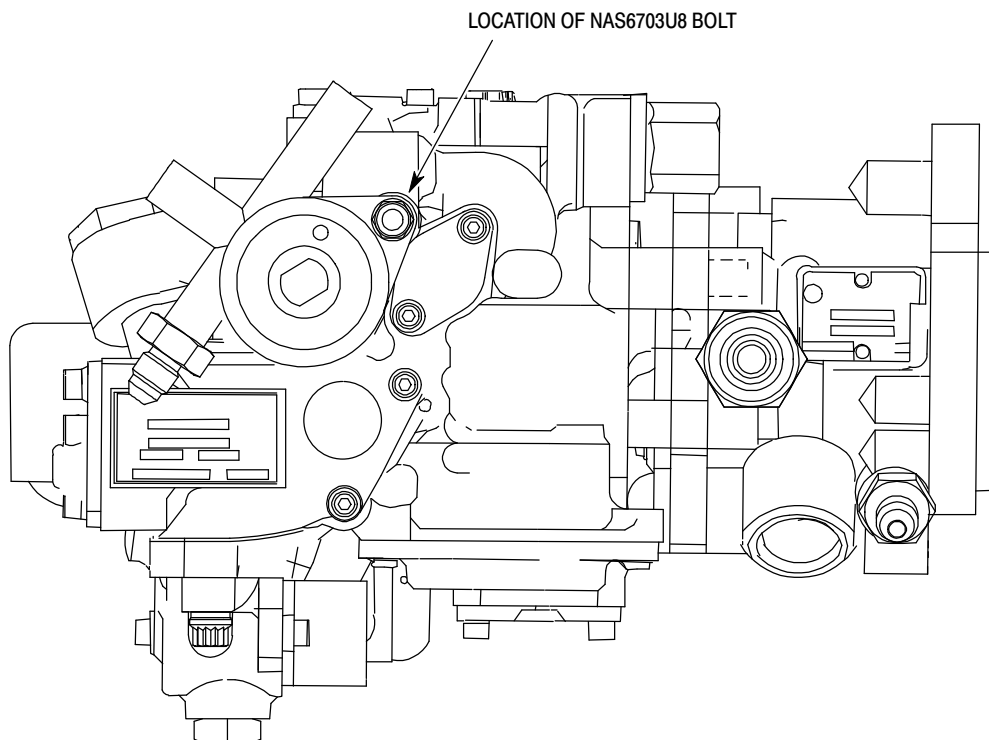
88-763

Inspection of an aircraft after a recent ground run revealed that the subject bolt had fallen out. A longer bolt will provide proper thread engagement and eliminate this from happening. Failure to comply with the requirements of this Service Bulletin may result loss of engine throttle control. This condition may result in a precautionary/emergency landing situation.

**Figure 1. Engine Fuel Control Box Attachment Bolt Replacement.**

- (1). Replace NAS6703U6 bolt with NAS6703U8 bolt per instructions contained in the Handbook of Maintenance Instructions (CSP-600HMI-2/3) Section 76-00-00 (ref. to Figure 1 below). **NOTE:** This installation is also shown in the Illustrated Parts Catalog (CSP-IPC-4, Section 71-00-60, Figure 3).
- (2). Record compliance to this Service Bulletin in the Compliance Record section of the helicopter Log Book.

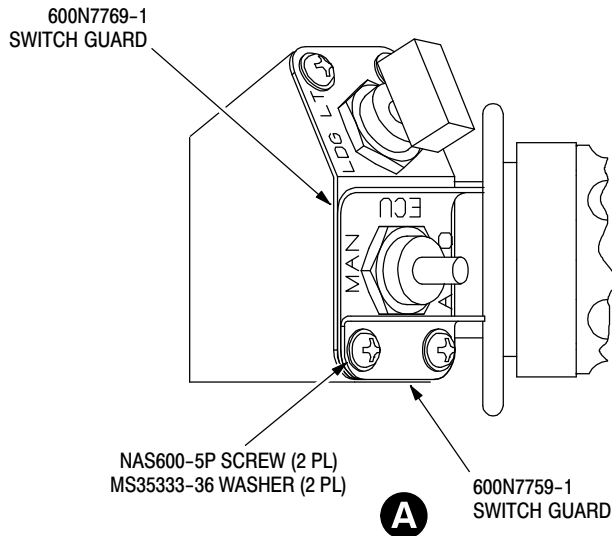
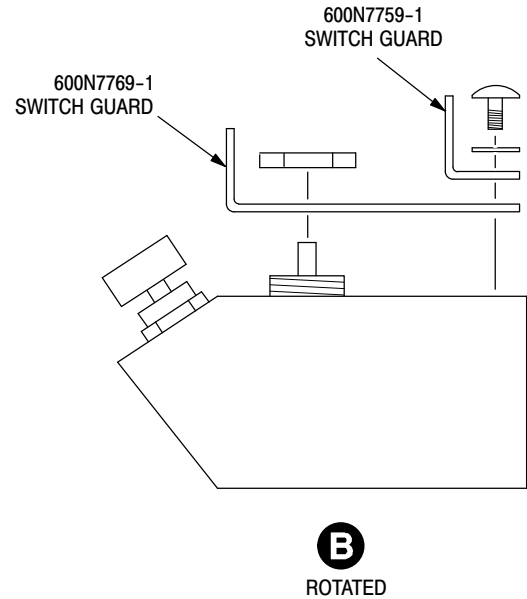
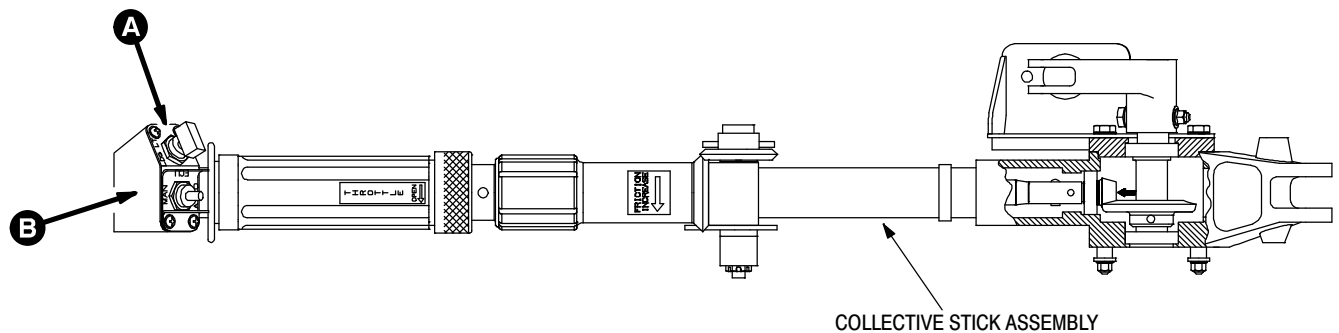
88-766

To install an additional guard near the Engine Control Unit (ECU) (manual/auto) switch located on the collective stick assemblies. The new guard provides additional protection against inadvertent ECU switch activation. Failure to comply with the requirements of this Bulletin may result in the switch being turned to manual mode during flight which could cause unanticipated speed-up or slow down the engine with associated changes in rotor RPM leading to possible overspeed.

**Figure 1. ECU Switch Guard Modification.**

Procedures in this Bulletin provide owners and operators with information pertaining to adding an additional guard to the collective stick assemblies noted above. The additional guard will add protection to both sides of the switch.

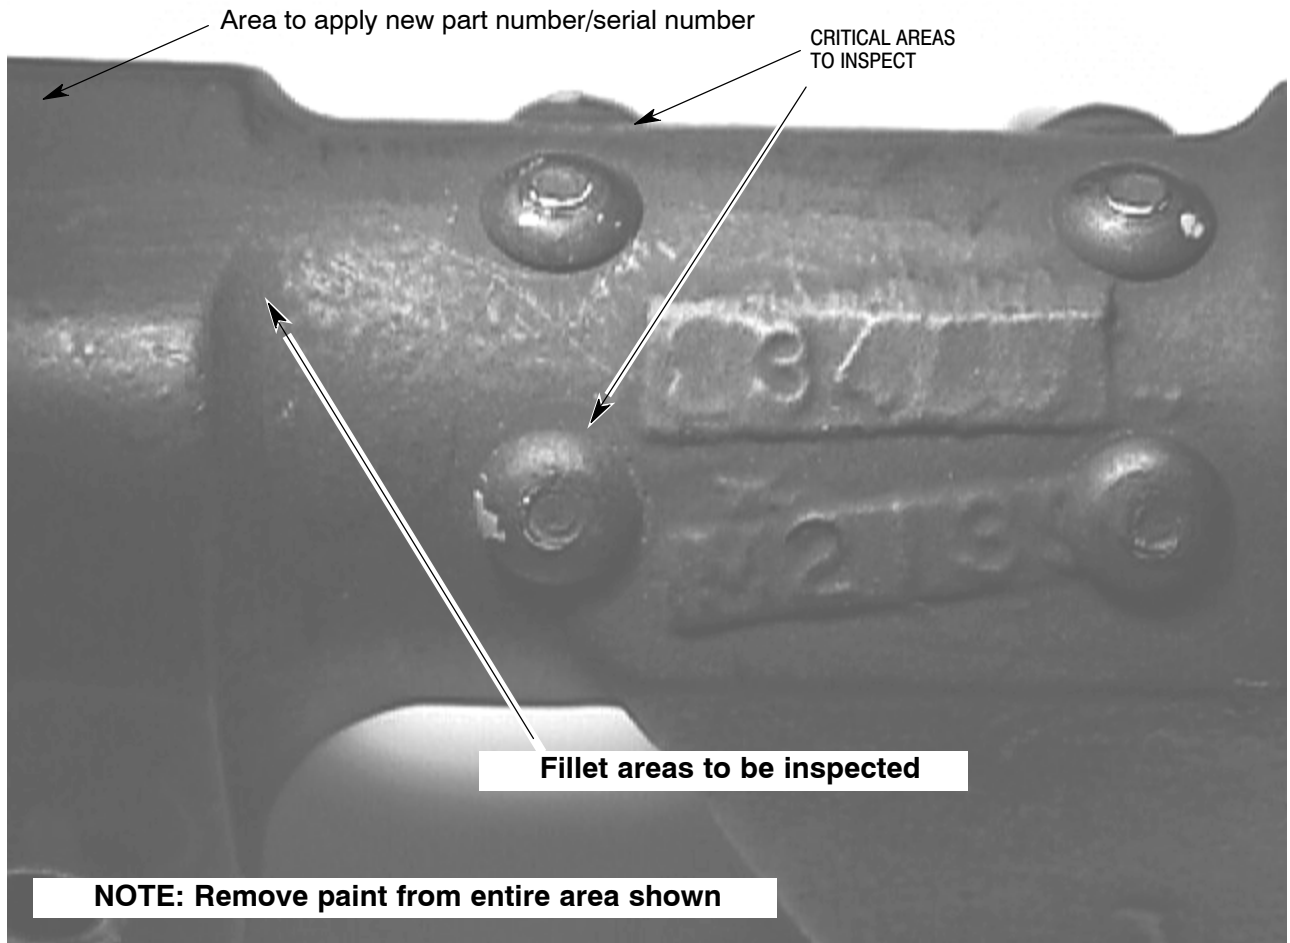
Figure 1. Cyclic Control Stick Inspection (Pilot)

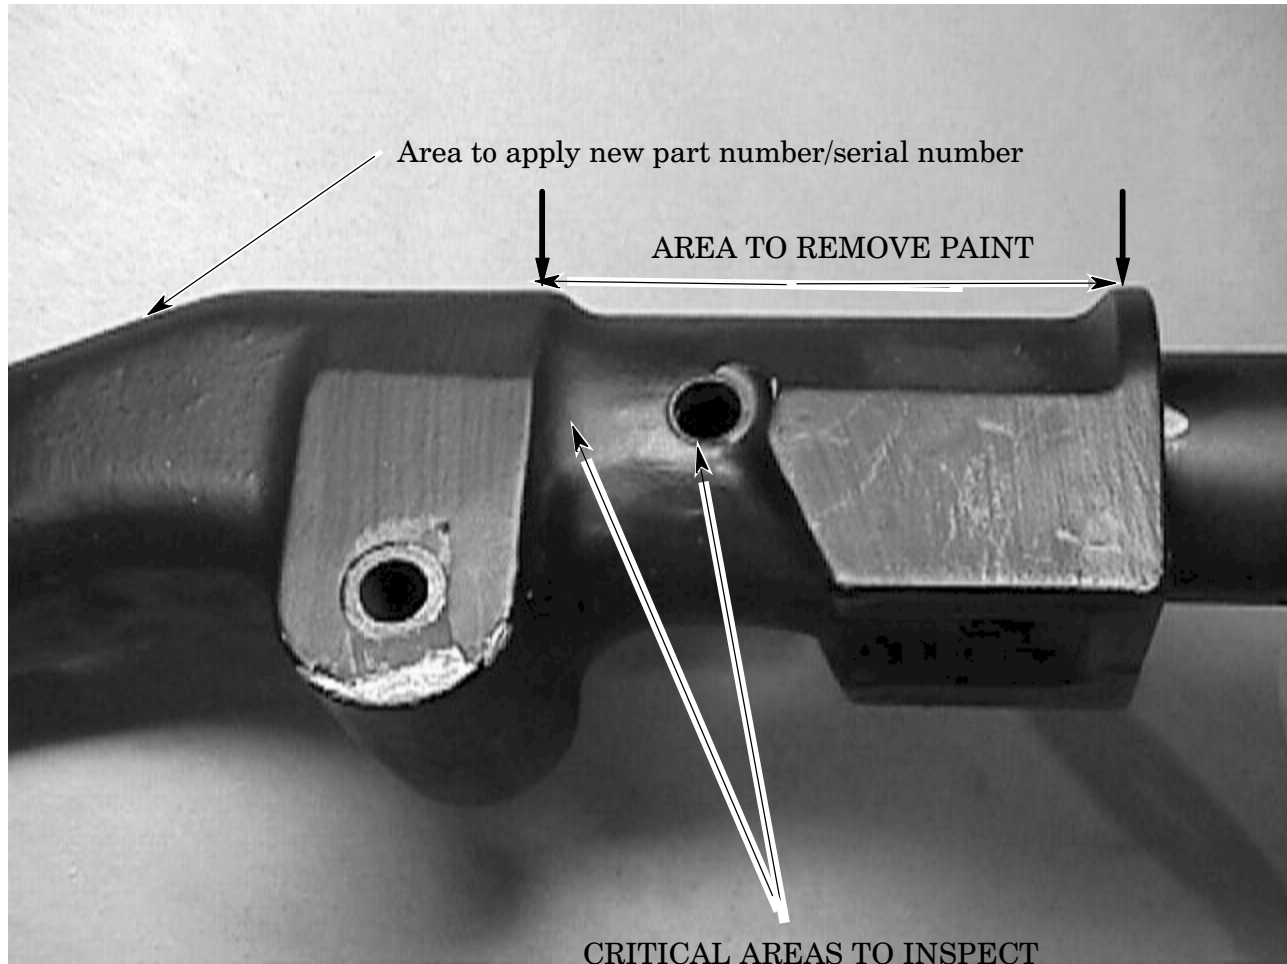
Figure 2. Cyclic Control Stick Assembly Inspection (Co-Pilot)

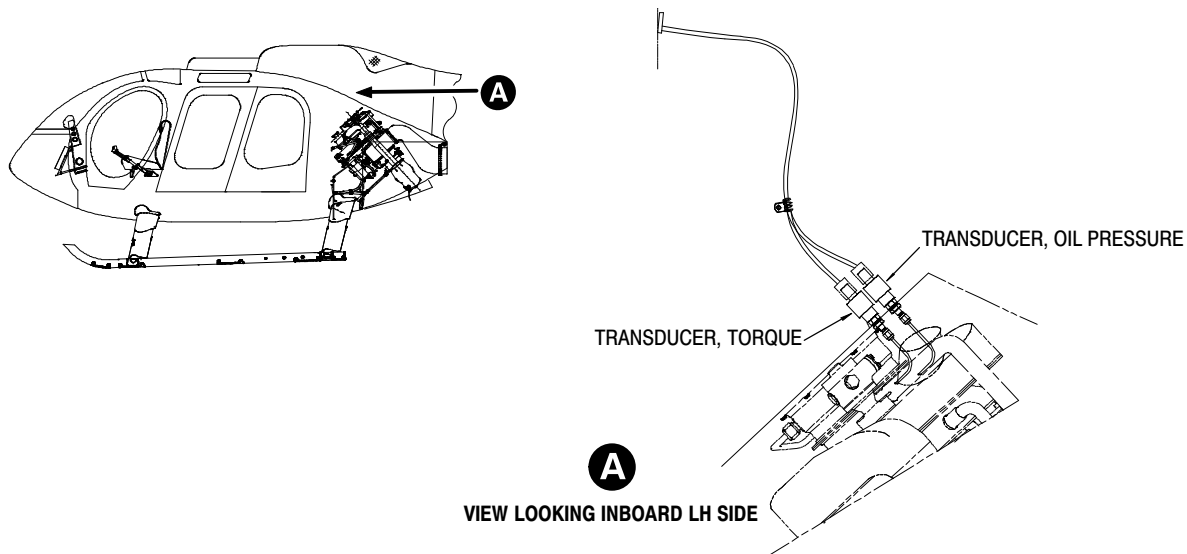
88-772

**Figure 1. Pressure Transducer Location**

- (1). Replace existing torque pressure transducer P/N PX9606 with new P/N PX9606-1 torque pressure transducer (Ref. CSP-HMI-2).

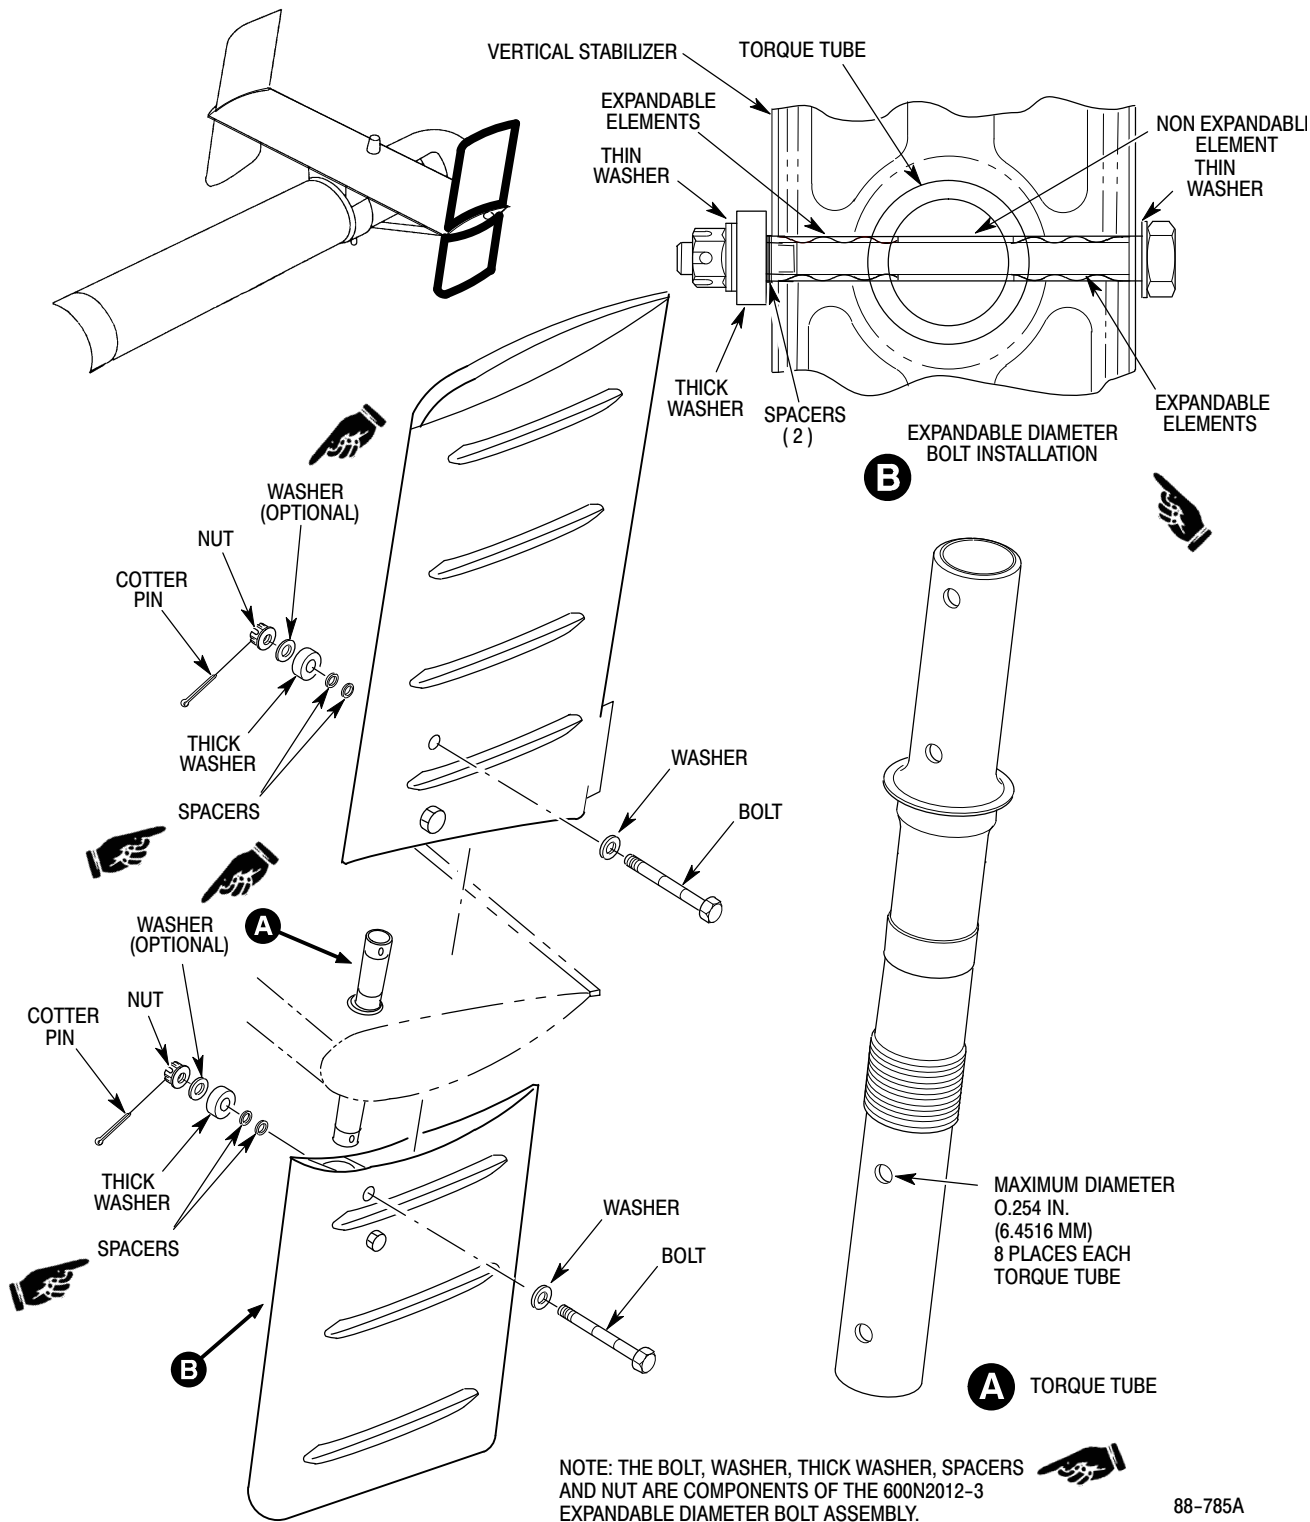
**Figure 1. Torque Tube Inspection and Expandable Diameter Bolt Installation**

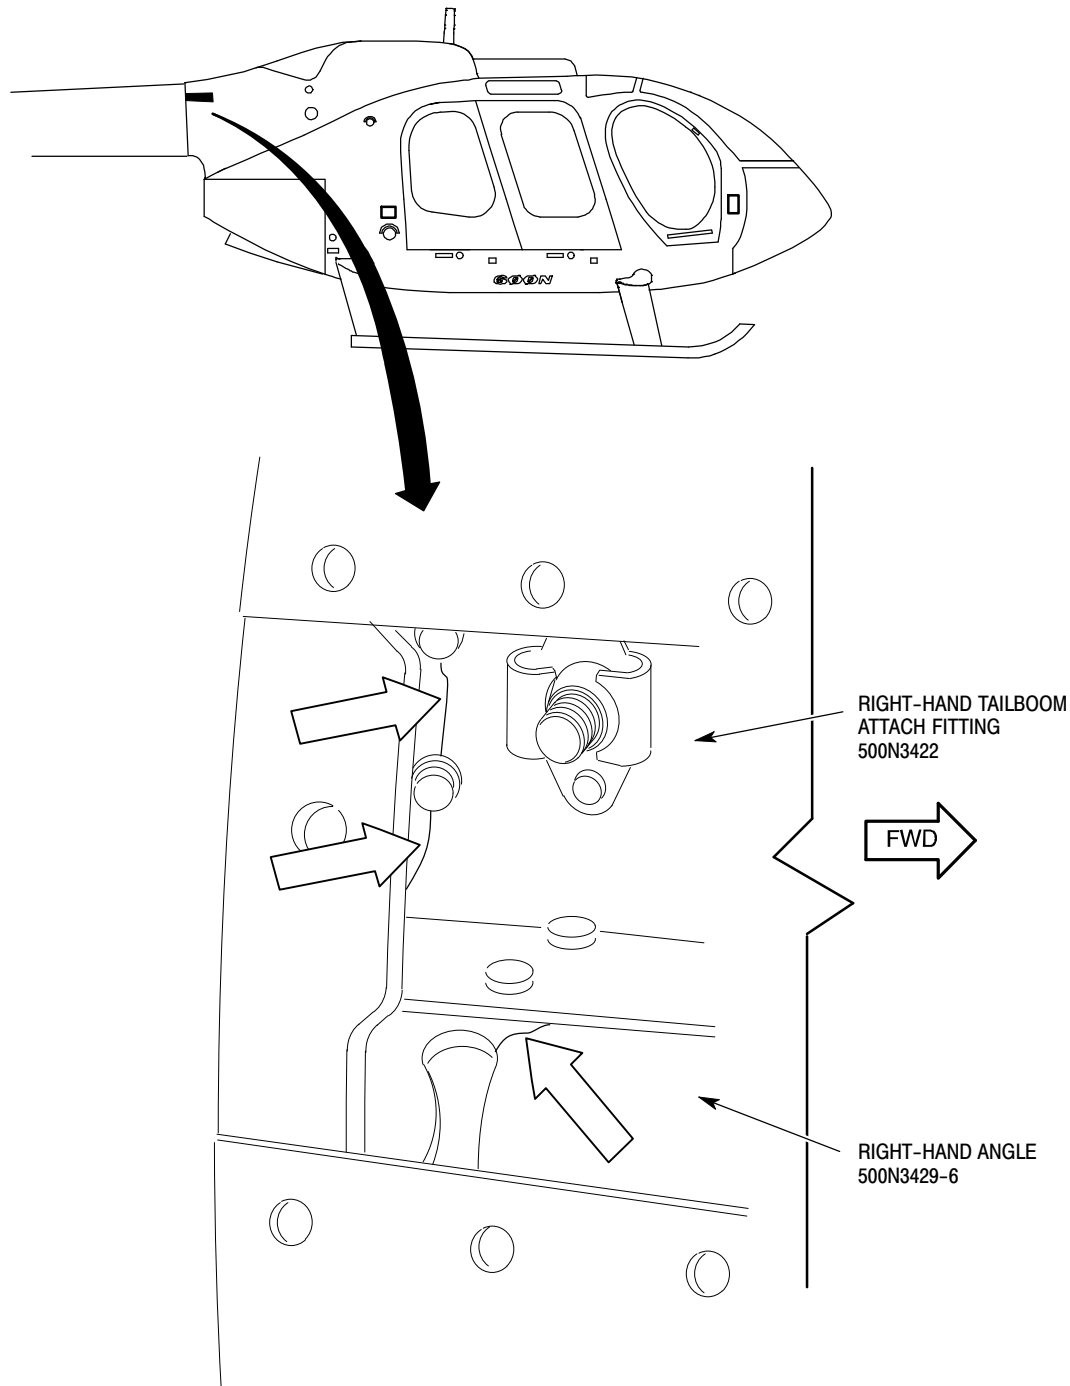
88-799

**Figure 1. Tailboom Attach Fitting and Angle Inspection**

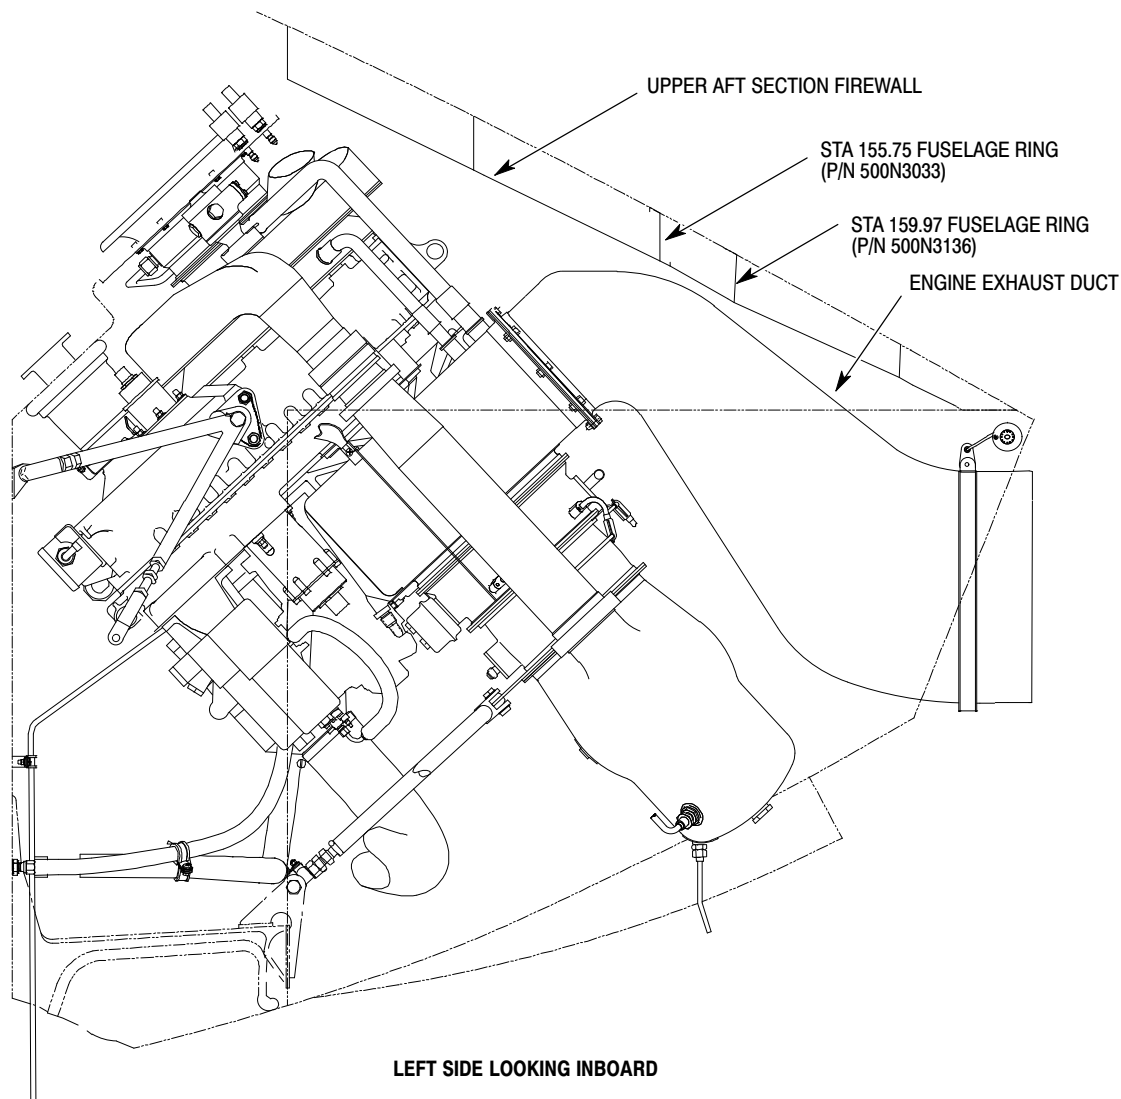
88-814

**Figure 1. Engine Exhaust Duct Inspection**

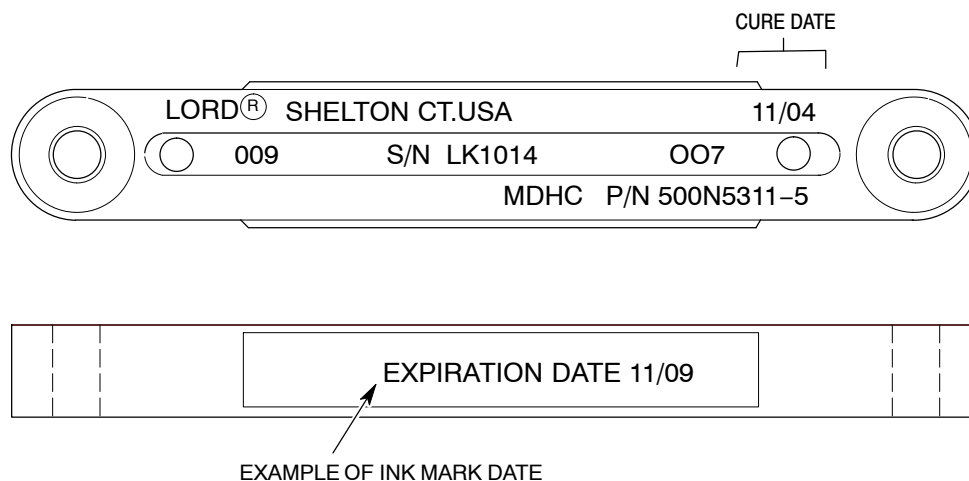
88-792

**Figure 1. Fan Tension-Torsion Strap Assembly**

- (3). Install new tension-torsion straps, retainer pins, bolts, countersunk washers, flat washers and cotter pins (Ref. CSP-HMI-2, Section 64-25-30).
- (4). Make a record in the Compliance Record section of the Rotorcraft Log Book that Part 2 of this bulletin is completed.

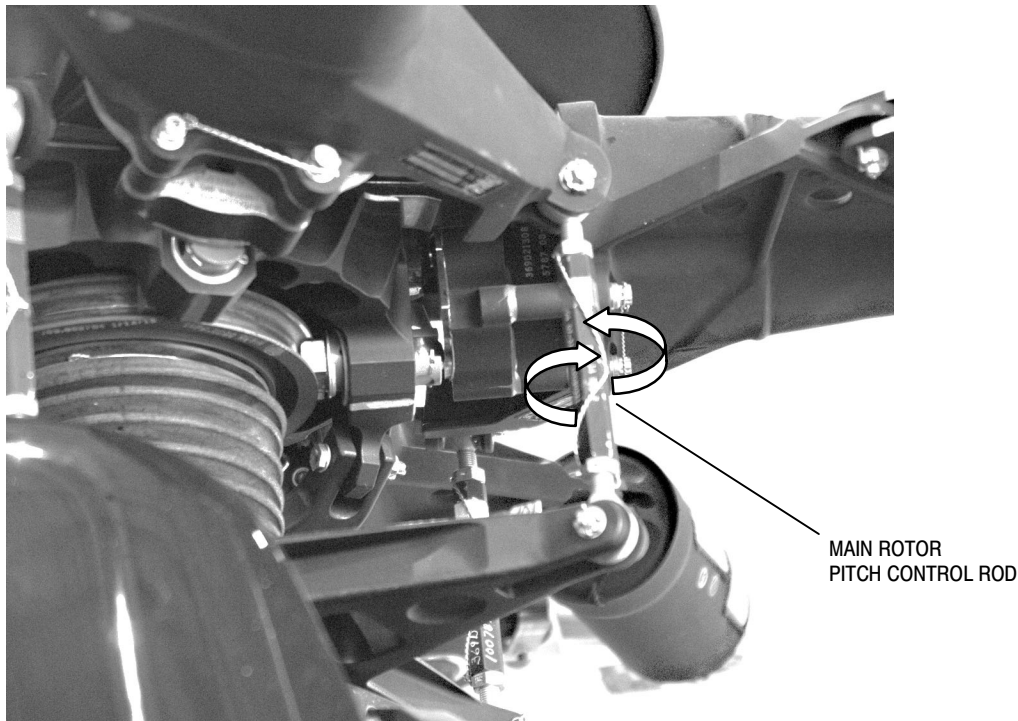
88-825

**Figure 2. Main Rotor Pitch Control Rod Assembly Movement Check**

- (3). If the main rotor pitch control rod assembly turns back and forth freely, do the following step:
  - (a). Do Step 2.E. for replacement of the main rotor pitch control rod end at a later date. Replacement can be postponed for a period of up to, but no later than, 300 flight hours or one year, whichever occurs first.
- (4). Do Step 2.B.(1)., Step 2.B.(2)., and Step 2.B.(3). again for each main rotor pitch control rod assembly.

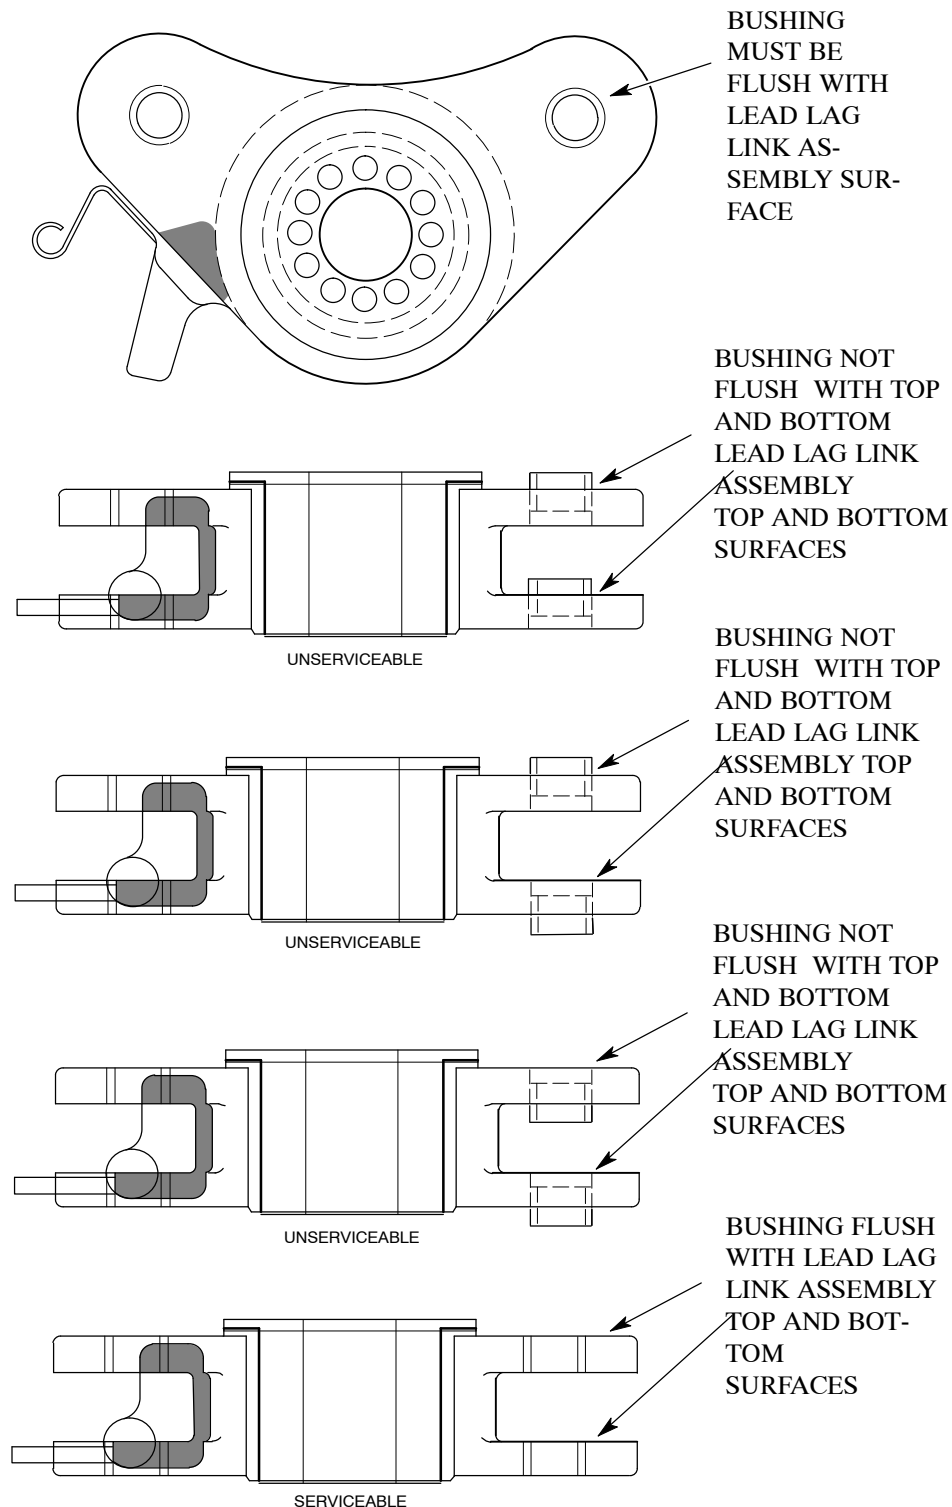
88-826

**Figure 1. Examine Main Rotor Hub Lead Lag Link Assembly Bushings**

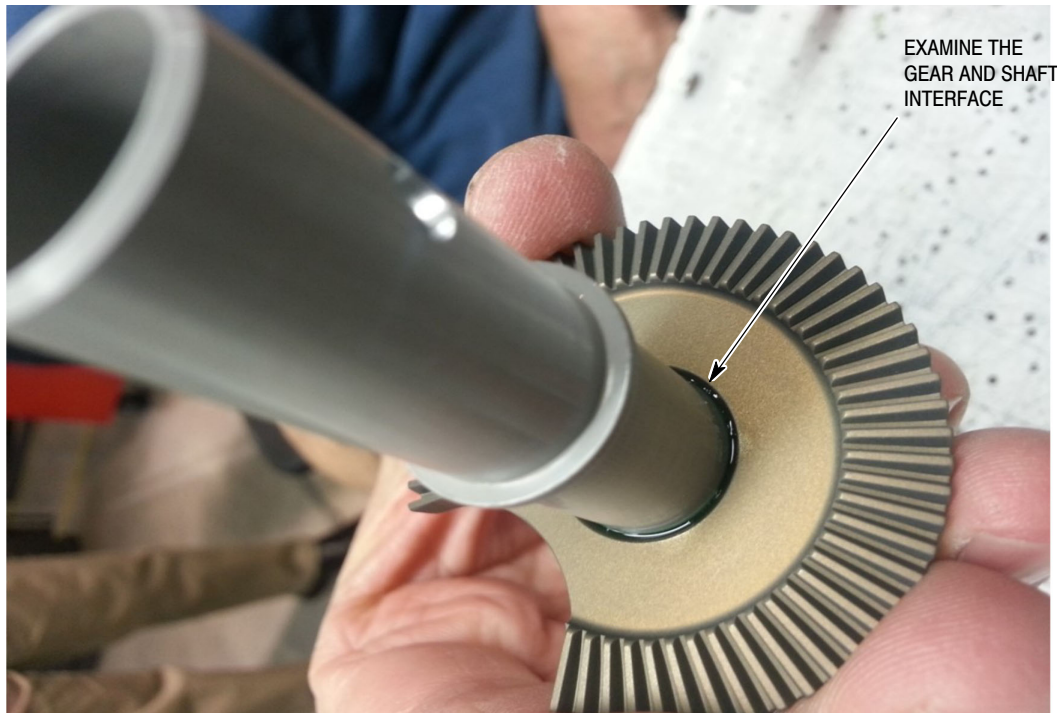
**Figure 2. Inspection of the Gear Shaft Assembly**

- (3). Examine the gear shaft assembly with a 10X magnification glass and strong light for evidence of Loctite.
  - (a). If there is Loctite, there will be a blue to green sheen in the interface of the gear and shaft.
  - (b). If there is no Loctite, return the gear shaft assembly to MDHI for replacement.

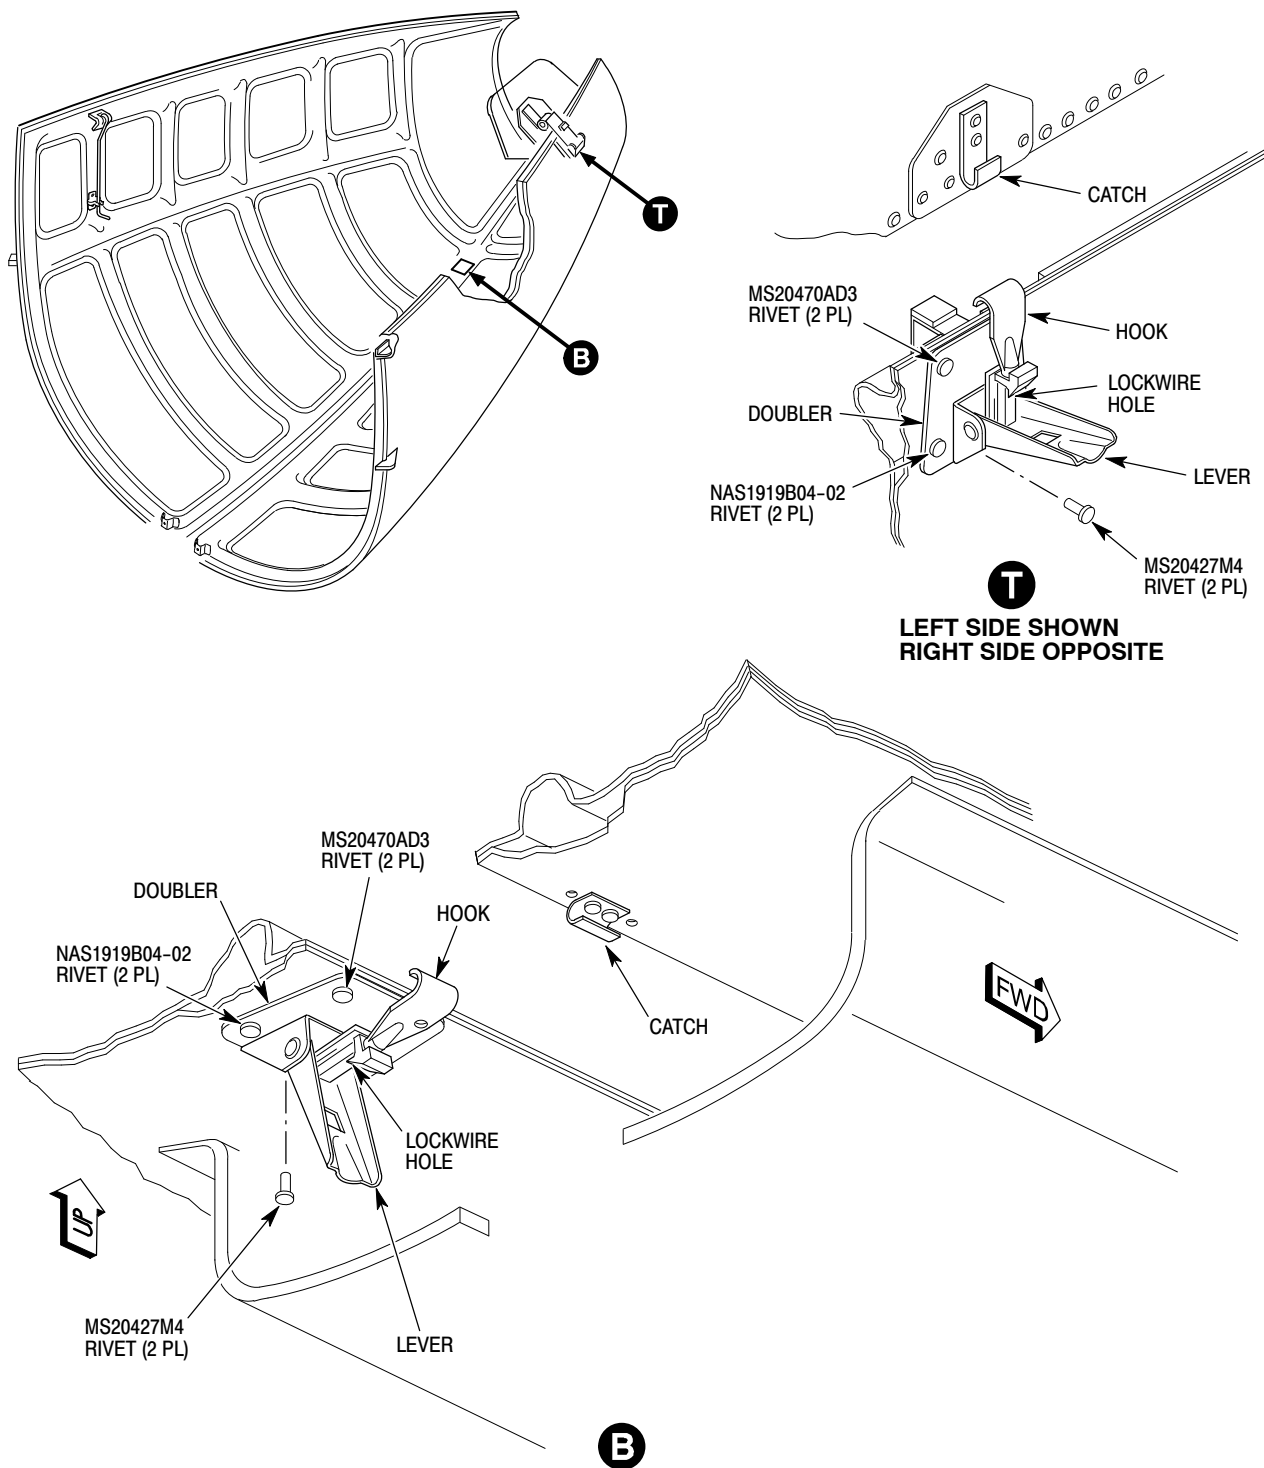
**Figure 1. Location of Latch Assemblies**

The V951L04-1X3BP latch assemblies, which are used in three places to lock the engine bay doors does not have the necessary lockwire hole in the draw hook. The lockwire provision is used to safety the draw hook once rigged. The 51L1-3X3AA latch assembly is an obsolete latch which must be replaced. A 369D22024-23 latch assembly is available for replacement of the latches without the lockwire hole and for 51L1-3XAA latches. Also, 369D22024-23 latches can be used to replace broken, missing, or worn 51L1-3XH3AA latches, as necessary, under normal service conditions.

Failure to comply with this bulletin can cause an installed latch assembly to become disengaged and cause the engine bay doors to become loose or open.

Procedures in this bulletin give owners and operators information to exchange latch assemblies with missing lockwire holes or obsolete latch assemblies for new latch assemblies with the lockwire holes.

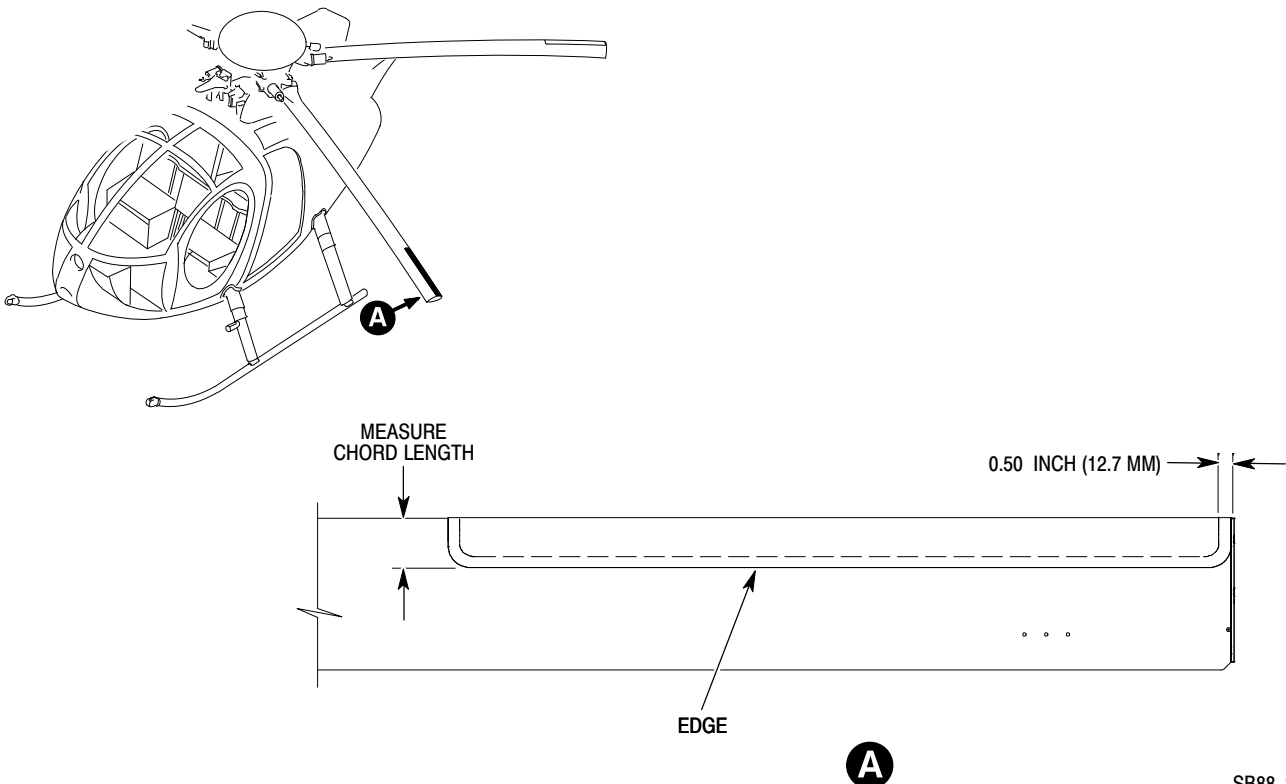
**Figure 1. Inspection of the Abrasion Strip**

Failure to comply with this bulletin can result in delamination or disbondment of the abrasion strip during operation. A loose abrasion strip or the loss of an abrasion strip can cause vibration and possible loss of control of the helicopter.

- (a). Examine the top and bottom of the abrasion strip installation for blisters, bubbles, delamination, and disbondment.
    - 1). Replace a main rotor blade with a blister, bubble, delamination, or disbondment.

- (b). Do a tap test (ref. CSP-HMI-3, Chapter 20, Nondestructive Inspection) on the top and bottom of the abrasion strip installation to find a void or voids (spaces of missing material below a surface with no indication of defects or damage):

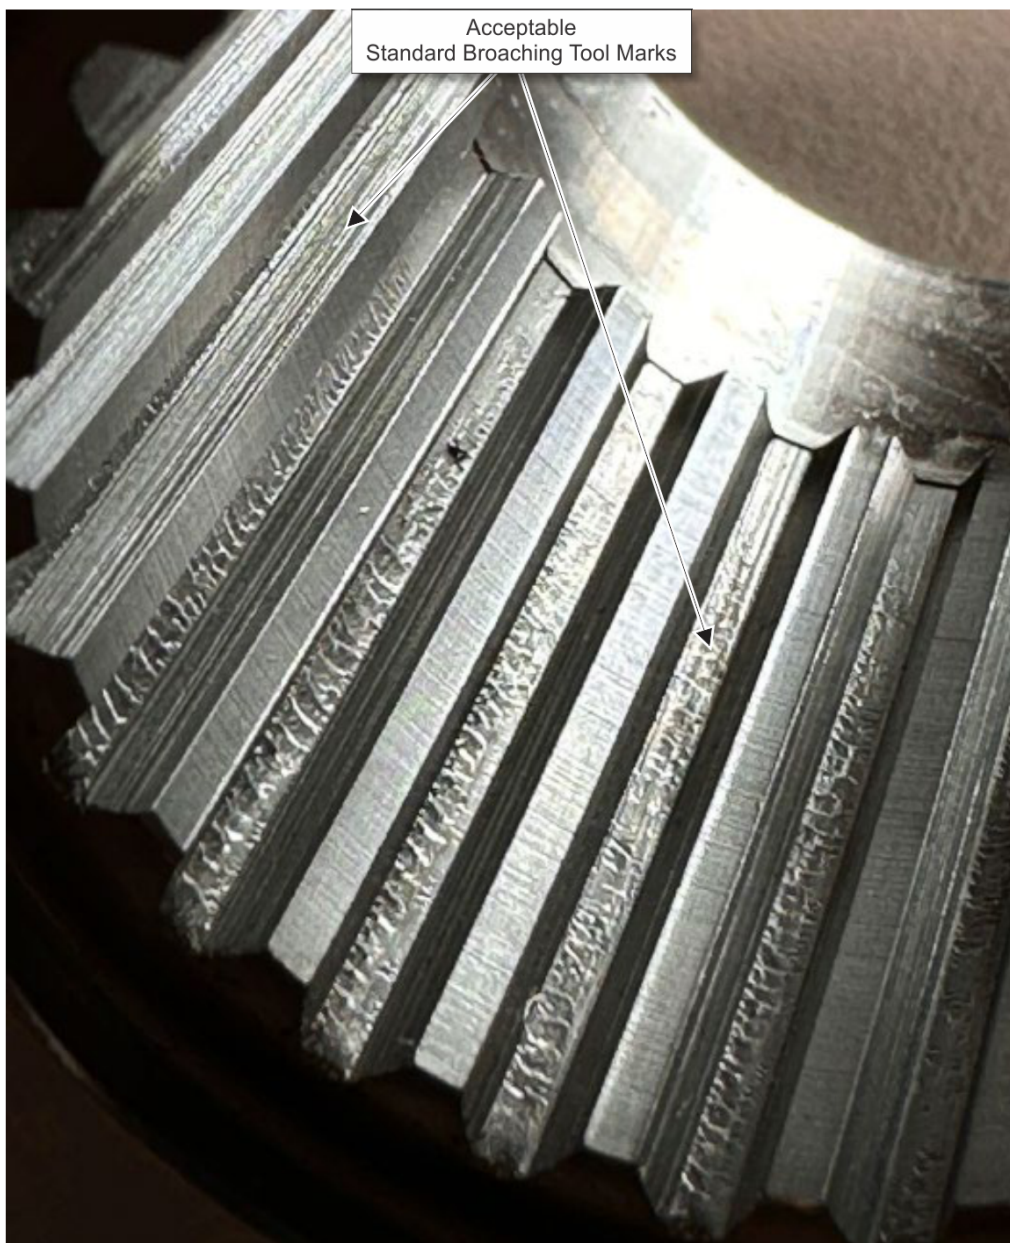
**Figure 1. Sample Image of Acceptable Splines**

**NOTE:** THE APPEARANCE OF TOOL MARKS DUE TO THE BROACHING PROCESS MAY BE PRESENT IN THE SPLINE AREA. THESE MARKS ARE COSMETIC ONLY AND NOT GROUNDS FOR REJECTION OF THE COUPLING.
